ER 2742  
DESIGN AND DEVELOPMENT  
OF A MAJOR ENGINE COMPONENT (COMPRESSOR)  
FOR A 60-KW TURBINE GENERATOR SET

FINAL REPORT

JUNE 1977

to  
US ARMY MOBILITY EQUIPMENT RESEARCH AND  
DEVELOPMENT COMMAND  
ELECTRICAL POWER LABORATORY  
FT. BELVOIR, VA 22060  
Report Under Contract No. DAWK02-75-C-0399

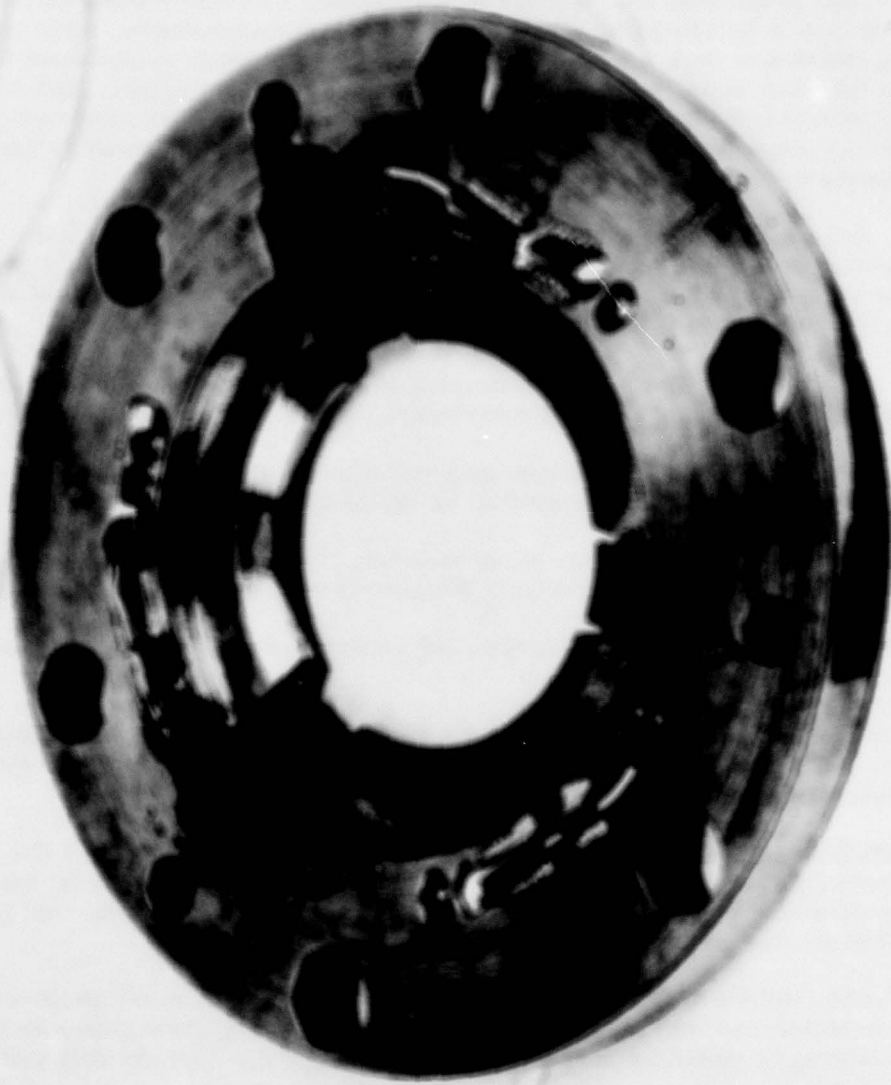
Figure 38. Bearing Thrust Monitoring Device

During the early phase of the test program, the rig was modified to incorporate a strain gage, thrust-measuring device to evaluate rotor end thrust during rig operation. Figure 31 shows the strain-gage bearing retainer plate that was used to measure the axial load on the thrust bearing. The gages are in a two-gage bridge

to provide temperature compensation and are epoxy-connected into position on three flexible tabs which support the bearing outer race. These tabs have a spring rate of approximately 750,000 lb/in. The tabs were spring-loaded to allow measurement of thrust loads in the range of -50 to +300 pounds. The thrust bearing is spring-loaded against a retainer plate by three ball-bearing washers acting against a floating bushing between the bearing and housing.

During the initial mechanical check runs, bearing thrust load instrumentation was not working correctly and further problems were experienced with the epoxy adhesive, which was found to be unsuitable for this application.

The transducer gages were replaced and bonded with a high performance adhesive called M-bond 610, which is formulated specifically for bonding transducer strain gages in applications up to 450°F. Prior to assembly in the engine test rig, the strain gage circuits were checked in a laboratory oven for temperature compensation up to 300°F. Also incorporated into the current build of the engine test rig was an increase in the bearing thrust preload from 50 to 100 pounds. This allowed negative bearing thrust to be measured up to 100 pounds. On the third mechanical checkout run, the bearing thrust-measuring device, which was now operating satisfactorily, indicated a negative thrust (toward engine exhaust) of 30 to 35 pounds while the engine test rig was operating at approximately 70 percent speed. The rotor thrust measuring device indicated 64 pounds negative while operating at approximately 98.5 percent speed.

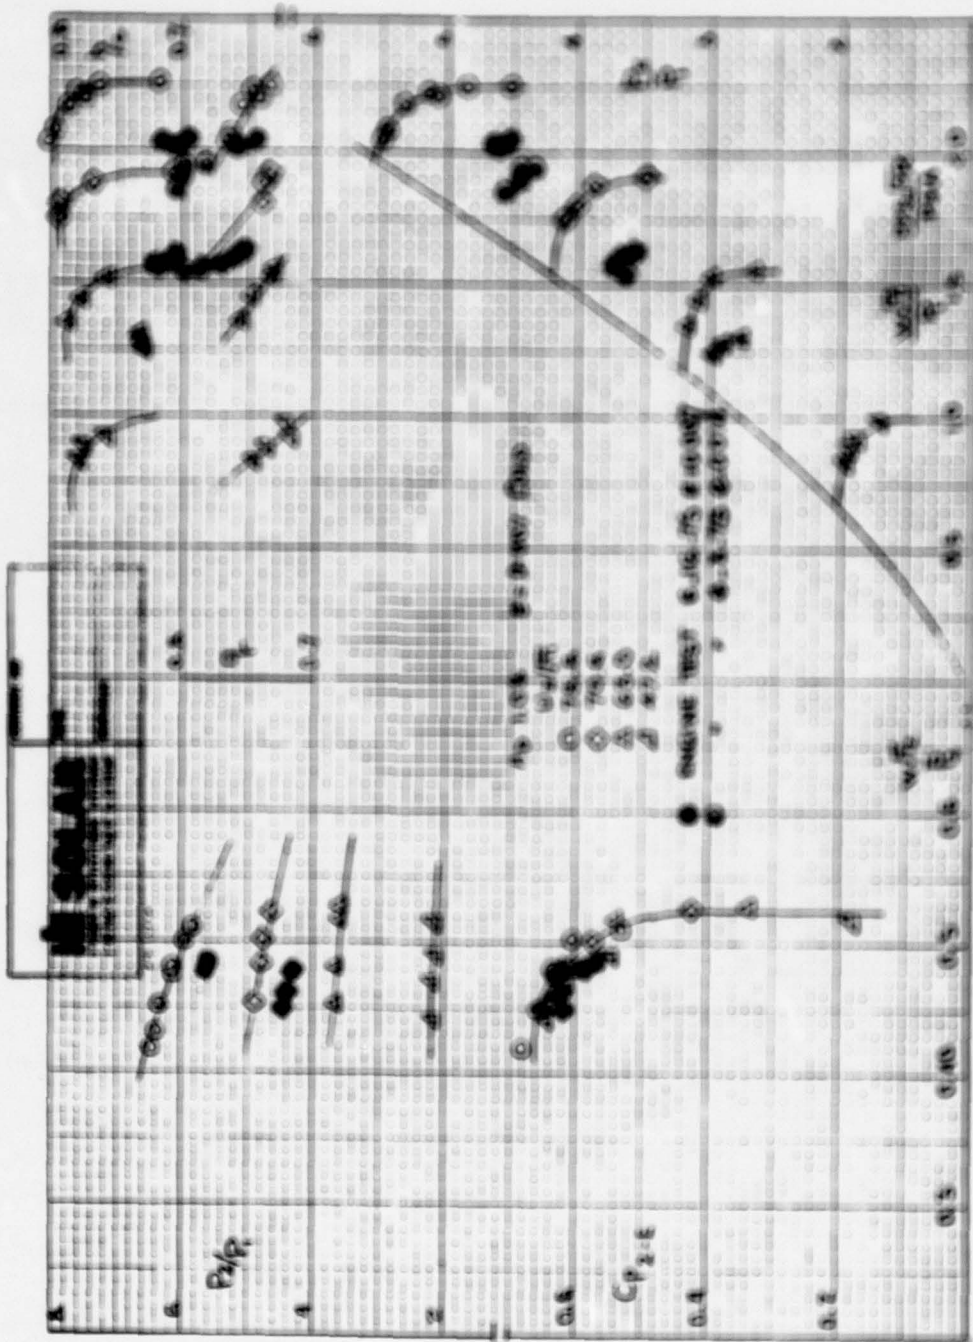
Figure 36. Compressor Performance (0.024-Inch Shroud Clearance)

Impeller axial clearance was therefore reduced to 0.014 inch on the next performance calibration on 6-3-75. The peak pressure ratio increased slightly to 4.6, see Figure 36. Examination of the compressor on subsequent shutdown revealed that the abrasible shroud coating had not been touched; thus, it was decided to re-shim to further reduce the axial clearance to the design setting of 0.007 inch and return the engine test rig for calibration. Subsequent compressor performance (obtained 6-16-75) showed that at design speed peak pressure and efficiency had increased to 4.7 and 72 percent respectively with a 13 percent increase in airflow. The results of this test are also shown on Figure 36.
