INVESTIGATION OF AN ALUMINUM ROLLING HELIX CRASH ENERGY ABSORBER

ARA, Inc.
2017 W. Garvey Avenue
West Covina, Calif. 91790

May 1977

Final Report for Period February 1975 - December 1975

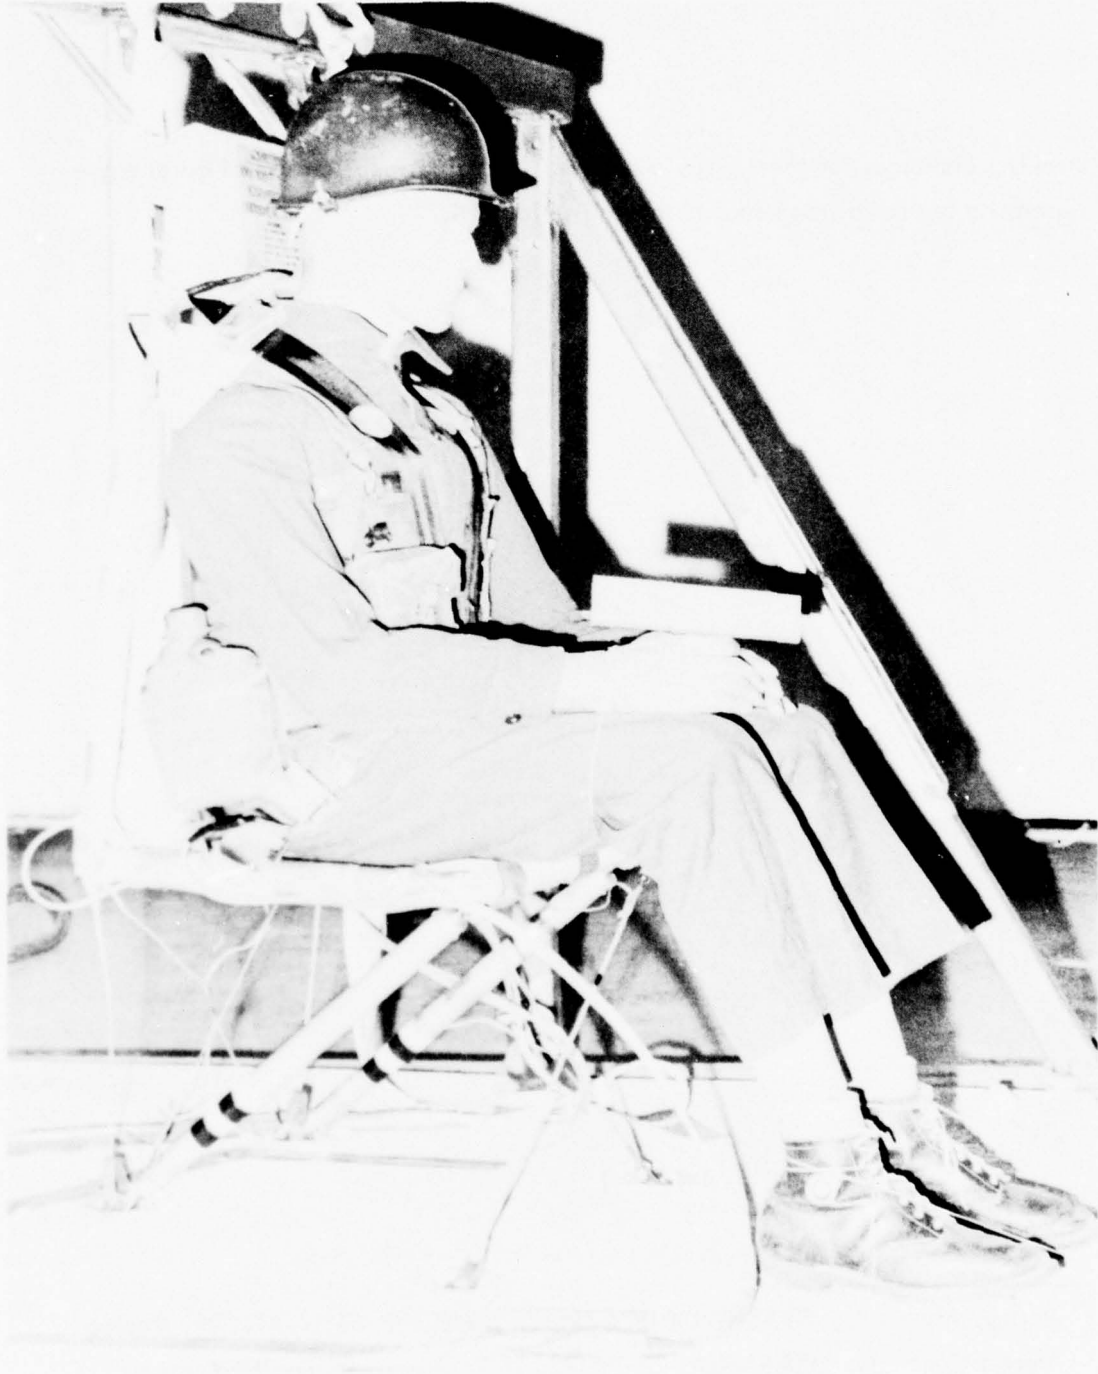
Figure 4. Typical Troop Seat Utilizing Energy-Absorbing Legs.

stroking distances for the energy absorber. A typical application of an energy-absorbing leg for a troop seat is shown in Figure 4.³
