TN no. N-1487

title: POROUS FRICTION SURFACE RUNWAY AT USNAS DALLAS, TEXAS

date: June 1977

CIVIL ENGINEERING LABORATORY

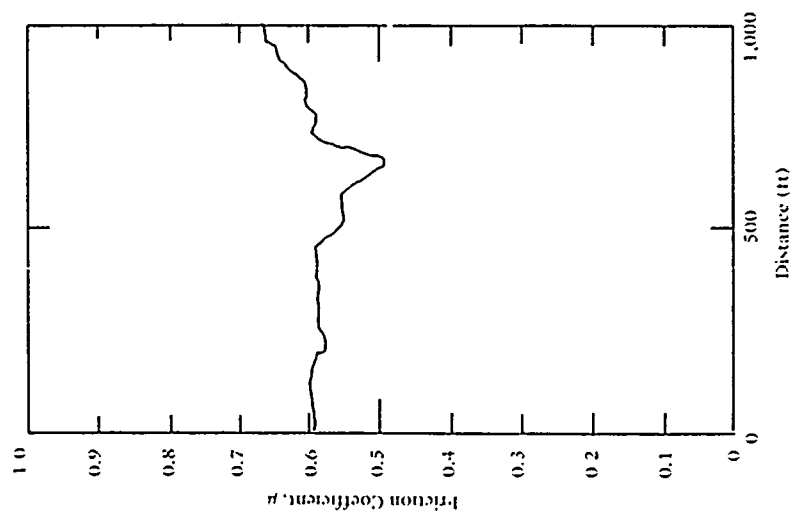
(a) Traffic area.

(b) Nontraffic area.

Figure 5. Mu-meter trace versus distance for porous friction surface at NAS Dallas on 6 January 1975.

The pavement skid resistance results are reported in terms of coefficient of friction, μ (μ), as measured by the Mu-Meter. The actual friction coefficient versus distance traces recorded during the first test run are shown in Figures 4 through 6. The traces show the variation of friction coefficient within each test section. Appendix B contains all test results for each Mu-Meter run made by CEL at NAS, Dallas.

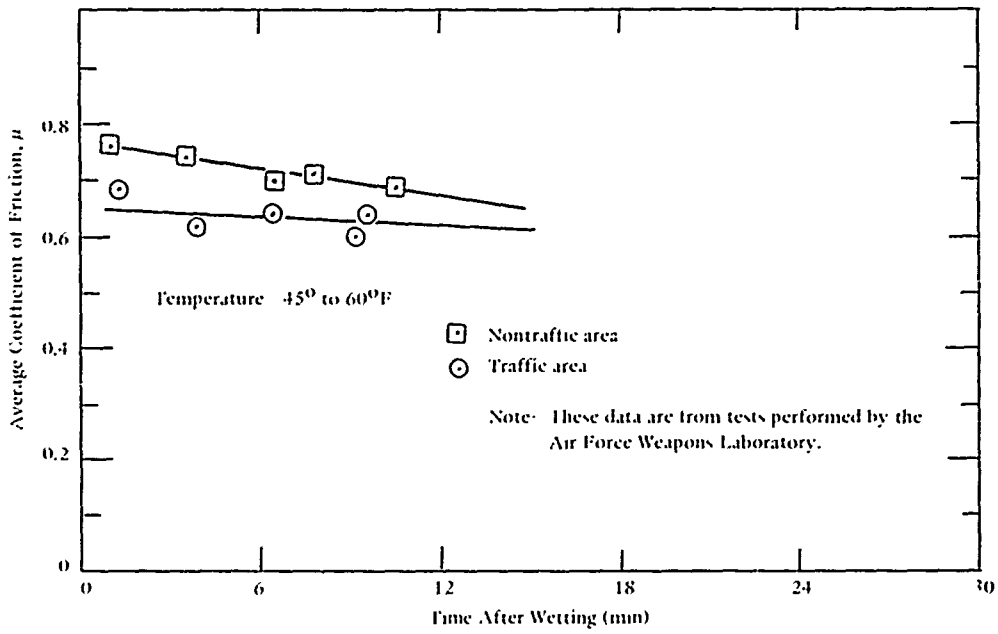
Figure 7. Mu-meter friction measurements for porous friction course at NAS Dallas in November 1971.

Figures 7 through 10 show changes in surface friction versus time after wetting for each pavement section tested. Figure 7 is plotted from data in Reference 1. These graphs demonstrate the natural drainage characteristics of the runway surface. The slopes of these curves show that the friction coefficient of the porous friction surface is not affected by time after application of water. This indicates the PFS is functioning as designed and is rapidly draining water from the pavement surface. For comparison, a typical plot of friction coefficient versus time after wetting for a conventional asphaltic concrete pavement is shown in Figure 11.

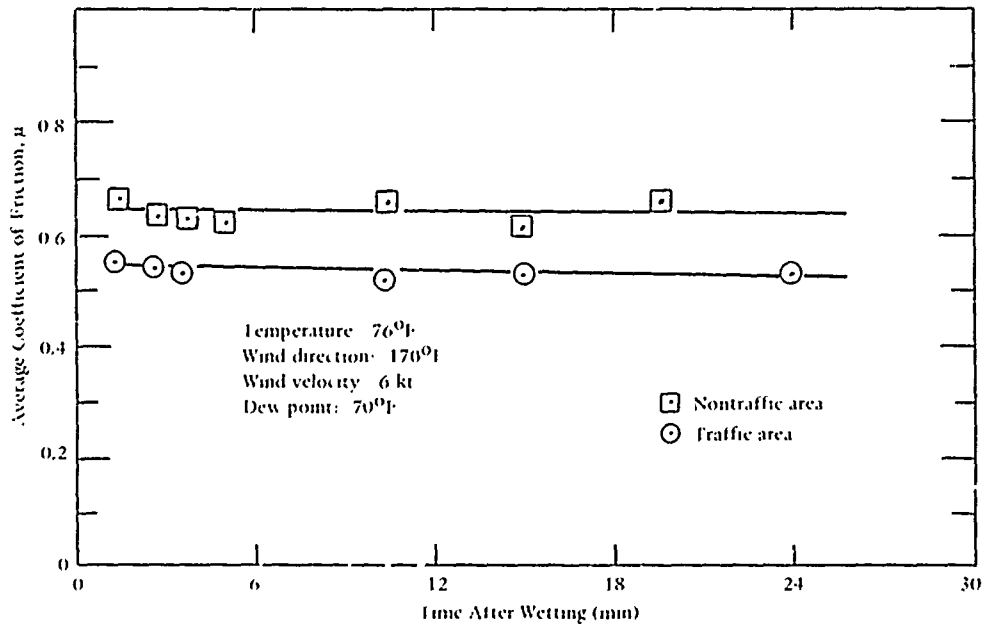
Figure 8. Mu-meter friction measurements for porous friction course at NAS Dallas in August 1974.

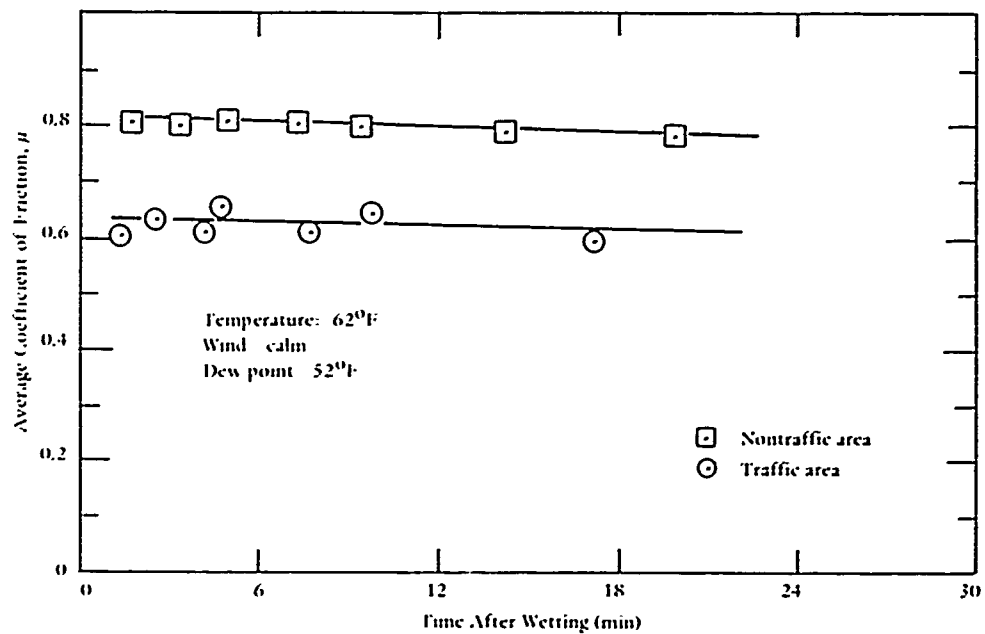
Figure 9. Mu-meter friction measurements for porous friction course at NAS Dallas in January 1975.

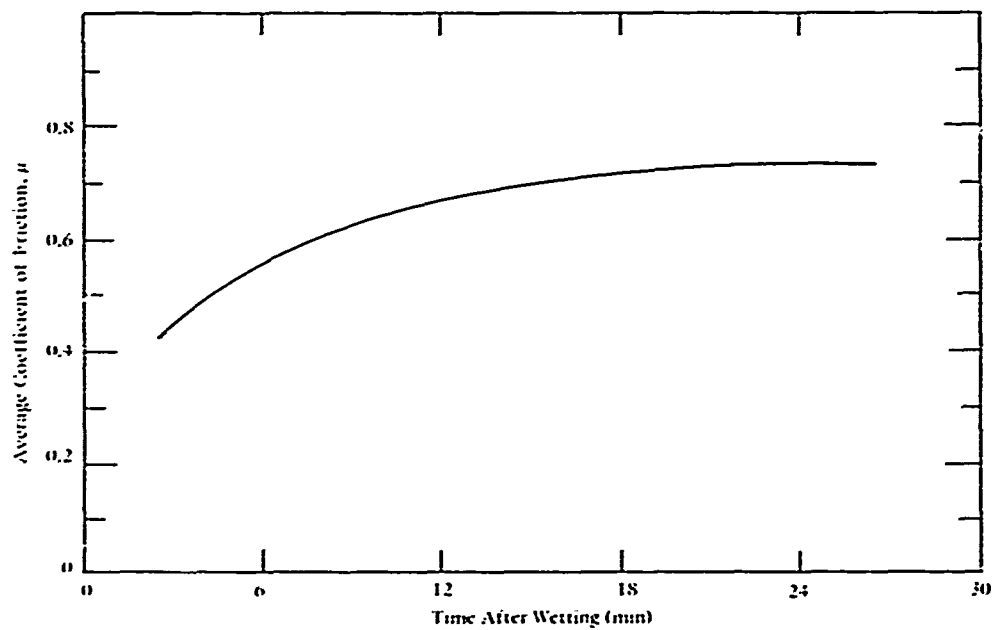
Figure 11. Typical mu-meter measurements on conventional asphaltic concrete.
