CREW ESCAPE CAPSULE RETROROCKET CONCEPT
Volume I
DEMONSTRATION PROGRAM

TECHNICAL REPORT AFFDL-TR-76-107 Volume I
FINAL REPORT FOR PERIOD MAY 1972 - OCTOBER 1975

AIR FORCE FLIGHT DYNAMICS LABORATORY
AIR FORCE WRIGHT AERONAUTICAL LABORATORIES
AIR FORCE SYSTEMS COMMAND
WRIGHT-PATTERSON AIR FORCE BASE, OHIO 45433

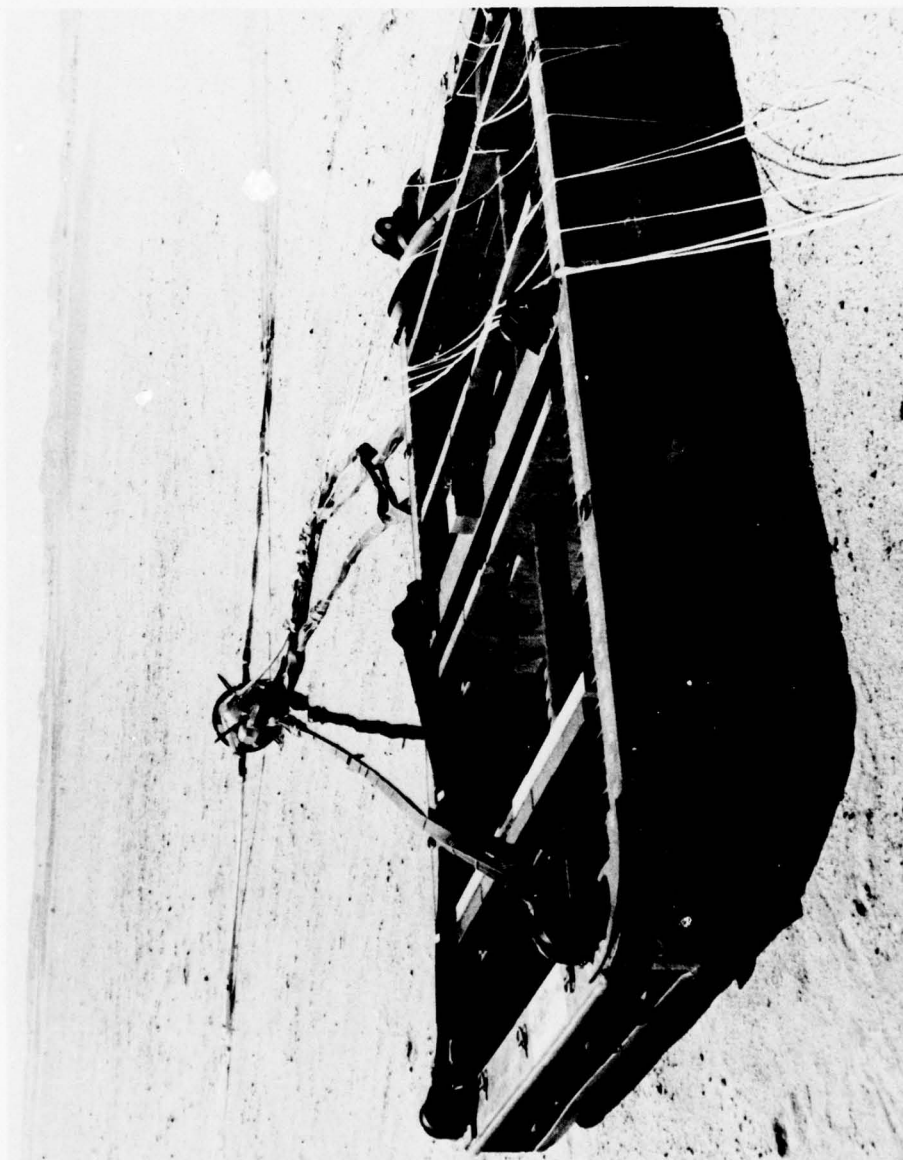
approximately a 45° angle. The parachute frame finally released from the support stand when one of the support stand fittings failed. Lift-off of the weighted tub was without incident. At approximately 200 feet above the ground during system ascent, the flashbulb, installed to indicate when the rocket safe-and-arm device was actuated, flashed indicating that the device was in the armed position. The only safety provided to keep this device from being actuated to the armed position was a metal clip that required approximately five pounds of force to release. The helicopter ascended to 3000 feet, made one dry run and released the weighted tub without incident on the test run. The parachutes' deployment, weighted tub stability, and impact were all satisfactory. See Figures 14 and 15.

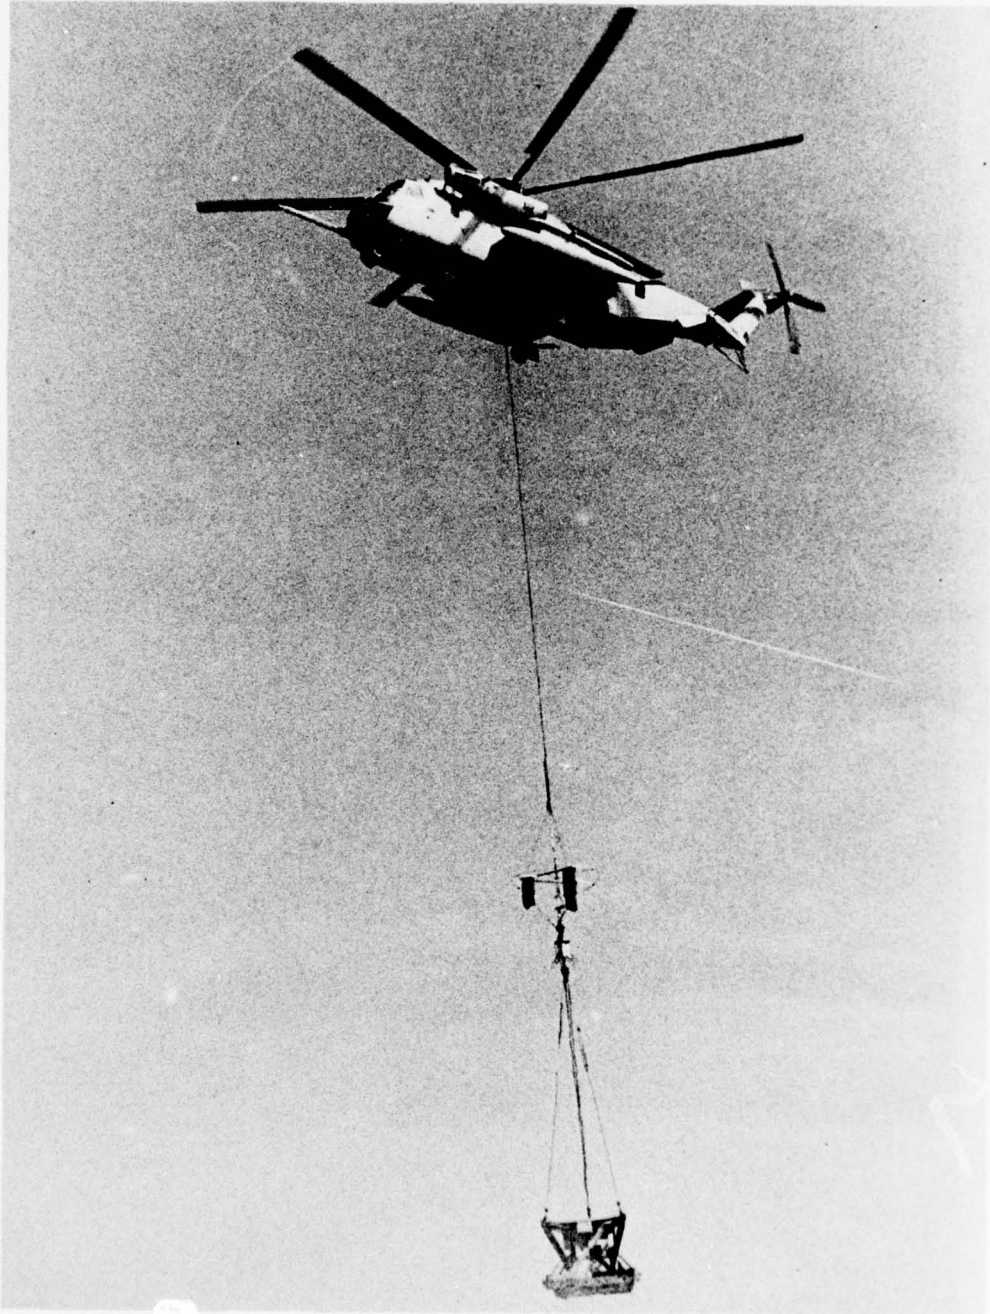
The test procedure was for the helicopter to lift the parachutes and frame from the support, followed by the rocket cluster/confluence fitting, and then pick up the test vehicle. The helicopter would climb to 2000 feet, fly one "dry run" pattern and then the test run. The test vehicle would be released at the center of the bull's-eye in the drop zone (see Figures 22, 23, 24 and 25). The sequence should be as follows:

- a. Before release - the helicopter operator switches on the telemetry, the on-board cameras and the power arm switch, then releases the vehicle by pushing in the release switch.
- b. At release - the electrical cable is disconnected, the safe-and-arm device is actuated, the F-1B timers are actuated and the parachutes start to deploy.
