AFFDL-TR-77-29

LOAD SPECTRUM EFFECTS ON BONDED COMPOSITE JOINTS

TECHNICAL REPORT AFFDL-TR-77-29
FINAL REPORT FOR PERIOD JANUARY 1972 to DECEMBER 1976

AIR FORCE FLIGHT DYNAMICS LABORATORY
AIR FORCE WRIGHT AERONAUTICAL LABORATORIES
AIR FORCE SYSTEMS COMMAND
WRIGHT-PATTERSON AIR FORCE BASE, OHIO 45433

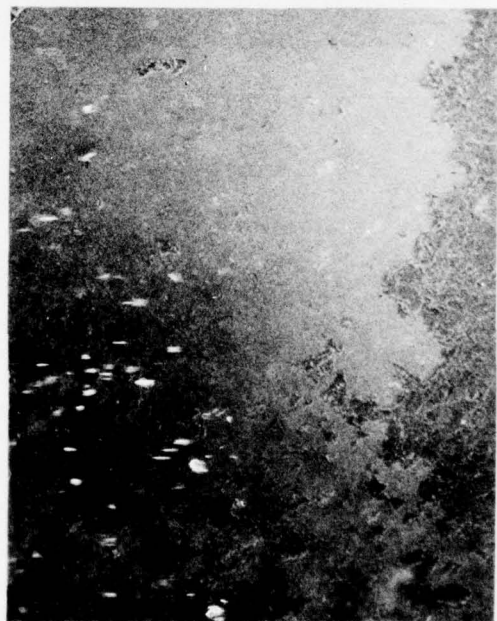
Figure 16. Typical Failed Areas on Titanium Strap, 15X.

Schedule 50 Specimen

Figure 15B was taken in the center of a large area of cohesive failure in the adhesive (Mode C). Figure 15C shows an area where the adhesive failed on the titanium surface (Mode A_T). To the naked eye this area had a dull appearance and it was suspected that a thin layer of adhesive might have remained on the surface. A shiny area where the titanium was scraped when prying the specimen apart was examined to compare with Figure 15C. This is shown in Figure 15D where the sanding pattern from the prebond surface treatment is clearly shown. Pictures of each of these areas taken at 15X are shown in Figure 16.
