18 USA **AVSCOM REPORT No. 77-26**

**PRECISION FORGING OF SPIRAL BEVEL GEARS.**

10  
**Roger R. Skrocki**  
**TRW Inc.**  
**Materials Technology**  
**Cleveland, Ohio 44117**

11  
**April, 1977**

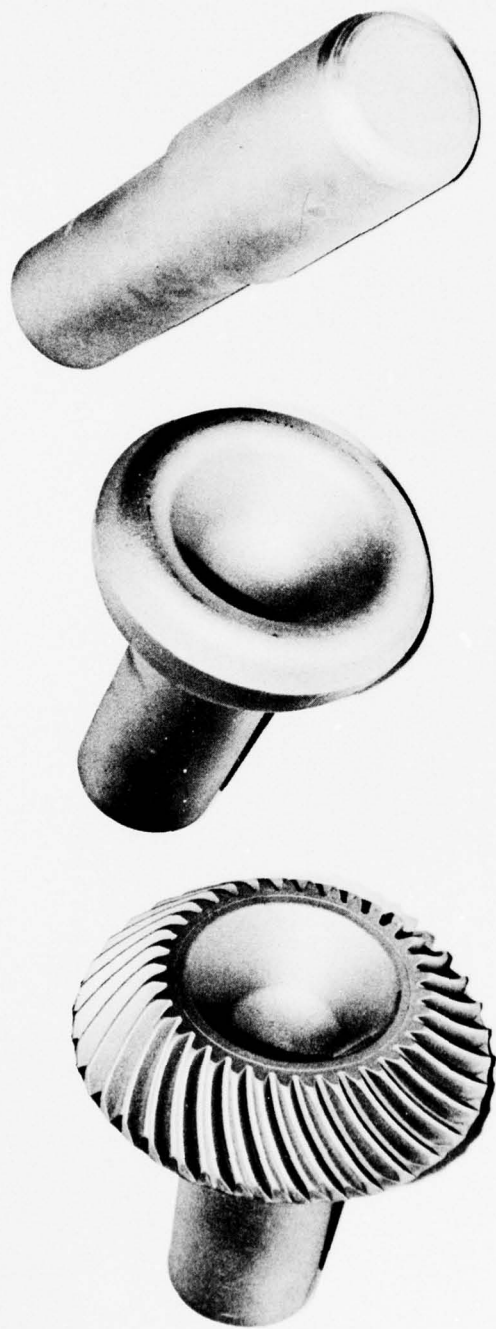
Starting Billet

Preform Forging

Finish Forging

Figure 2.2. Sequence of Deformation for Pinion Forging.
