**A-7E
THERMAL
RADIATION CLOSURE
FUNCTIONAL EVALUATION**

**NAVAL WEAPONS EVALUATION FACILITY
ALBUQUERQUE, NEW MEXICO 87117**

NWEF Report 1089

18 March 1972

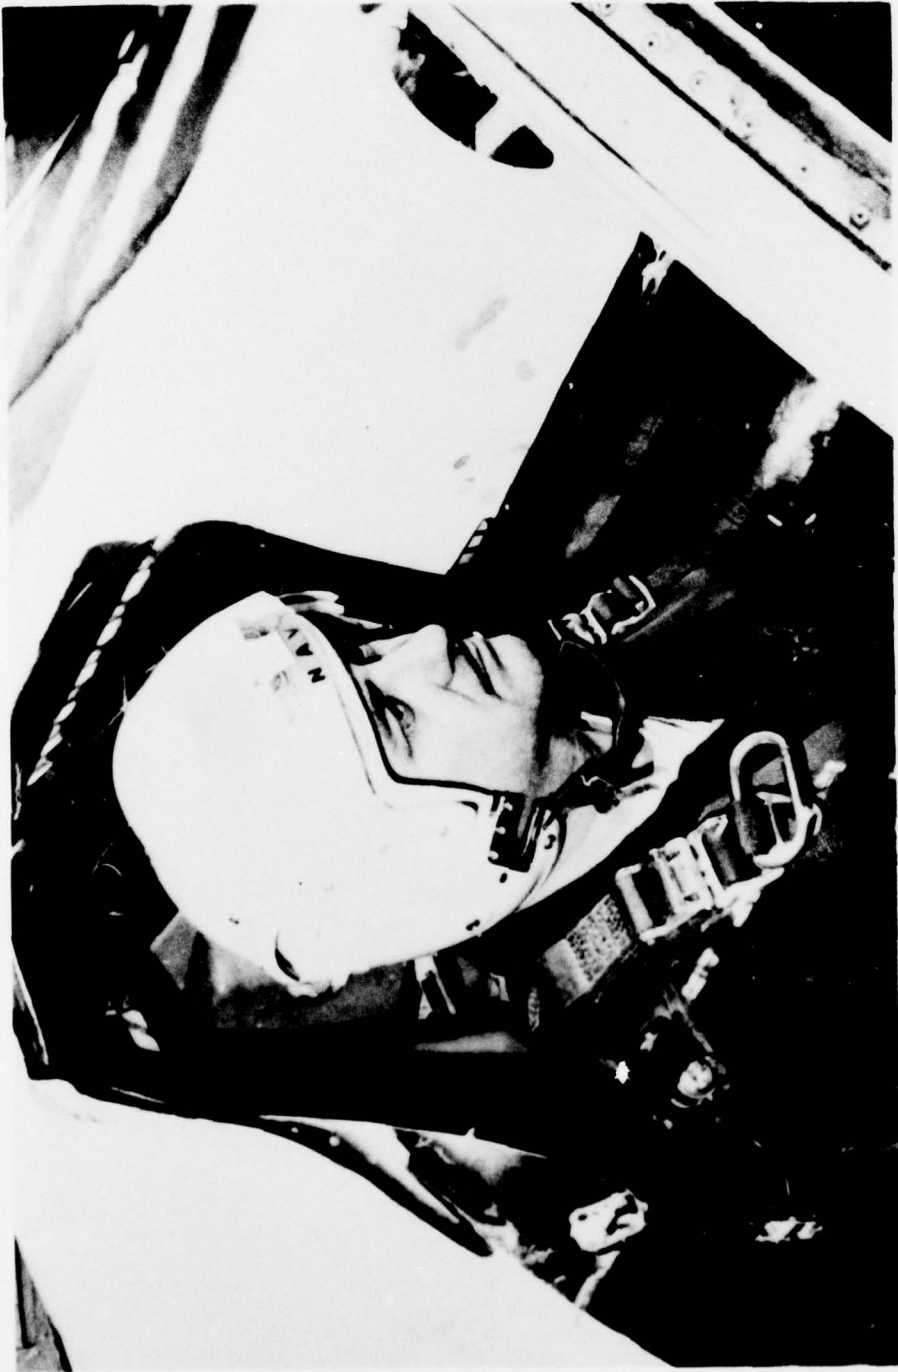
FIGURE 1. TRC in Ready Position, Pilot in Full Flight Gear.

Three A-7 pilots were selected to participate in this test series. All were dressed in full flight gear (Fig. 1) and were buckled in to simulate as closely as possible pilot restrictions at the time of the accident. Each pilot was instructed to manually open the TRC from the closed to the open position a minimum of five times. Each was also instructed to use one hand only at the center (Fig. 2) right side (Fig. 3) and left side of the TRC in an effort to induce binding. The TRC handles on left and right sides were also used individually for opening the closure. No binding was encountered either by the pilots, the maintenance personnel, or the project engineer. The maintenance personnel and the project engineer performed the same operations but were not strapped in or dressed in flight gear. Further, the project engineer was able to open the TRC with his left arm only without removing his right hand from the control stick. This was accomplished by actuating the detent release handle with the left elbow and applying an upward opening pressure on the handle at the forward left edge of the TRC. However, one of the pilots who was of smaller stature than the engineer, noted that it was next to impossible for him to open the closure with one hand, but he had no difficulty whatsoever in depressing the detent release handle with his left elbow and opening the closure with his right hand (Fig. 4).

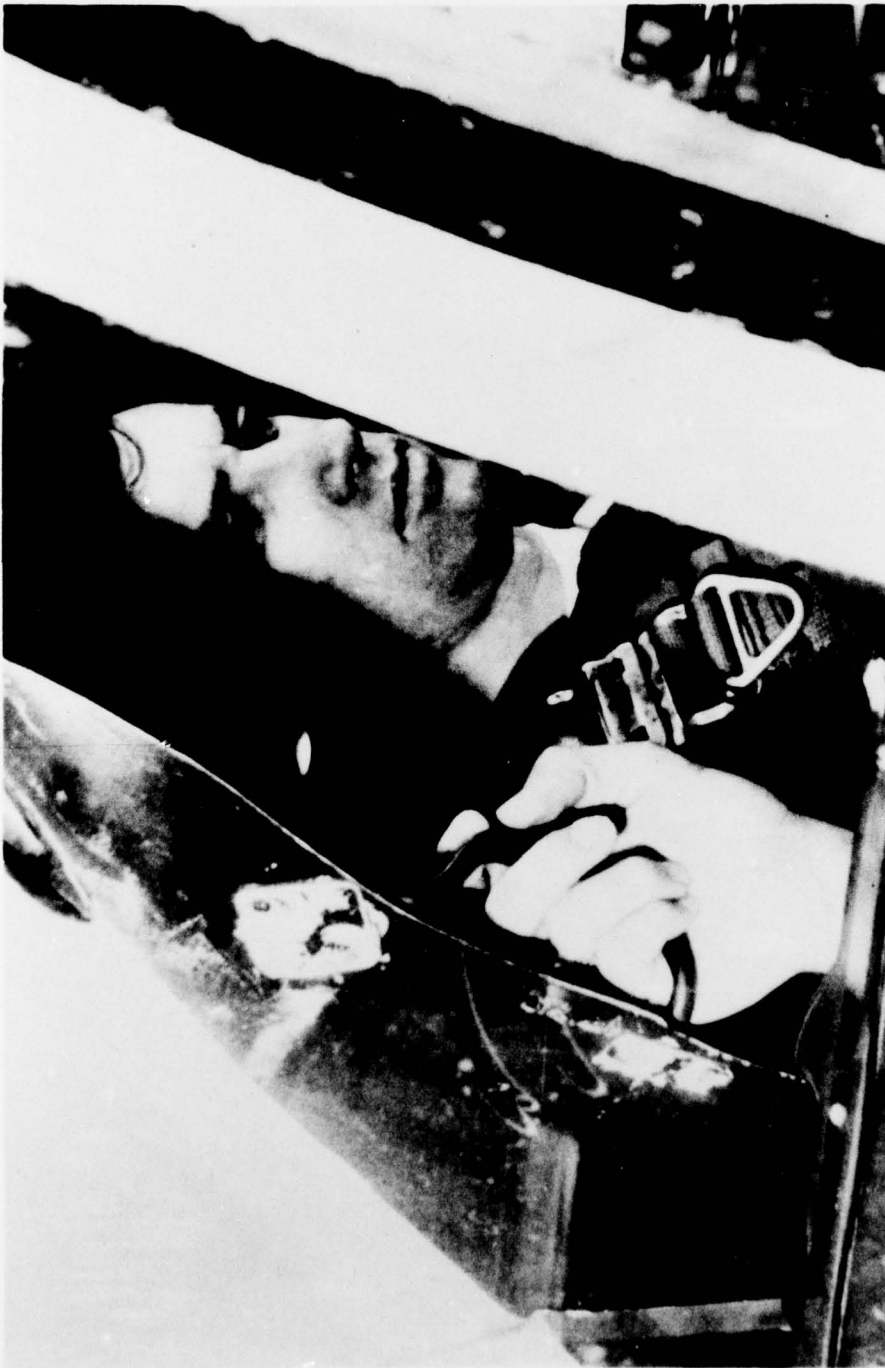
FIGURE 4. TRC Operation, Hand Pressure on TRC Handle.
