TECHNICAL REPORT ARLCB-TR-77031

EROSION IN 81MM MORTAR TUBES

V. Peter Greco

US ARMY ARMAMENT RESEARCH AND DEVELOPMENT COMMAND
 LARGE CALIBER WEAPON SYSTEM LABORATORY
 BENÉT WEAPONS LABORATORY
 WATERVLIET, N. Y. 12189

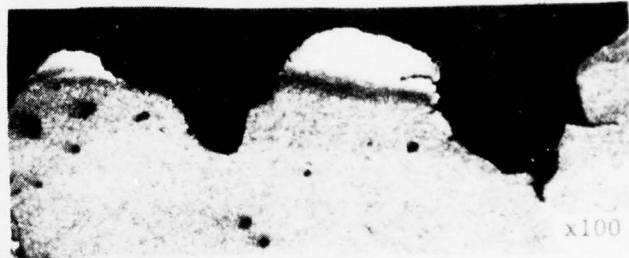
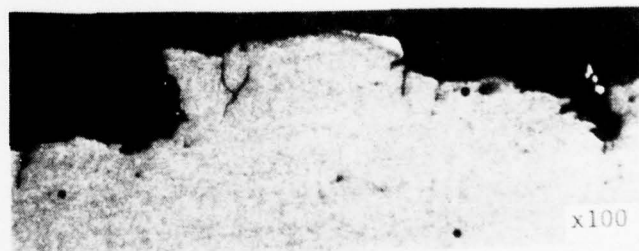
(A)
SURFACE VIEW OF THE
3 ERODED ANNULAR GROOVES
(DARK BANDS)

(B)
LONGITUDINAL CROSS SECTION
SHOWING PROFILE OF THE
FORWARD ERODED GROOVE

(C)
MICROSCOPIC SURFACE VIEW
OF FORWARD GROOVE SHOWING
WHITE LAYER ON PEAKS

(D)
MICROSCOPIC SURFACE VIEW
OF THE FORWARD GROOVE
SHOWING SEVERAL CRACKS

Figure 4. Eroded views of a condemned 81mm mortar tube after field firing of approximately 7500 rounds.

A severely eroded 81MM Mortar Tube (which was fired in the field) was metallographically studied in an attempt to determine the significant factors leading to the annular groove erosion which form the 3 rings. Figure 4a shows a sectional surface view of the 3 annular grooves. Figure 4b shows the longitudinal cross-sectional profile of the forward eroded groove. While visual examination of the eroded surface shows a severe pitted condition which appears to be caused by purely mechanical forces, microscopic cross-sectional examination (see Figures 4c and 4d) has revealed patches of the typical white layer (presumably due to thermal cycling) normally found in large caliber rifled gun tubes.

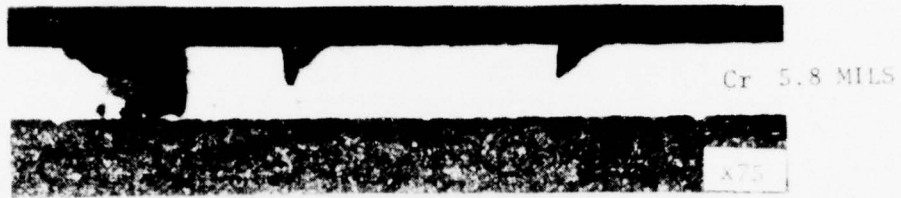
Figure 12. Cross section of chromium deposit on mortar steel with "V" notch sections removed, leading to early failure.

which were 2 mils or greater in thickness failed prematurely by excessive spalling and were withdrawn early during the 1500 rd test. Field tests also showed chromium coatings (2-5 mils thick) to perform poorly in a similar manner. An explanation for this behavior can be offered if we look at the wear plot from Finnie et al in Figure 5, which shows a brittle surface to result in greatest wear at a 90° angle of impingement. In reality, electrodeposited chromium can be classified as a brittle surface and therefore explains such a behavior. Figure 12 shows a cross-section of chromium on mortar steel with initial "V" notch segments of chromium progressively sheared away.
