DREO TECHNICAL NOTE NO. 77-17 ✓  
DREO TN 77-17

## EVALUATION OF A RESERVE-PRIMARY ZINC/AIR BATTERY TO POWER THE AN/TRN-30 BEACON

⑩ by  
William A. Armstrong and Walter J. Moroz  
Primary Power Sources Section  
Electrical Power Sources Division

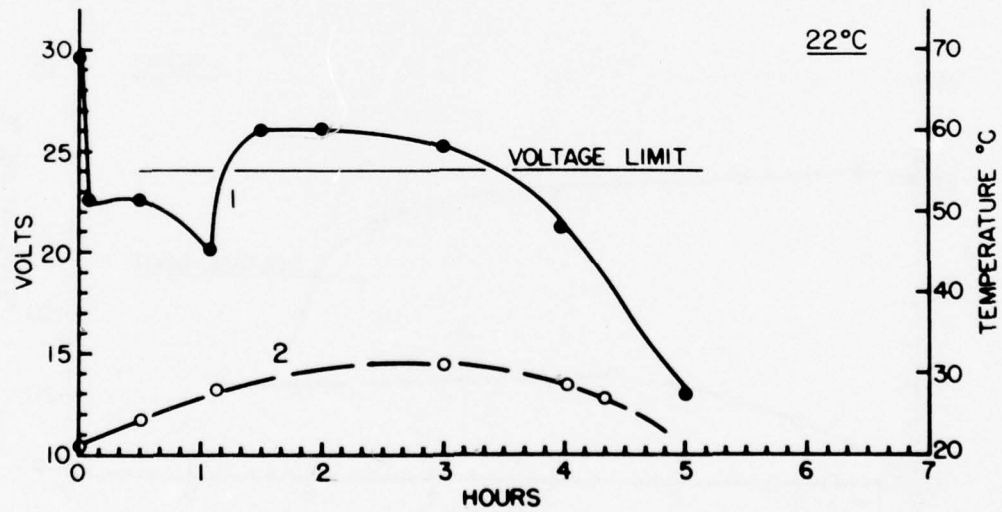
Fig. 8: Discharge at Room Temperature of Battery No. 4 With Forced Air Circulation Started When Battery Voltage Decreased to 20V.

1. Voltage                      2. Temperature

Test (c): Initiation of the circulation fan when the battery voltage reached 20V after 1.1 h of discharge raised the voltage to about 26V and permitted a further 2.6 h of run time to 24V to be obtained (Figure 8).

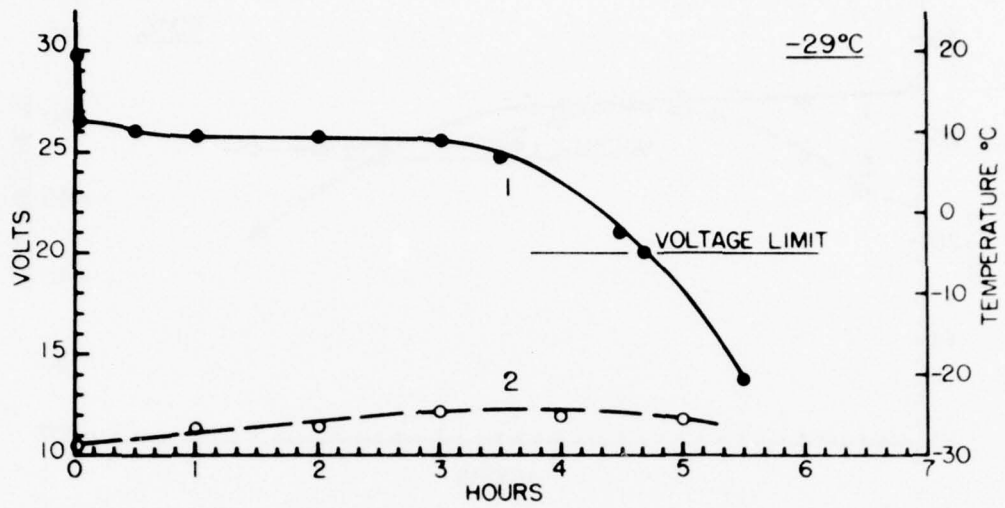
Fig. 13: Discharge at  $-29^{\circ}\text{C}$  of Battery No. 45.  
1. Voltage 2. Temperature

The results of discharge Tests III(a) - III(d) (Appendix "B") are recorded in Figures 10-16 and summarized in Table II. It was demonstrated in the previous section that the specified 5 hours of operation to a 24V cut-off at 22°C could not be attained. For this reason and because of the small number of batteries available, no further discharges into the 8.0 ohm load were done at room temperature. Instead battery No. 36 was discharged at a constant current of 3.0A impressed by a power supply. This discharge was carried out on a bench with a small fan providing air circulation.

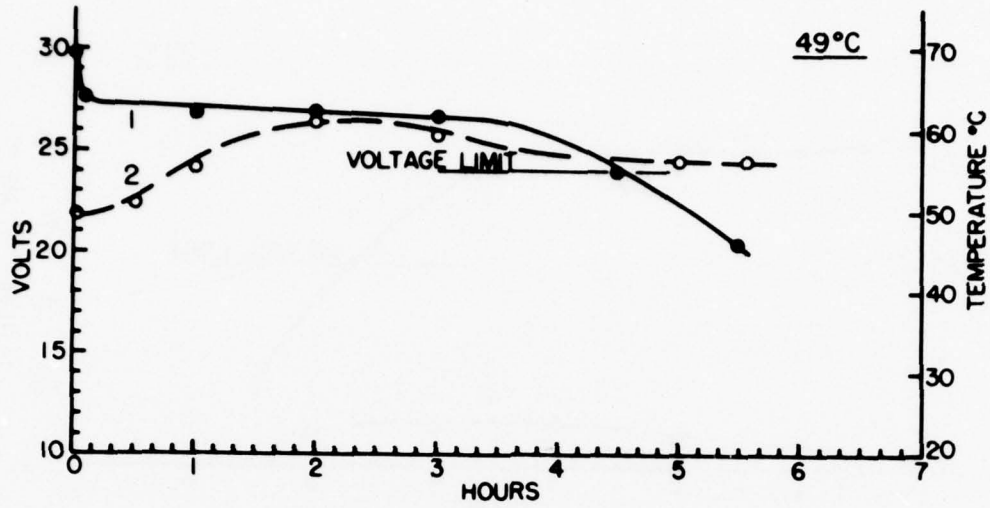
Fig. 15: Discharge at 49°C of Battery No. 47.  
1. Voltage      2. Temperature

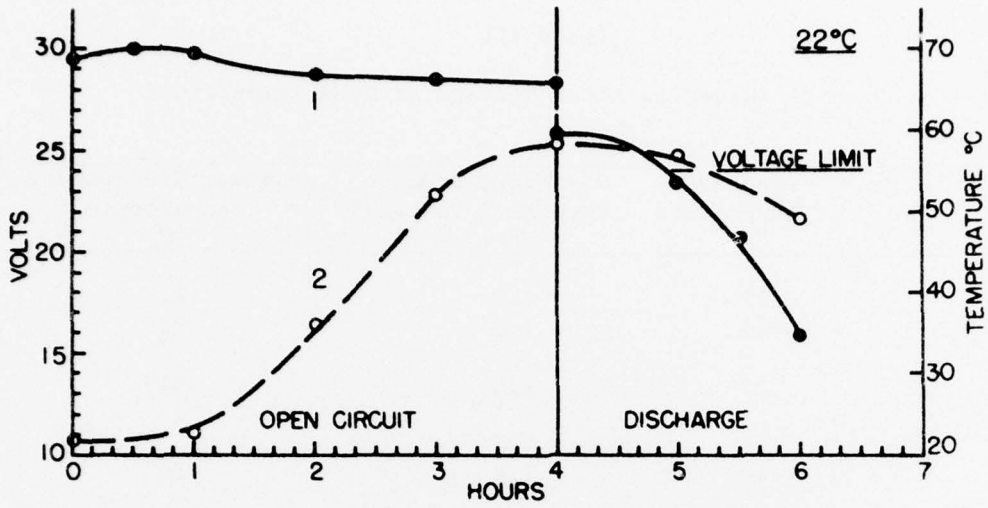
Fig. 18: Discharge After 4 h Activated Stand at Room Temperature of Battery No. 29.

1. Voltage      2. Temperature

The results of discharges made following activated storage of Batteries 29 and 30 are shown in Figures 18 and 19. Four hours after being activated, Battery No. 29 was discharged 1.0 h to the 24V cut-off. Seven hours after activation, the OCV of Battery No. 30 was well below the 24V value and no discharge on load was possible.

1. Battery performance deteriorated to an unacceptable level during four hours stand after addition of electrolyte.
2. The increase in battery temperature during stand and the affect of air circulation on the OCV (Figures 18 and 19) indicate that the batteries were self-discharging at a rapid rate.

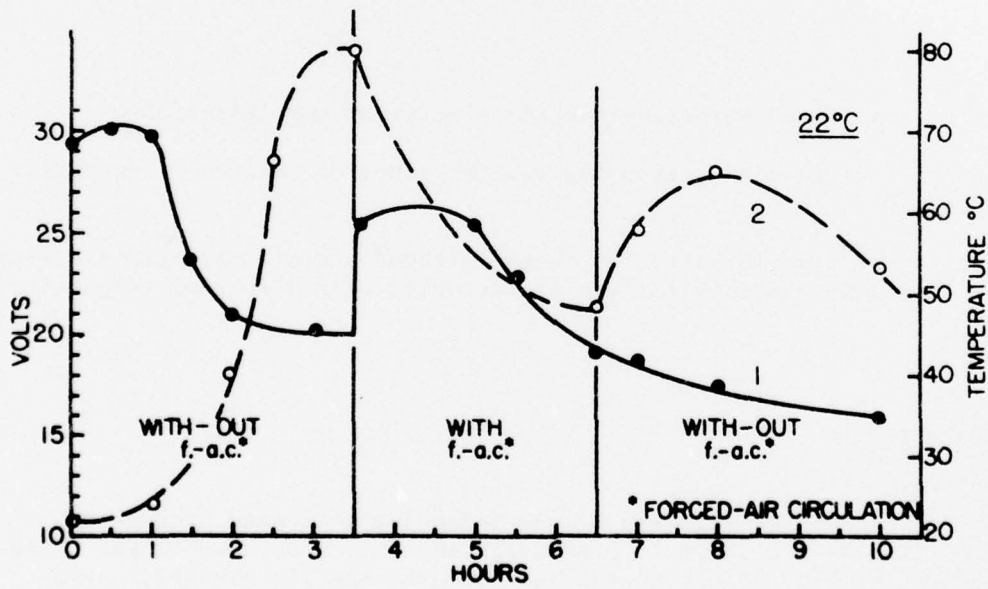
Fig. 19: Behaviour of Battery No. 30 During 24 h Activated Stand.

1. Voltage      2. Temperature

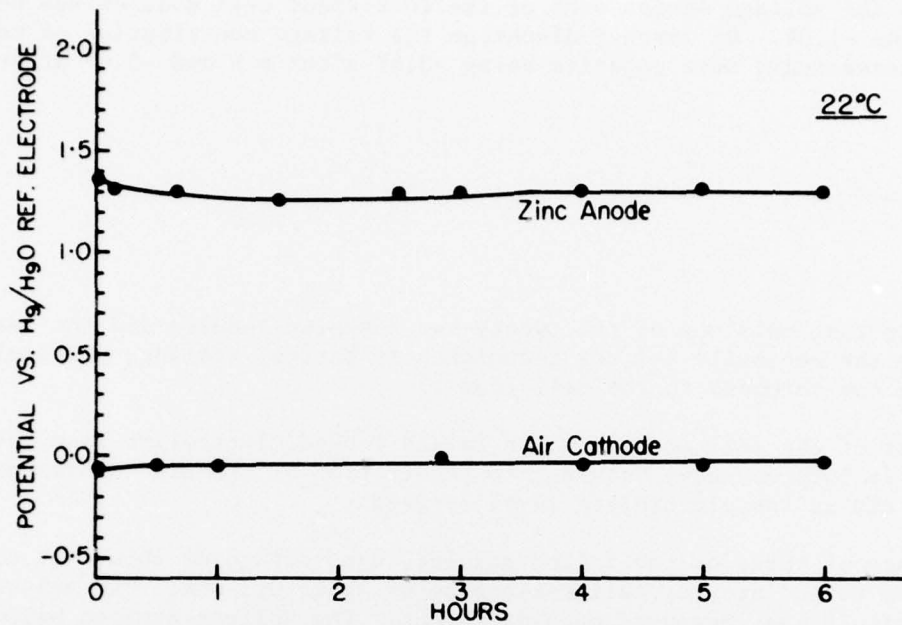
Fig. 20: Electrode Potentials of Cell Module 13, Battery No. 34.

The individual cell voltages of Battery No. 34, one of those re-sealed by the contractor, are listed in Table IV while the electrode potentials with respect to a mercury/mercuric oxide reference electrode of cell 13 are plotted in Figure 20. Plots of total battery voltage and electrolyte temperature are given in Figure 21.

From Figure 20 it can be seen that potentials of both the zinc and air electrodes of cell 13 changed very little after the first hour of discharge. Both electrodes behaved normally and there was no evidence of either excessive polarization or intermittent internal shorts at either electrode.
