NAVEODFAC TECHNICAL REPORT TR-184

**FABRICATION AND TESTS OF THE PROTOTYPE
SURFACE/SHALLOW-SUBSURFACE
CLEARANCE VEHICLE (SSCV)**

FINAL REPORT

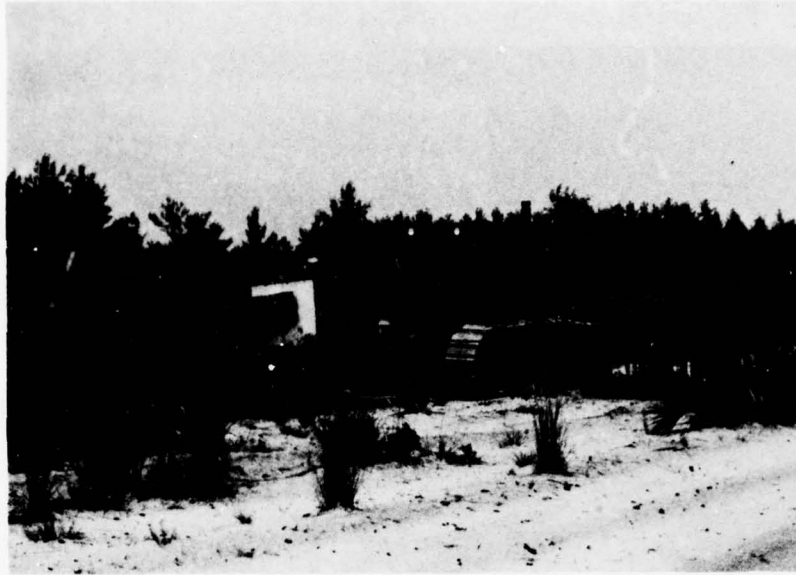
Figure 14. Ground cover along the run-in line between the Main Bull and Live Ordnance Impact Area.

The system was moved around the southeast quadrant of the Main Bull, turned left through 360° and onto the road that marks the run-in line. This road contains a large number of MK 76 and MK 106 practice bombs and a variety of scrap metal. As seen in Figure 14, the ground cover on each side of the road is palmetto, grass and brush, and pine trees.

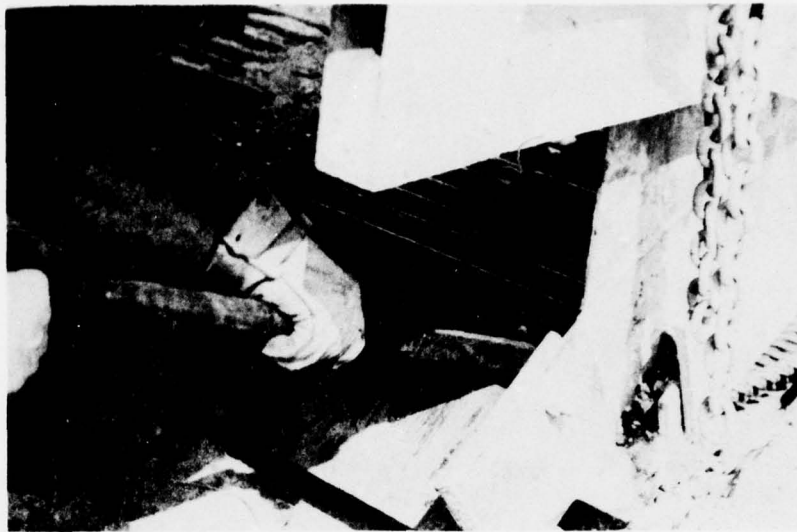
Figure 16. Prybar used to release jam in the Draper chain.

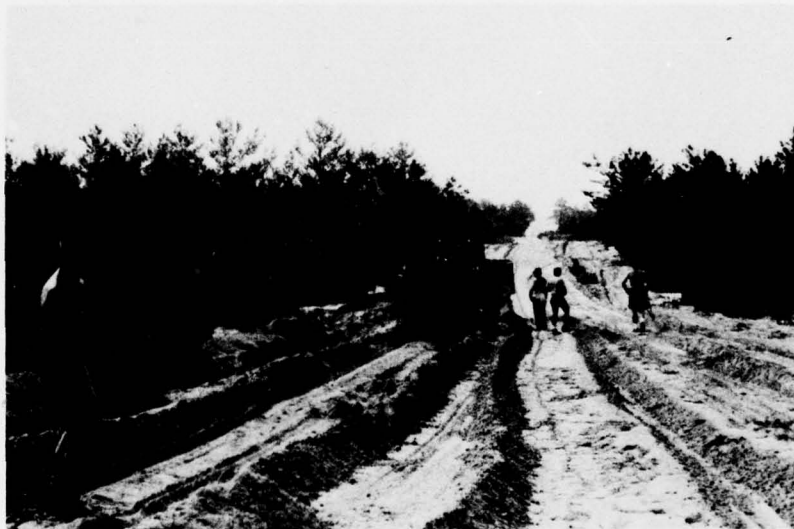
Figure 17. Clearance of the run-in line road between the Main Bull and the Live Ordnance Impact Area.

Before resuming clearance of the run-in line road, the area was back-bladed with the TD-20 to give a fresh, level test-bed for the day's operations. SSCV clearance of this area is shown in Figure 17.
