# MAGNETIC PERTURBATION INSPECTION OF ARTILLERY PROJECTILES

Russell D. Williams  
John R. Barton  
Southwest Research Institute  
P.O. Drawer 28510  
San Antonio, Texas 78284

Final Report

Subject: Final Technical Report  
Contract DAAG46-76-C-0075, SwRI Project 15-4670  
"Magnetic Perturbation Inspection of Artillery Projectiles"

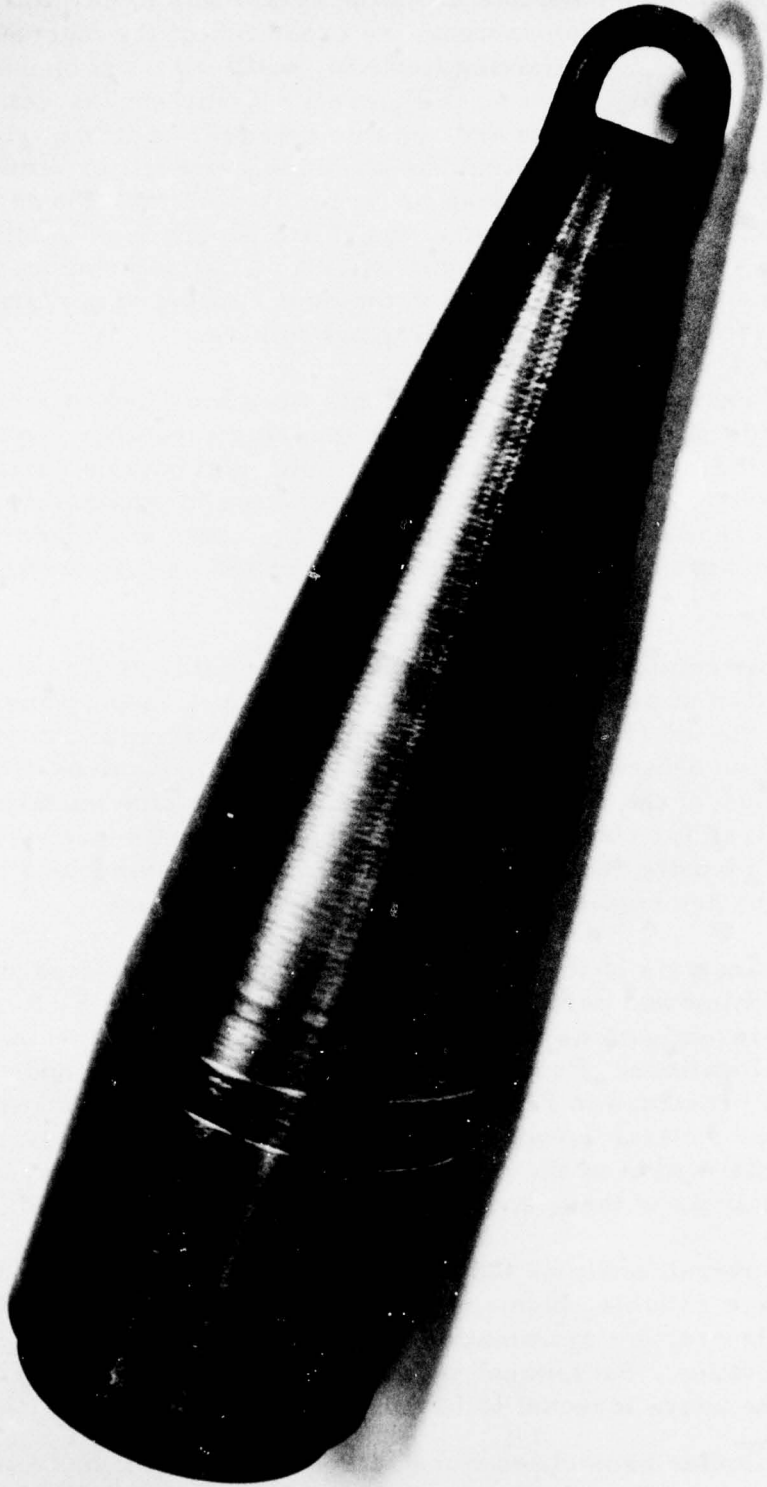
FIGURE 1. M549, 155MM PROJECTILE

The primary objective of this program was to develop a bench-type laboratory system to demonstrate the capability of the magnetic perturbation inspection method for detecting flaws in artillery projectiles. A photograph of a projectile is shown in Figure 1\*. Complete inspection of the inside and outside surfaces and reliable detection of flaws oriented in either the circumferential or longitudinal directions with major dimensions of 0.050-in. long x 0.015-in. deep or larger is desired. Flaws of interest are: cracks, seams, cold shuts, splits and inclusions. Additionally, the bench-type system should demonstrate magnetizing techniques, scanning mechanisms and signal processing methods capable of performing inspections at a rate of several projectiles per minute.

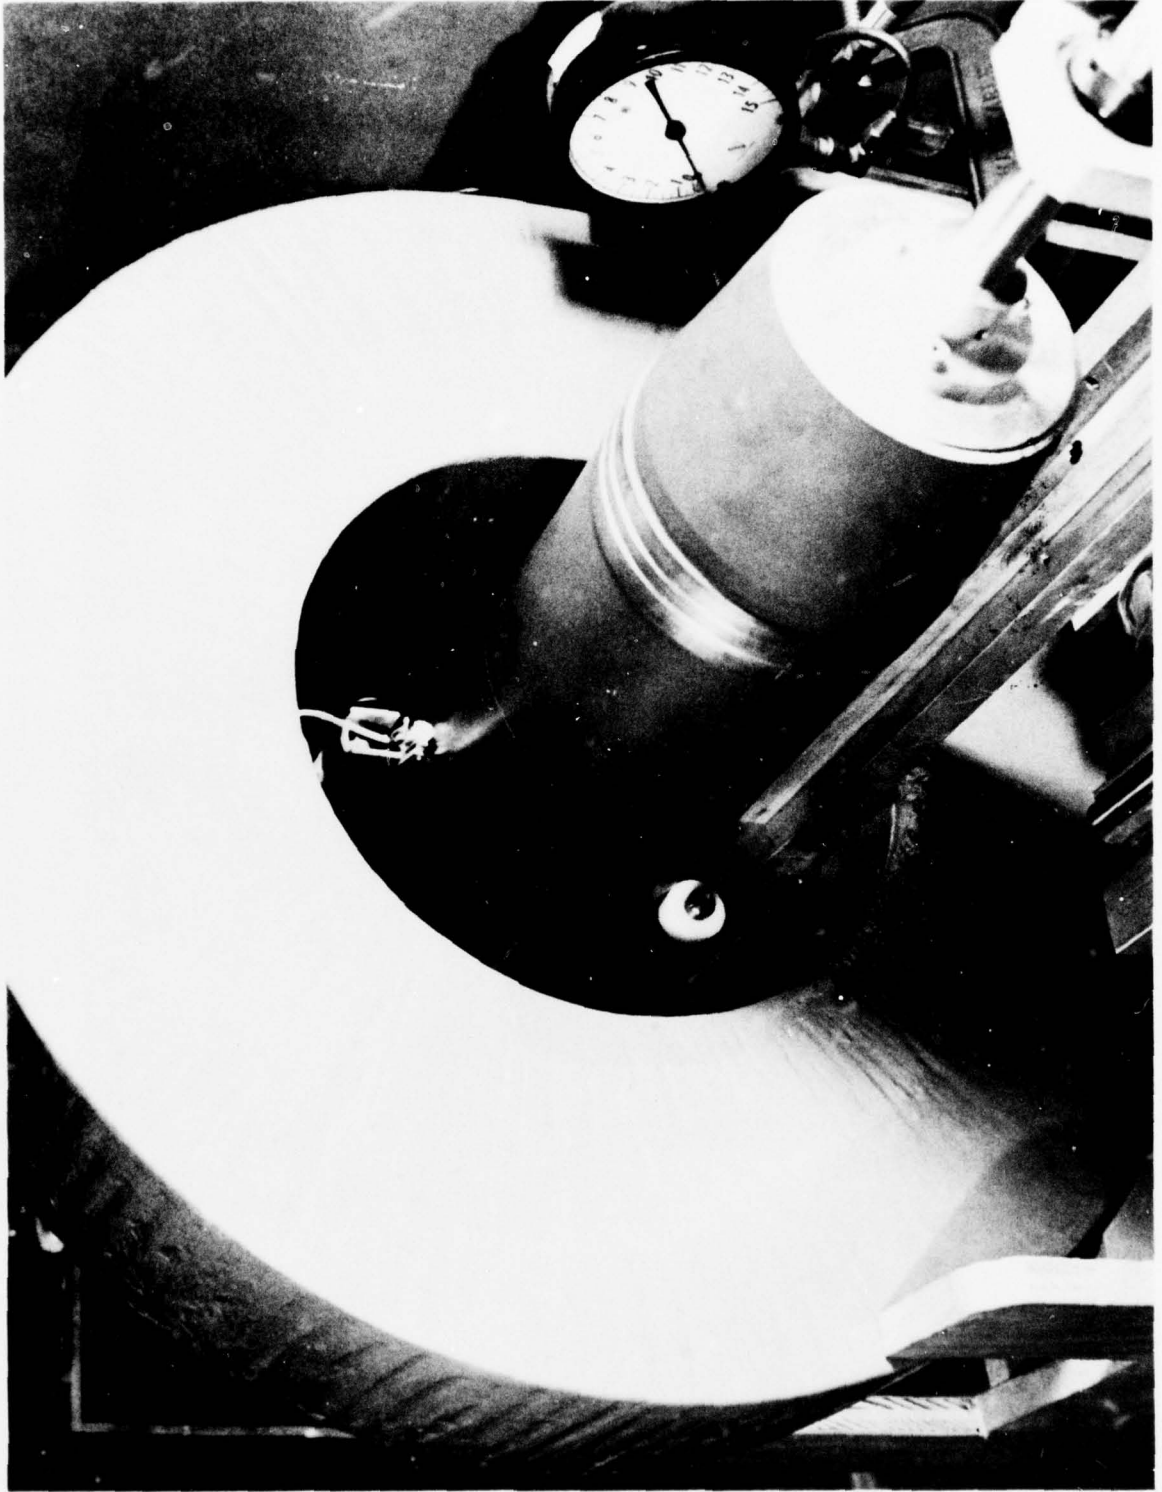
FIGURE 12. PROBE CARRIAGE IN BURET SECTION (Long Bed Device)

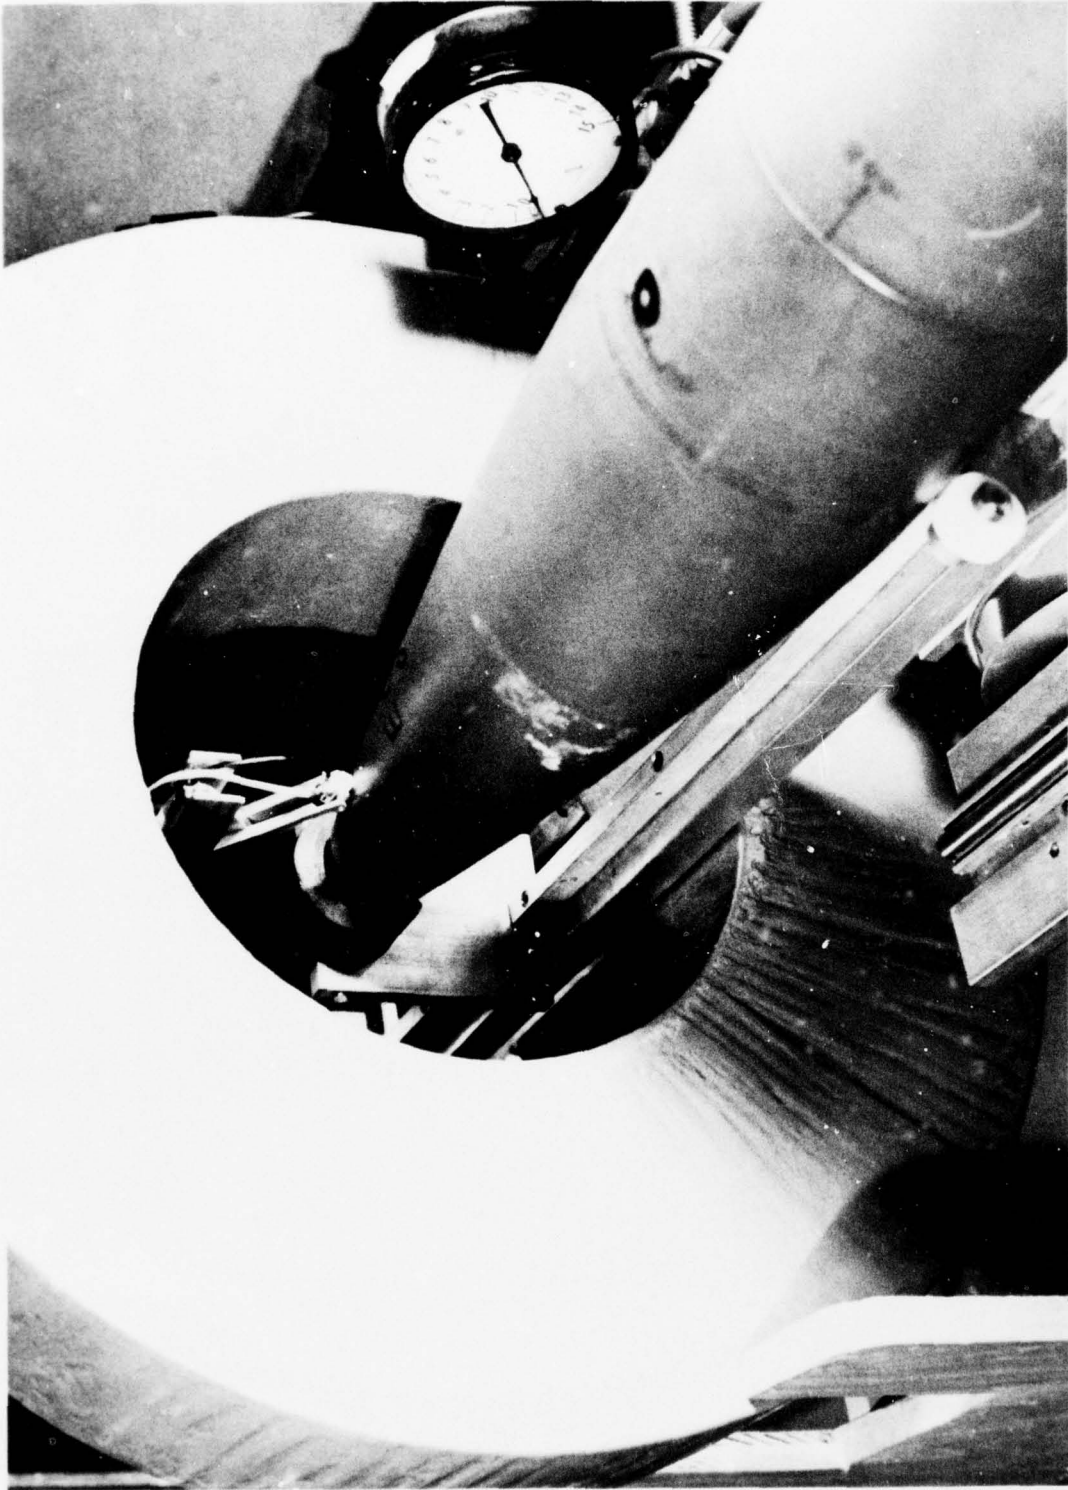
FIGURE 13. PROBE CARRIAGE IN OGIVE AREA (Long Bed Device)

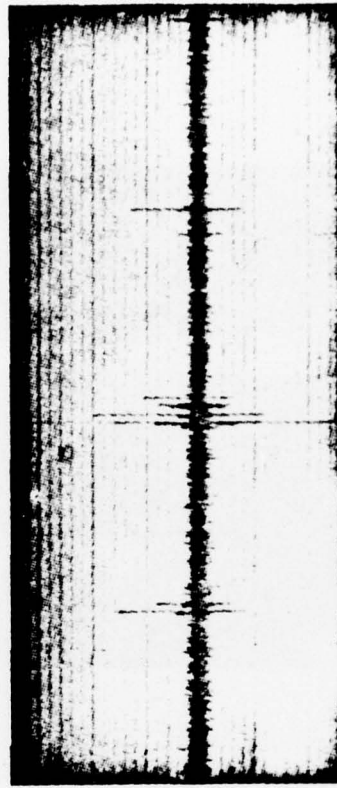
TIME-SERIAL DATA FROM HELICAL SCAN OF MAGNETIC INDUCTION PROBE WITH APPLIED CIRCUMFERENTIAL FLUX

FIGURE 16. SCHEMATIC, ILLUSTRATING MAGNETIC FIELD ARRANGEMENT AND RECORDING SEQUENCE
