9 Special Report 77-32

6 AERIAL PHOTOINTERPRETATION OF A SMALL ICE JAM

10 Stephen L. DenHartog

11 Oct 1977

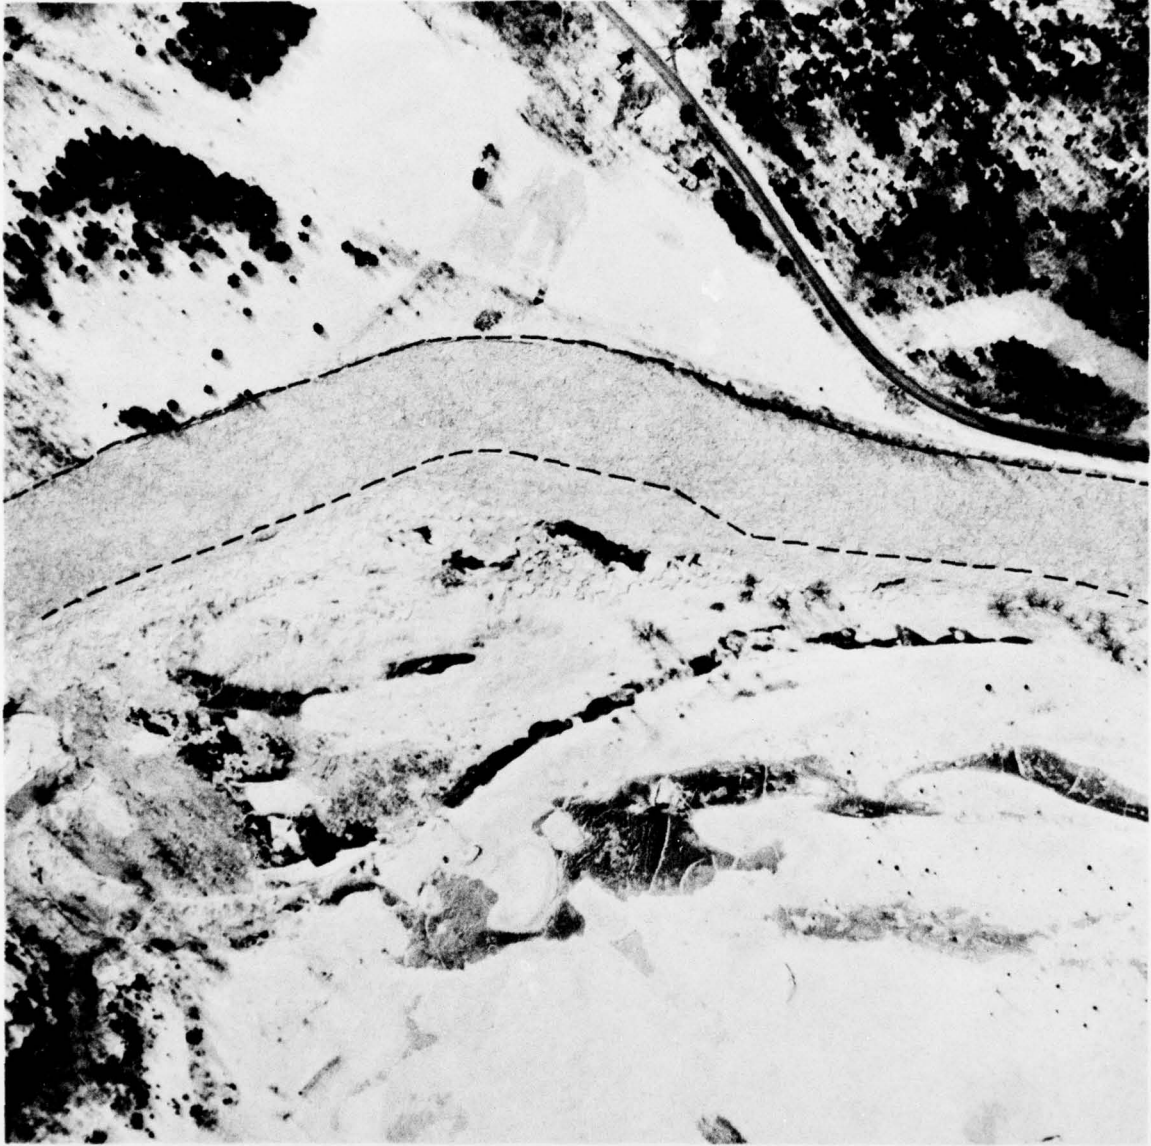
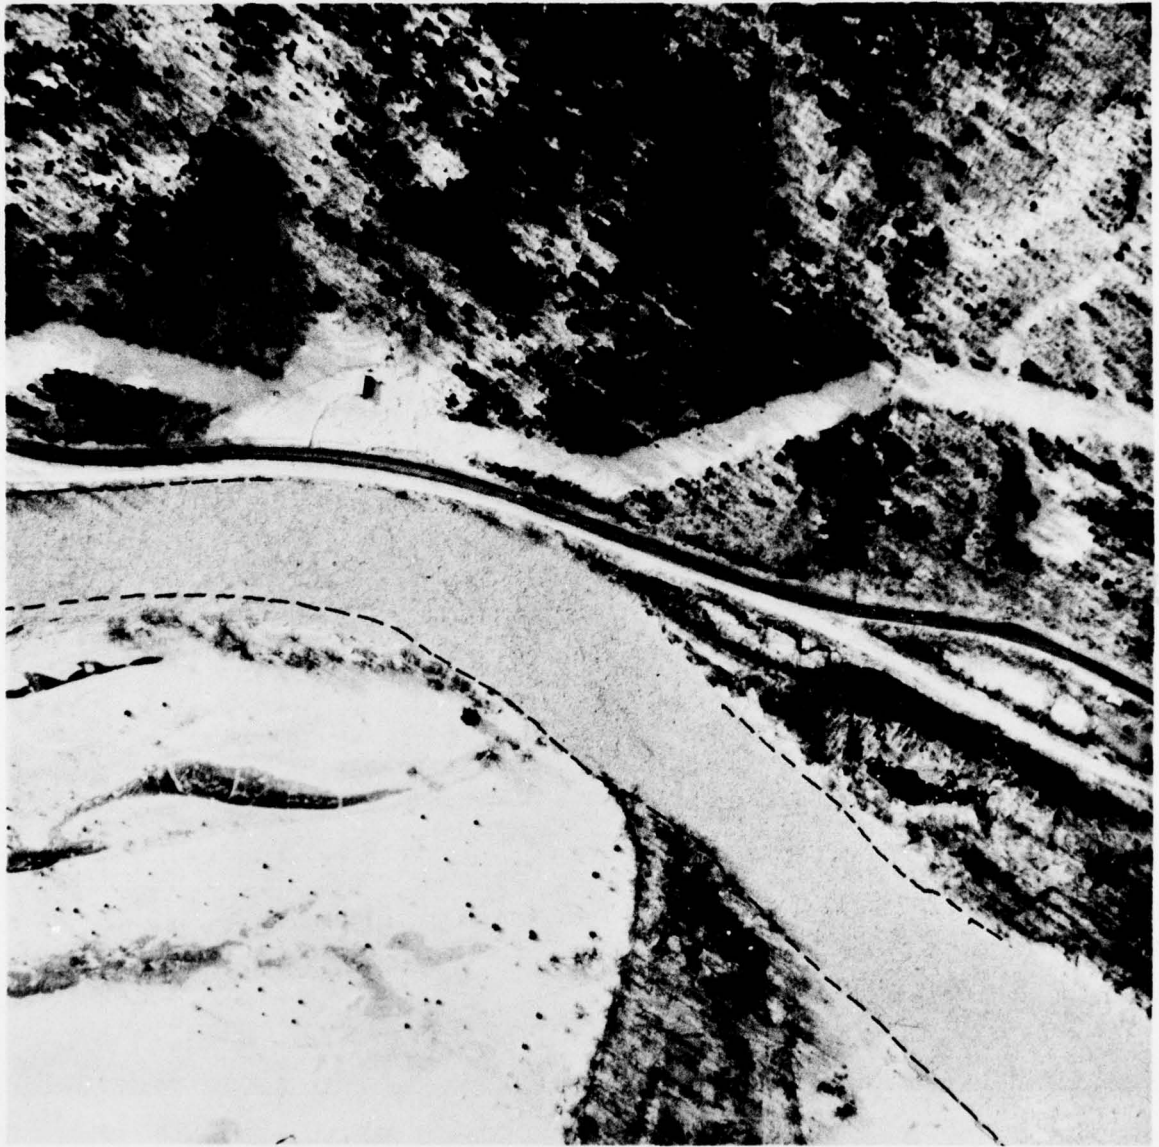
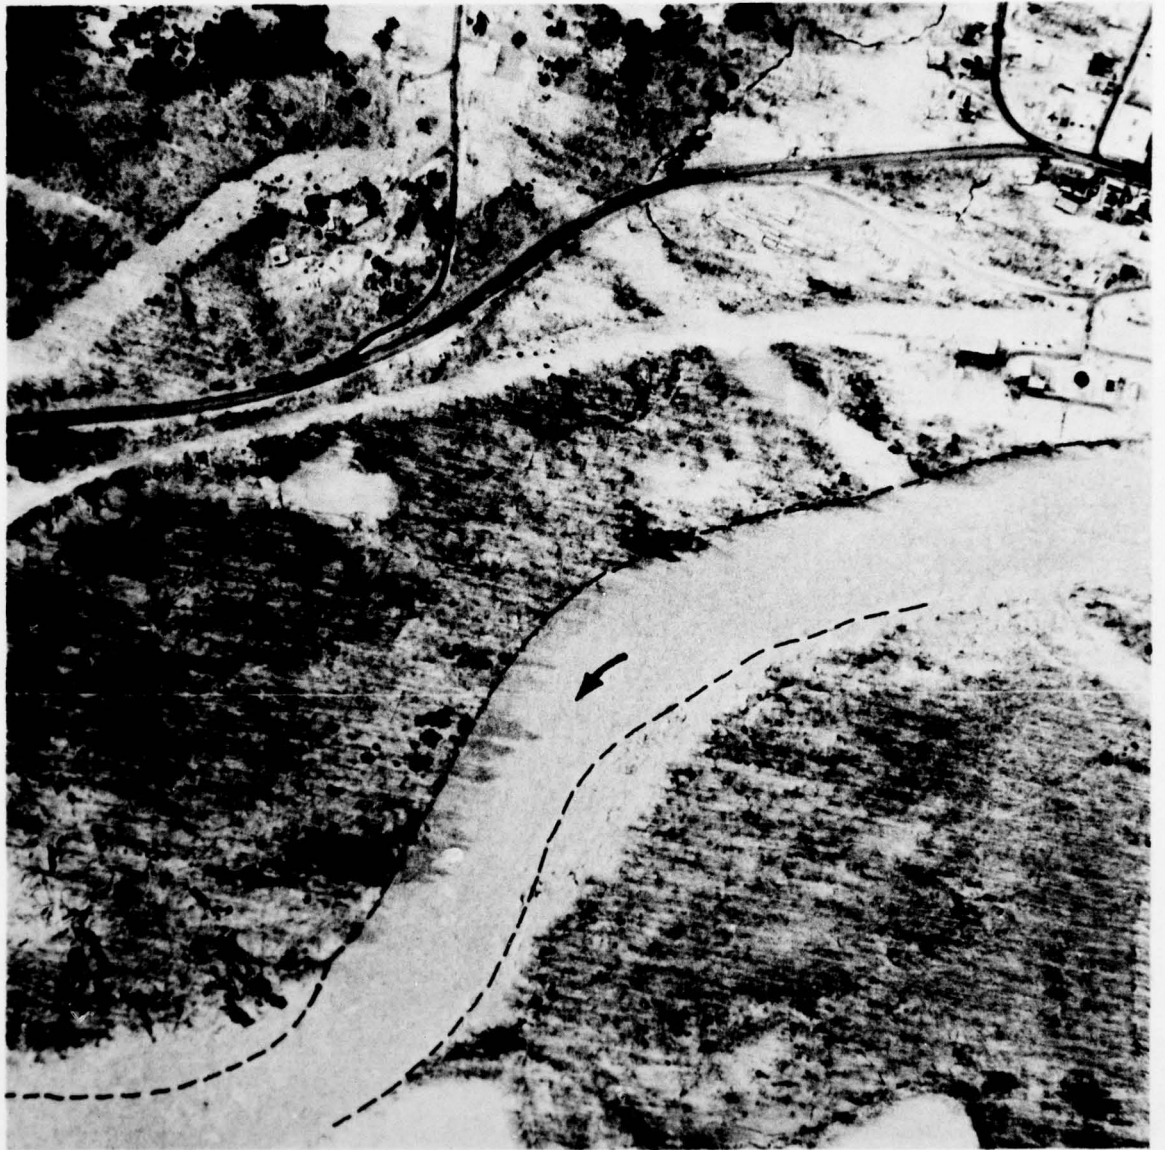
Figures 2d-2g are included merely to show the length of the jam. They all show the typical rough surface of an ice jam, some shear lines near shore and towards the upstream end, and the inclusion of a few larger pans.

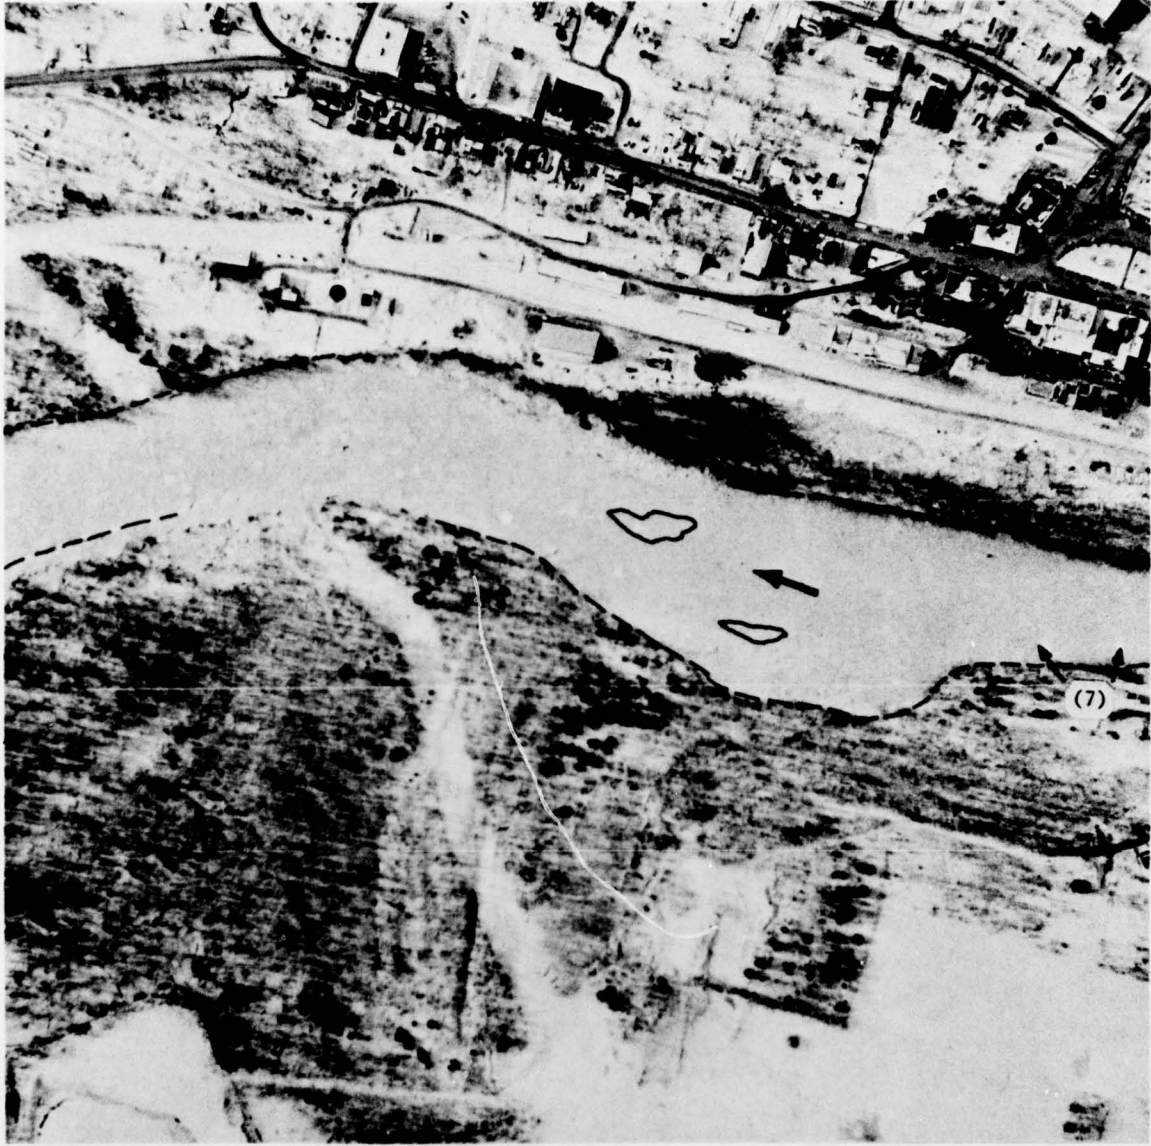
h

Figure 2h shows the upstream end of the jam and no indication of the bars and shallows that are so prominent on the 30 April photos. When observed from the bridge three days before the winter photos were taken (Fig. 3a, b and c), the upstream edge of the ice was nearly at the ridge edge of Figure 2h. Close inspection of this photo and also Figures 2i and 2j shows a number of arcuate ridges (7), concave upstream from the earlier edge of ice upstream to the bridge. Apparently these were formed by the loose, sporadic flow of ice which drifted downstream after the main ice run. By 31 January the weather had cooled and the flow had decreased so underturning of ice blocks and compression of the jams by internal packing was no longer happening.

The pattern in Figures 2h and 2i and the downstream portion of Figure 2j shows this gradual upstream accumulation of ice. The texture is much smoother than that shown of the major part of the jam. The open water areas, though limited, indicate an ice thickness of essentially one layer. Figure 2j shows the confluence of the Baker River (8) with the Pemigewasset (9). The ice in the Baker had not moved, which apparently decreased the severity of this jam. The ice cover on the Pemigewasset from the confluence with the Baker upstream until nearly the edge of the photograph was new ice that had frozen in place since 28 January.

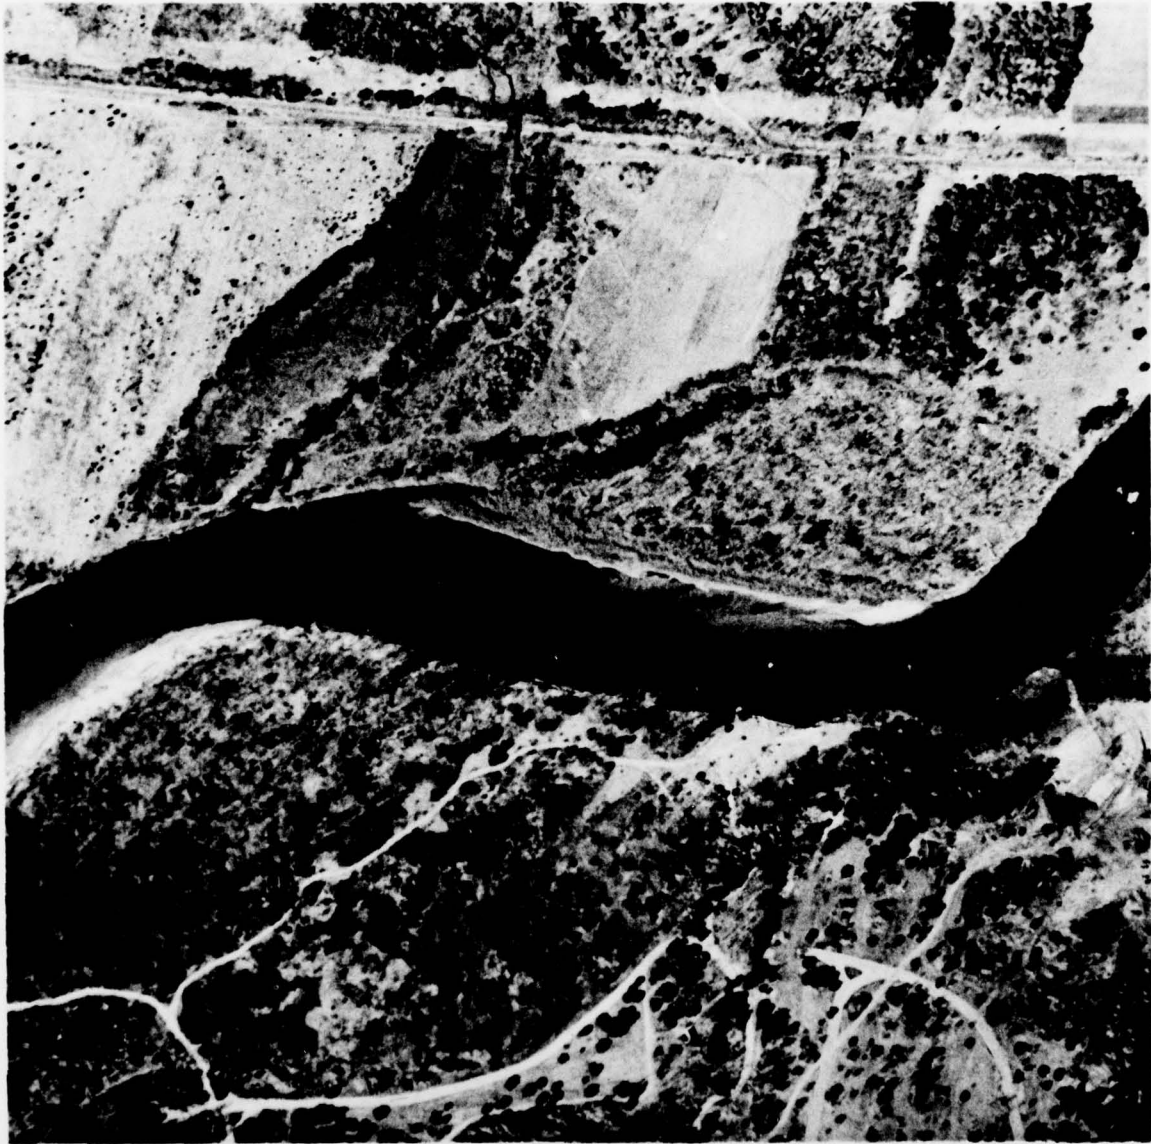
By 30 April all the ice was gone, the water level was fairly low, and the leaves were not yet out. The 30 April photos show the river banks and bars at a level similar to winter conditions. A dashed line on the winter photos depicts the 30 April water line. The sand bars, bends in the channel and constrictions did not cause this jam. How much they contributed to the final location of the foot of the jam by slowing the ice movement is unknown. This jam was caused by the back water from a dam some eight miles downstream.

Figure 3. Aerial photographs of Pemigewasset River, 30 April 1977.
