AFAPL-TR-77-26

**EVALUATION OF POWDER PROCESSED TURBINE ENGINE
BALL BEARINGS**

**UNITED TECHNOLOGIES CORPORATION
Pratt & Whitney Aircraft Group
Government Products Division
West Palm Beach, Florida 33402**

Technical Report AFAPL-TR-77-26
Interim Report for Period May 1975 - December 1976

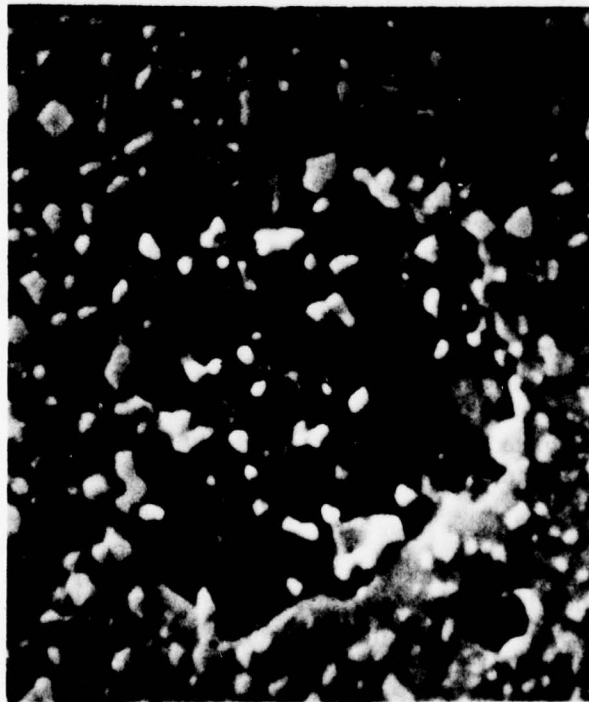
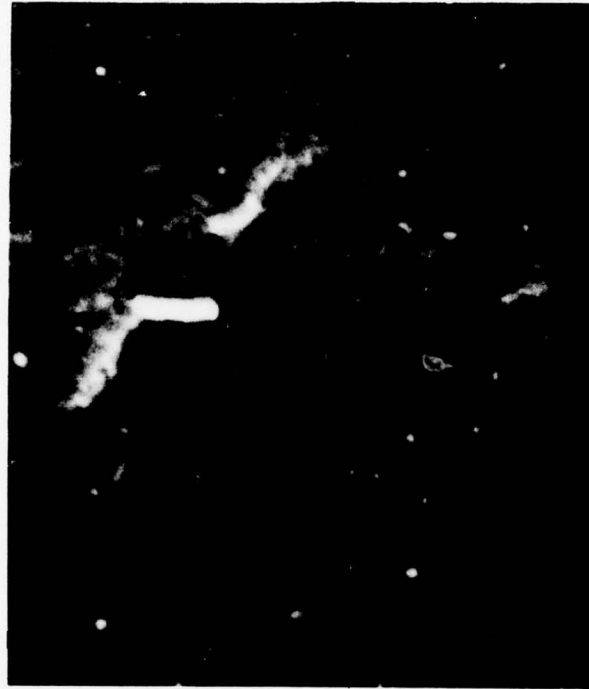
Figure 12 Scanning Electron Micrographs. Typical spherical aluminum oxide inclusion, left photograph, observed in T-15 alloy, and typical angular silicon oxide inclusion, right photograph, observed in EX00007 alloy.

The observed inclusions were identified as silica or alumina by electron microprobe analysis. Figure 12 presents scanning electron micrographs of the two types of inclusions. The largest inclusion dimension was 0.00075 inch. To put this cleanliness level in perspective, conventional vacuum melt material specifications allow a J-K rating of 1 for alumina/silicate inclusions with particle size width of 0.0005 inch and length up to 0.010 inch. Jernkontoret Standards specify that the materials be viewed at a magnification of 100X when the cleanliness value is assigned. Photomicrographs of the subject materials taken at 100X did not adequately magnify the inclusions to allow proper identification and sizing. Figure 13 is an example of alloy appearance at 100X. Therefore, additional photomicrographs were taken at 500X. Regions which were considered to contain inclusions of the largest size were photographed to demonstrate that even these areas met the J-K Standards for a rating of 1/2. Figures 14, 15 and 16 are illustrations of transverse and longitudinal sections of the three alloys. Figure 17 presents the microstructures of the three alloys as they appear in the annealed state. These photomicrographs were taken at 1000X to enlarge the carbides for closer examination. The carbides are estimated conservatively to be half the size of what is typically obtained when the alloys are conventionally processed.

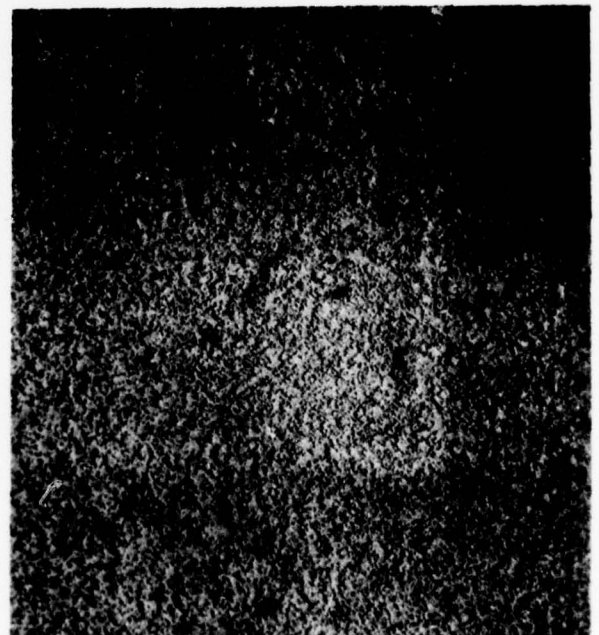
Figure 14 Powder Processed AISI M-50 Alloy. Worst fields of inclusions as observed in samples of the 13/16" diameter barstock. The larger inclusions were 0.00020" long x 0.00013" wide. Overall the J. K. rating was estimated to be better than 1/2.

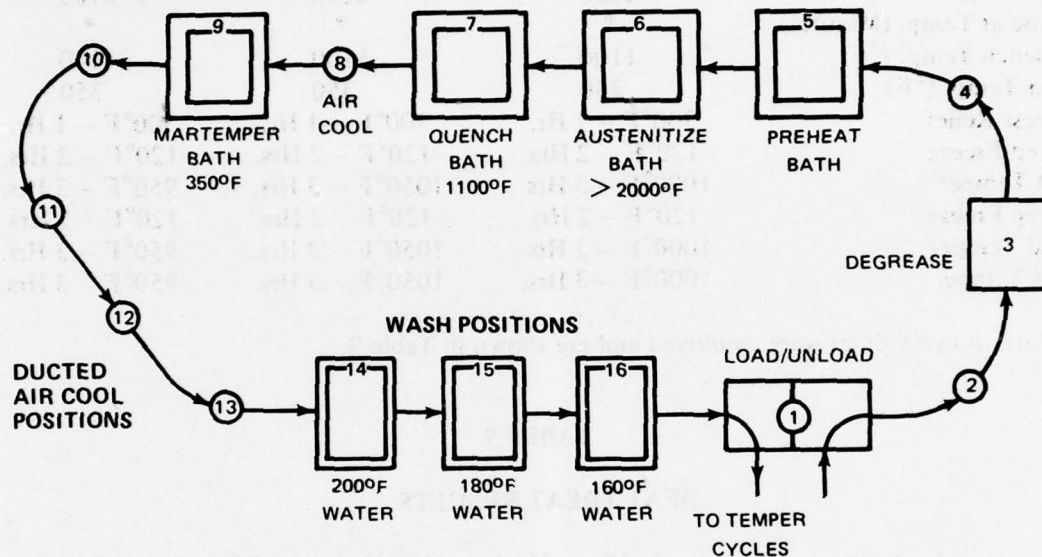
SIXTEEN WORK STATIONS ARE INDICATED. TIME AT EACH OPERATION IS PREDETERMINED AND THE BASKETS CONTAINING THE WORK PIECES ARE MOVED AUTOMATICALLY. THE OPERATOR LOADS AND UNLOADS THE BASKETS AND MONITORS TEMPERATURE READOUTS.

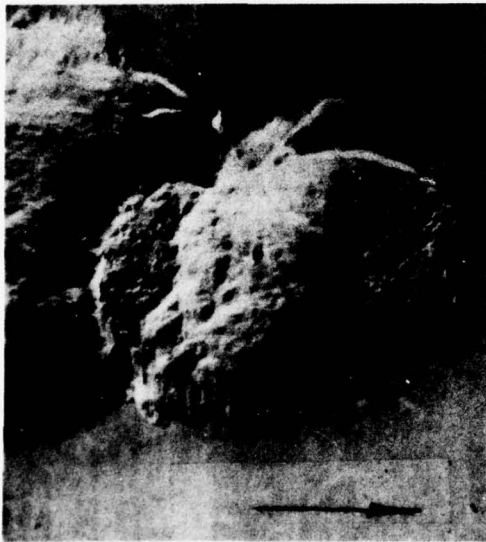
Figure 35 Typical Ball Spall. Rolling contact fatigue failure is typified by small metal chips flaking from the ball surface. Cracks originate either at a surface or sub-surface defect and under the influence of alternating stress modes, either compressive or tensile, cracking propagates until a critical size is reached and a metal chip falls away. Cracking continues at the leading edge of the spall, as shown in the right hand photo, and contributes to the propagation of spall damage. Arrow indicates leading edge of the spall.

Ball failure; that is, spalling of the ball surface as illustrated in Figure 35, or successful completion of a 40 hour test period constitutes termination of a test. After completion of at least ten tests, or as many as twenty, for a given ball lot the data are reduced by Weibull analysis techniques. This is done to determine the B-10 fatigue life of either the subject ball material, the ball processing method or the test lubricant.

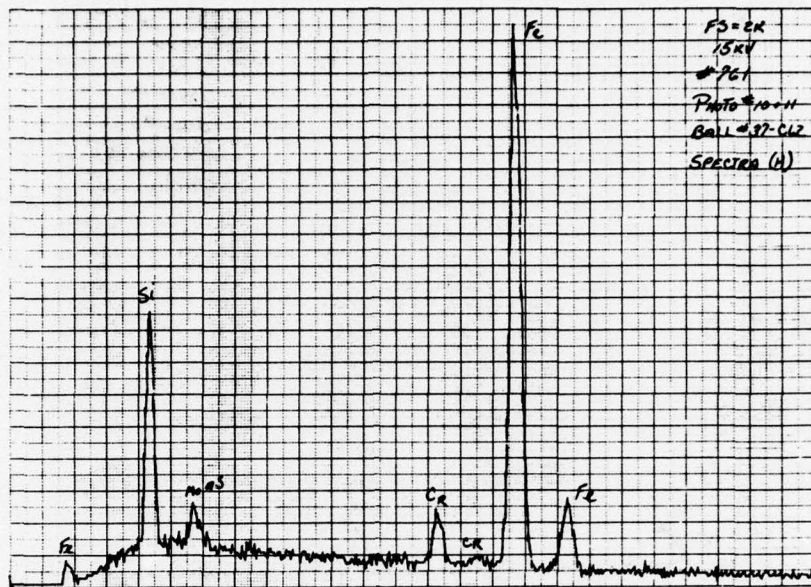
Figure 51 Electron Microprobe Trace P/M M-50 Ball S/N 37. This trace revealed the presence of silicon. This ball spalled after 108.7 million stress cycles.

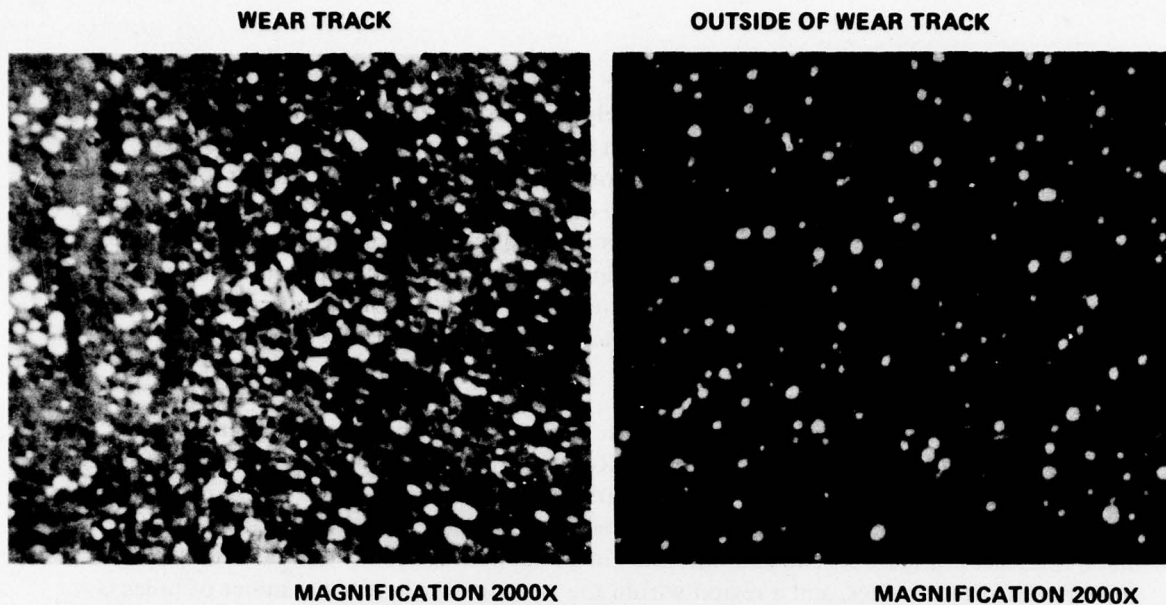
Figure 57 Holes in Surface of P/M T-15 Ball, S/N 10. (Left) Numerous holes are apparent along the edge of the wear track. They appear aligned. It is not known whether they are the result of coalescence of holes or simply due to carbide fracture and fallout. (Right) Occasional holes are present in this region which is away from the wear track. These holes seem to be associated with carbides that have fallen away from matrix metal surface.
