MECHANICAL ENGINEERING NOTE 363

VIBRATION INVESTIGATION OF HELICOPTER ENGINE
COOLING FAN

N. S. SWANSSON and G. A. DUKE

March 1977

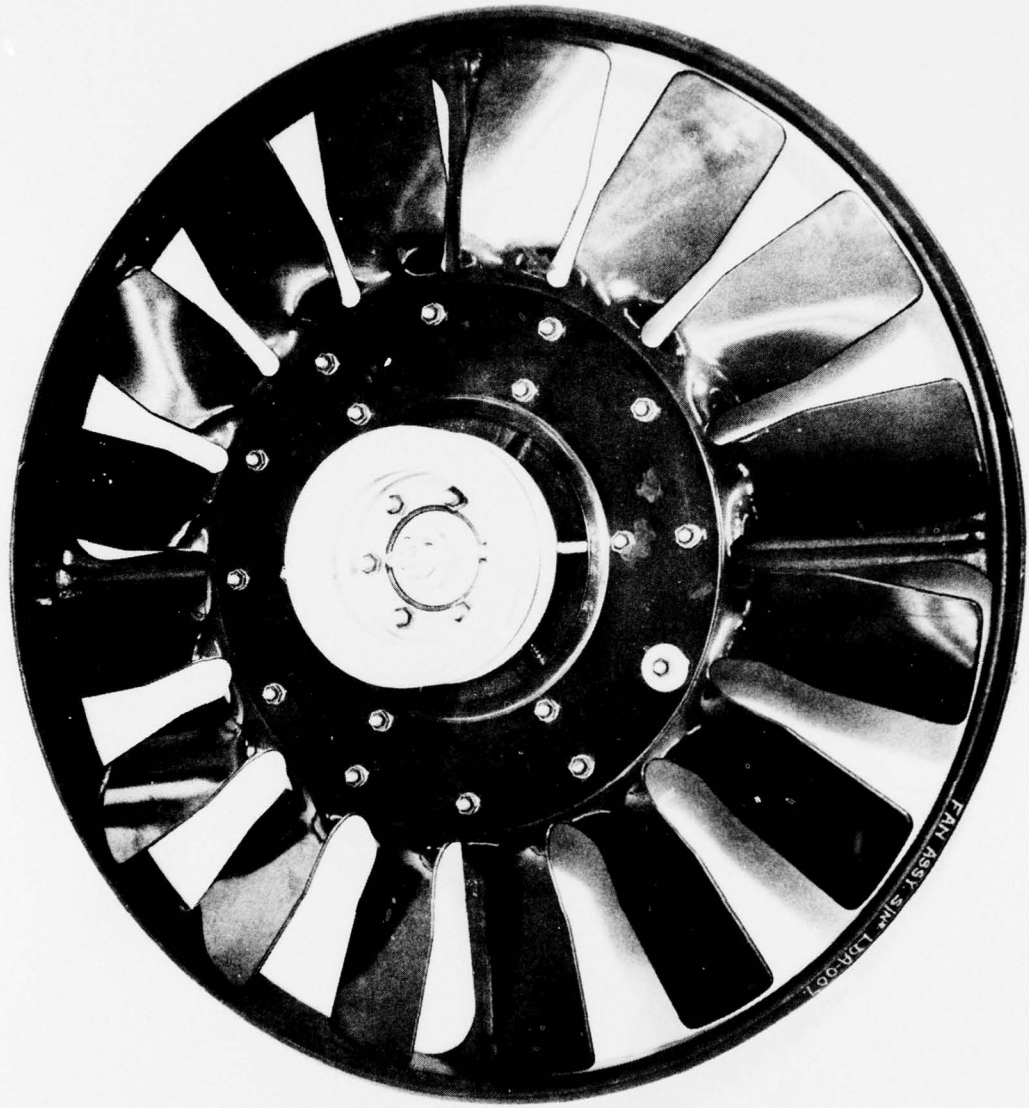
FIG. 1. THE COOLING FAN ASSEMBLY - FRONT FACE

The fan disc (Fig. 1) has 16 blades pressed from aluminium sheet. Originally three stiffening discs were bolted to the front face of the fan, with an outer circle of 12 bolts having load sharing washers bearing on the rear face of the fan disc, and an inner circle of 6 bolts which attached the assembly through a spacer to a cast aluminium hub. The fan is driven by twin V belts, the belt pulley being bolted separately to the hub, and has a normal operating speed of 4800 rpm.

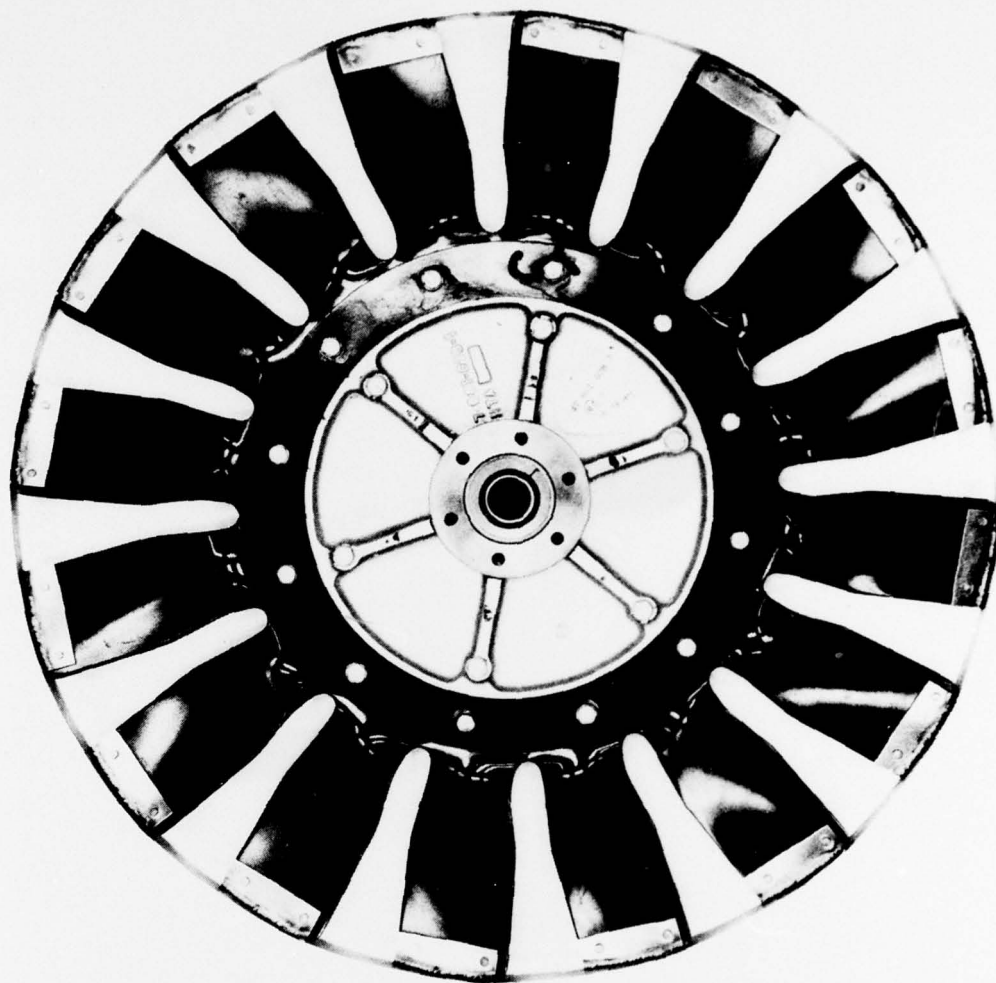
FIG. 2. THE SHROUDED FAN FROM DOWNSTREAM SIDE

sisted (Fig. 2) of a stainless steel shroud ring fitted over the blade tips, which were first machined so that the ring would maintain the original overall diameter. The shroud was retained by thin stainless steel plates rivetted to the blades close to their tips, and welded to the shroud itself.

A shroud substantially limits the vibration modes which will be produced by excitation of a given shaft order. Because the blade tips are constrained to move together, modes with adjacent blades in opposite phase will be suppressed. At the same time the 'umbrella' mode with all blades in phase, and the 'tilting' mode with one nodal diameter will be reduced in frequency since, although the stiffening effect of the shroud will slightly increase the blade natural frequency, the extra mass loading will tend to reduce it and the latter effect will dominate in these modes. Ewins (Ref. 3) gives a detailed description of coupled modes in a detuned blade-disc system, and the effects of a shroud in suppressing the excitation of particular modes.
