MISCELLANEOUS PAPER S-77-9

## PRELIMINARY INVESTIGATION OF GENERAL-PURPOSE MAT/PANEL MATERIALS

Soils and Pavements Laboratory  
U. S. Army Engineer Waterways Experiment Station  
P. O. Box 631, Vicksburg, Miss. 39180

May 1977

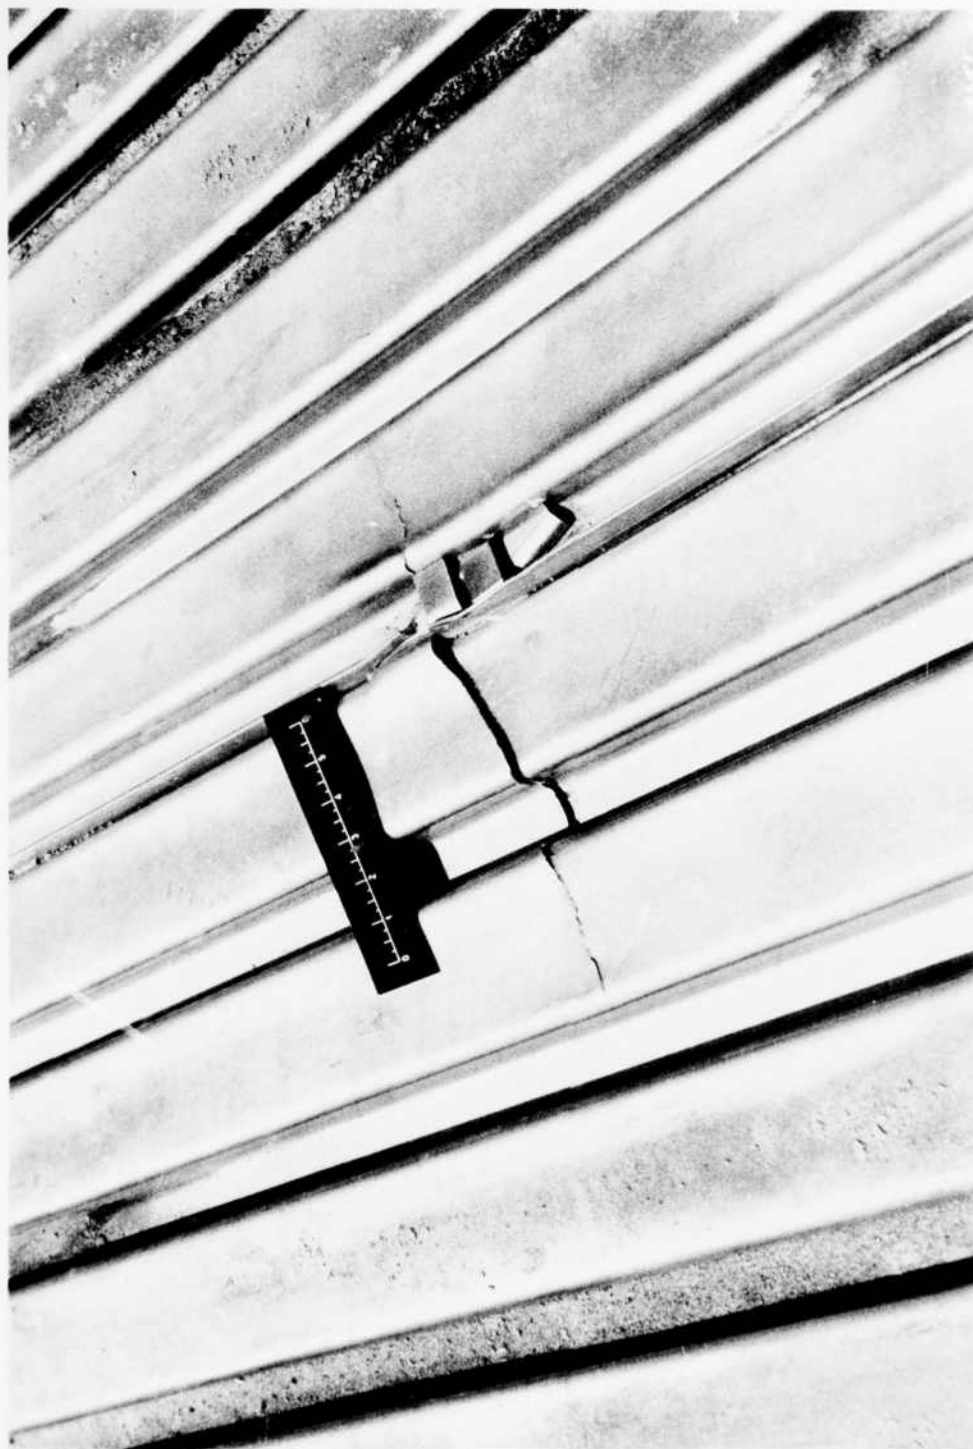
Photo 19. Split in Fletcher panel 43 after 3000 passes

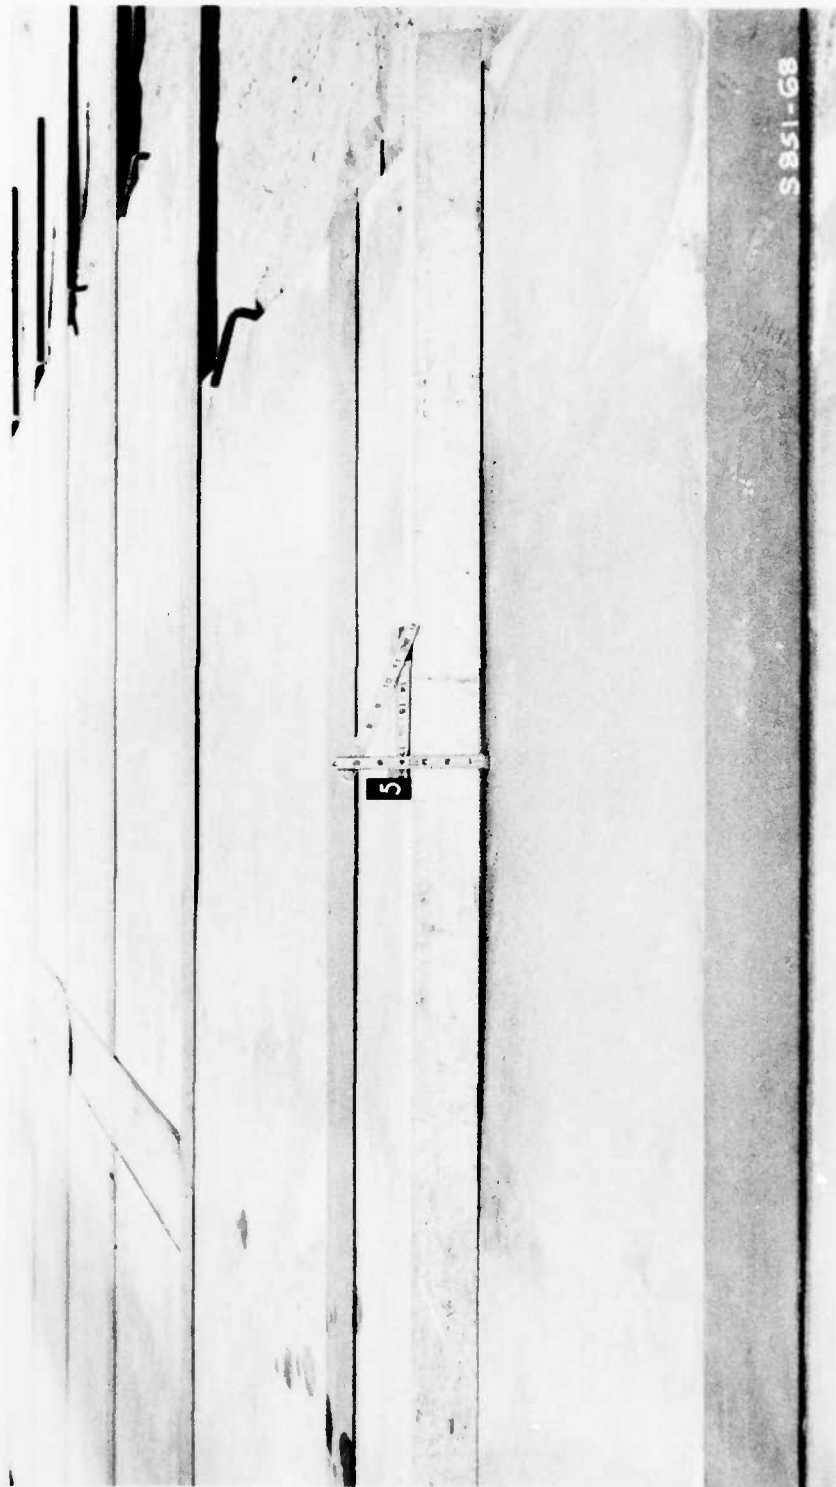
Photo 24. M. C. Gill panel 3 deformed 1/4 in. at 1000 passes

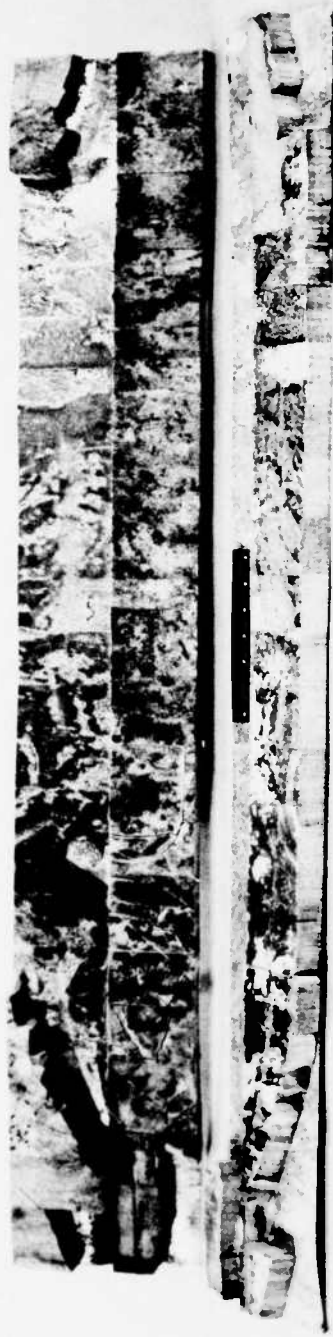
Photo 26. Cross section of failed M. C. Gill balsa wood panel

36. At 1600 passes, panel 1 had a 1-in. break in the south wheel path which progressed to 4-1/2 in. at 1720 passes. At 1900 passes, panel 4 had a 2-in.-long break. At 2000 passes, the item was considered failed as disbondment was extensive in both wheel paths. The section is shown at the completion of traffic (2000 passes) in Photo 25. Panels 1, 4, and 5 had top skin breaks, and panels 1, 3, and 4 had bottom skin breaks. The maximum length of breaks on the top and bottom was 5-3/4 in. Panel 4 was dissected to inspect the internal

core failure and adhesive failures (see Photo 26). Only about 5 percent of the bond of the specimen in Photo 26 had to be forced apart by hand as the other 95 percent had failed during the traffic test.

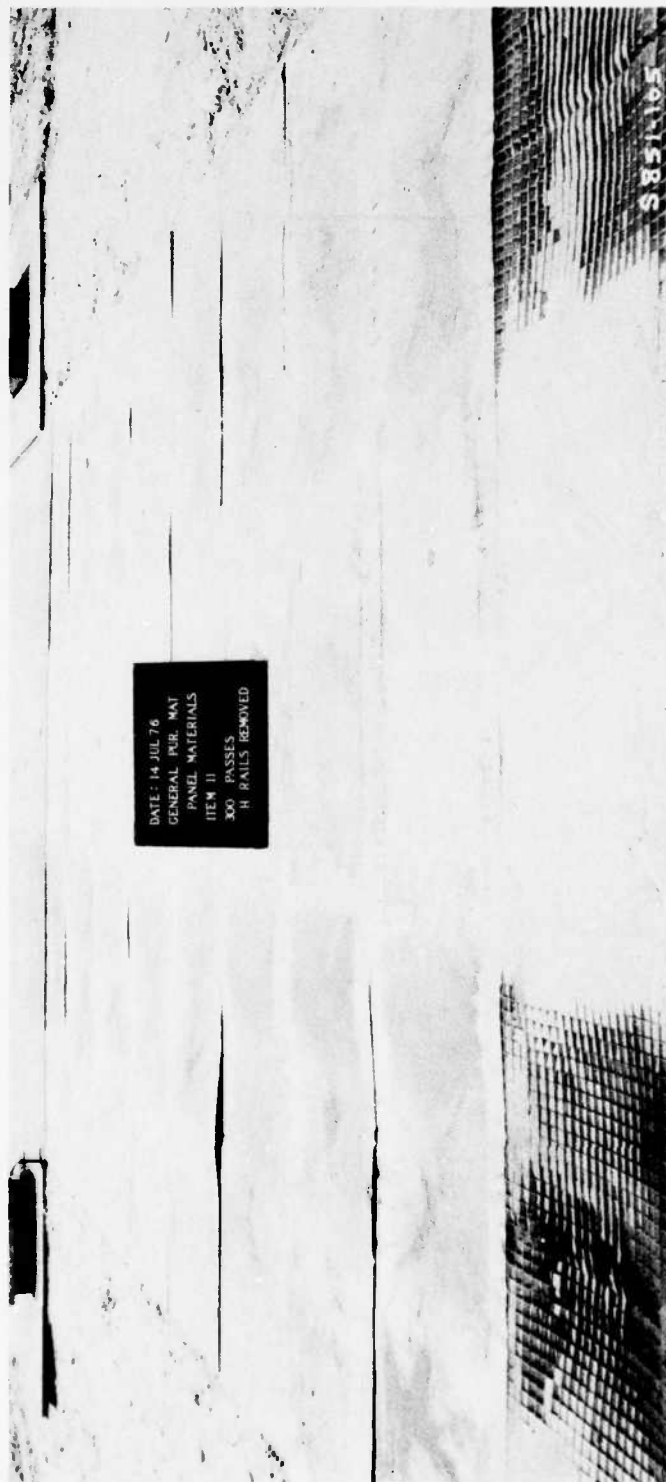
Photo 41. With H connectors removed, the top skins of the Spur-Ecolite sandwich panels are shown disbonded in wheel paths at 300 passes

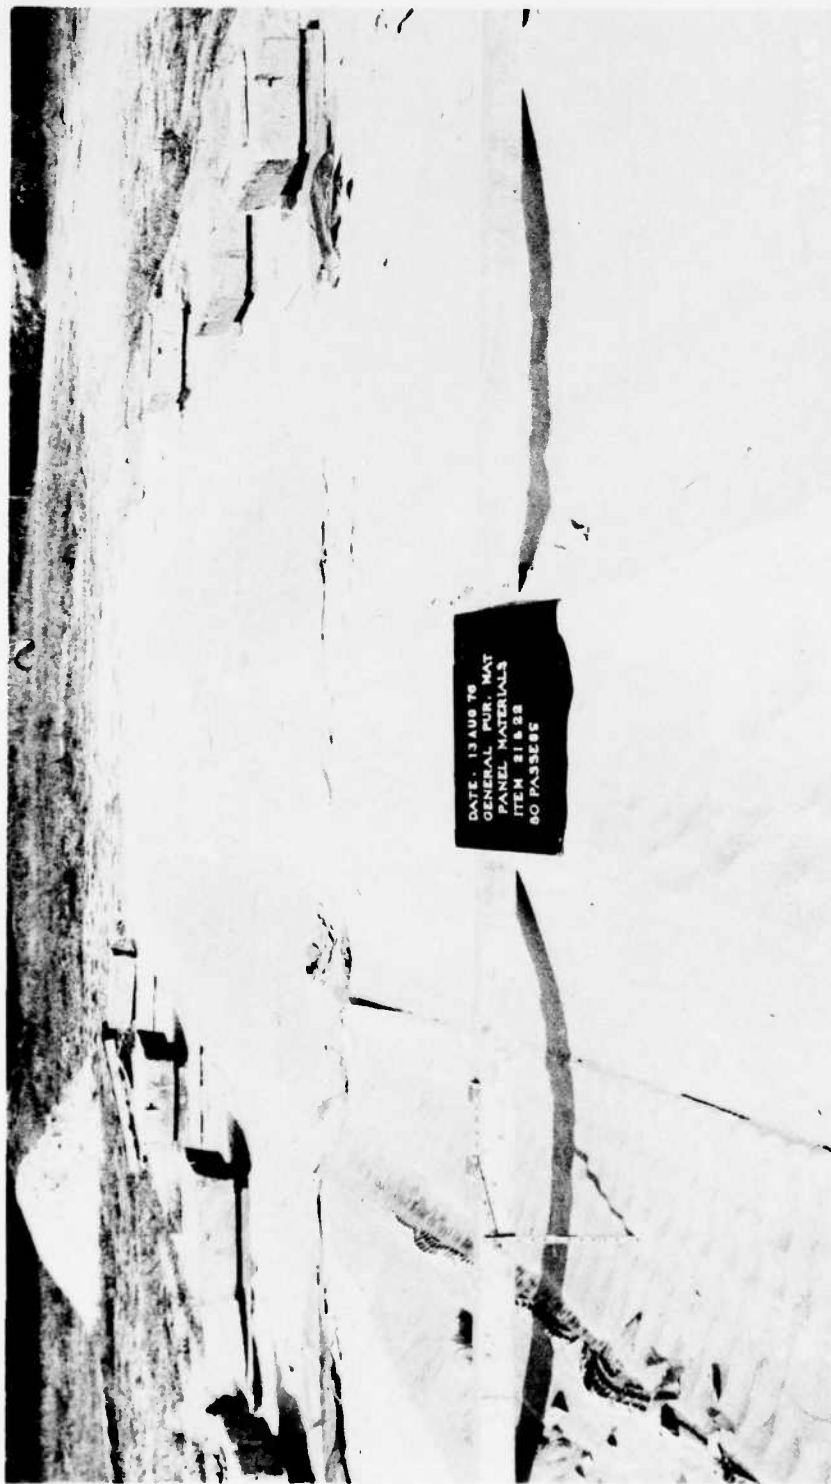
Photo 42. Items 21 and 22, Spur-Ecolite one-skin panels; failed item 21 (left) with skin up and unfailed item 22 (right) with skin down at 80 passes

58. A verification test was conducted on two Spur-Ecolite panels containing one skin, in which one panel was placed on sand with the skin up (item 21) and the other was placed with the skin down (item 22). The test vehicle was again used and two panels were placed on the sand in parallel lanes with the long axis in the direction of traffic, so that both panels could be trafficked simultaneously and thus easily compared. After 80 passes of the test vehicle, the panel with the skin up had failed. The core had disbonded from the skin, the core was split and broken, and the skin was wrinkled. However, after 80 passes on the panel with the skin down and the core openings filled with sand,

there was no disbondment and no apparent failure. Profile data (Plate 12) indicate that the panel with the skin down (item 22) embedded approximately one-half as much as the panel with the skin up (item 21) at an equal number of passes. Thus, as anticipated in initial studies of the design, the Spur-Ecolite panels with one skin perform better on sand if the skin is placed down and the open-square cells are filled with sand (Photo 42). This arrangement assures that the cells will be filled with sand which provides added strength to the core members.

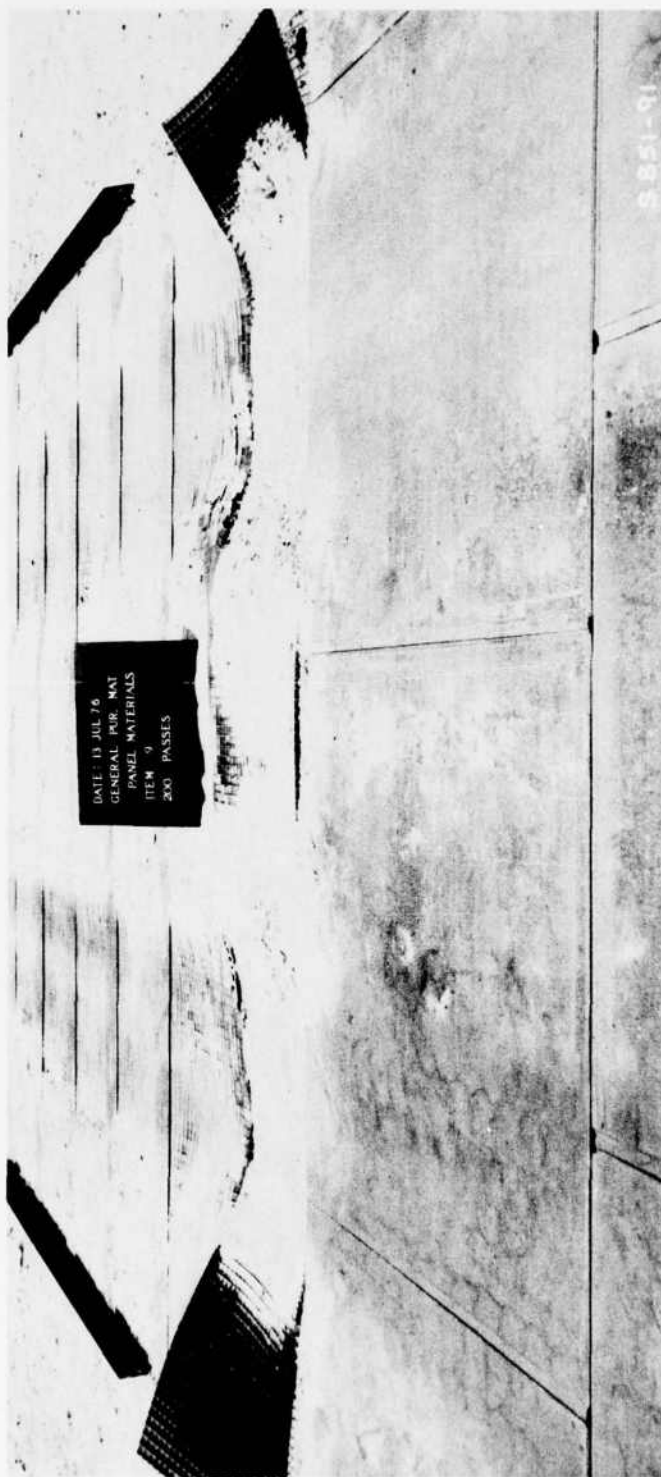
Photo 46. Ecolite 1- by 1-in. core, item 9, at 200 passes

67. In initial testing of the core, one of the 1-in. cores was placed on the dry sand, filled with sand, and trafficked with 400 passes of the test vehicle (item 9). During the first 200 passes, the core material performed satisfactorily in the wheel paths as the core continued to embed in the sand; however, the untrafficked areas tended to curl up and/or remain higher than adjacent material and cracks and breaks began to occur between these areas (Photo 46). After 300 passes, core crushing occurred as the sand escaped from the cells and the core was torn and flattened (Photo 47). For all practical purposes, the material was considered failed at this time as it would cause a hazard to vehicular traffic tires. The 1-in. grid core was placed on the sand again and the voids were filled with sand; however, the long axis of the core was oriented with the direction of traffic (Photo 48). In this test the test vehicle was allowed to drive up on the core from the sand; however, the drive wheels of the truck, in attempting to pull out of the immobilizing sand, caused severe breakage of the unprotected open-grid core material (Photo 49). Thus, the single thickness of the unsupported 1-in. core alone on the sand did not prove to be an adequate supporting material for the vehicle as loaded; hence, the 1/2-in. grid core in a single layer was not tested.

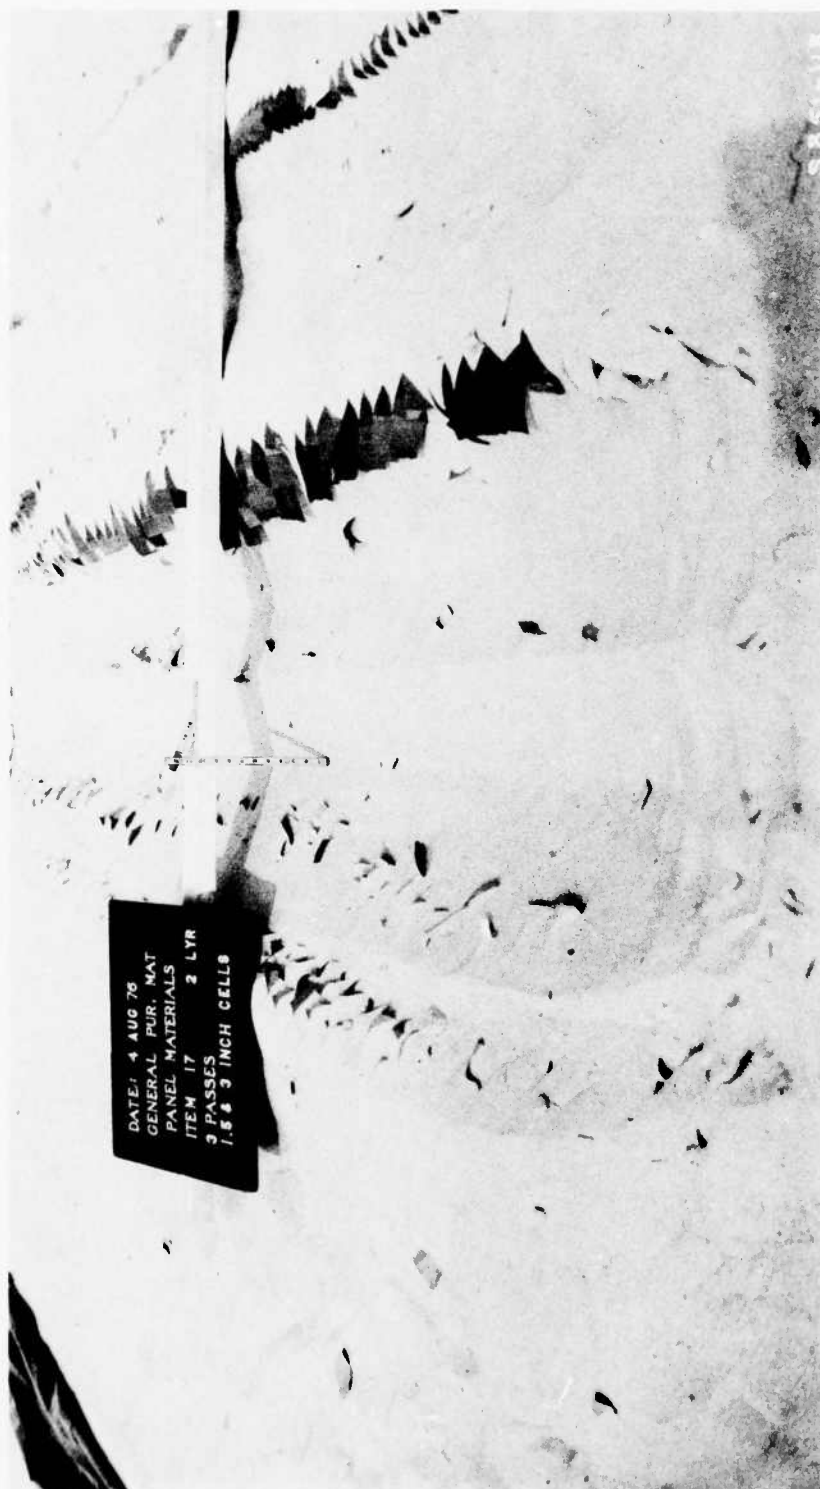
Photo 51. Hexcel paper honeycomb core, 3-in. cells, 2 in. thick, in double layers, item 17 (south), after 3 passes

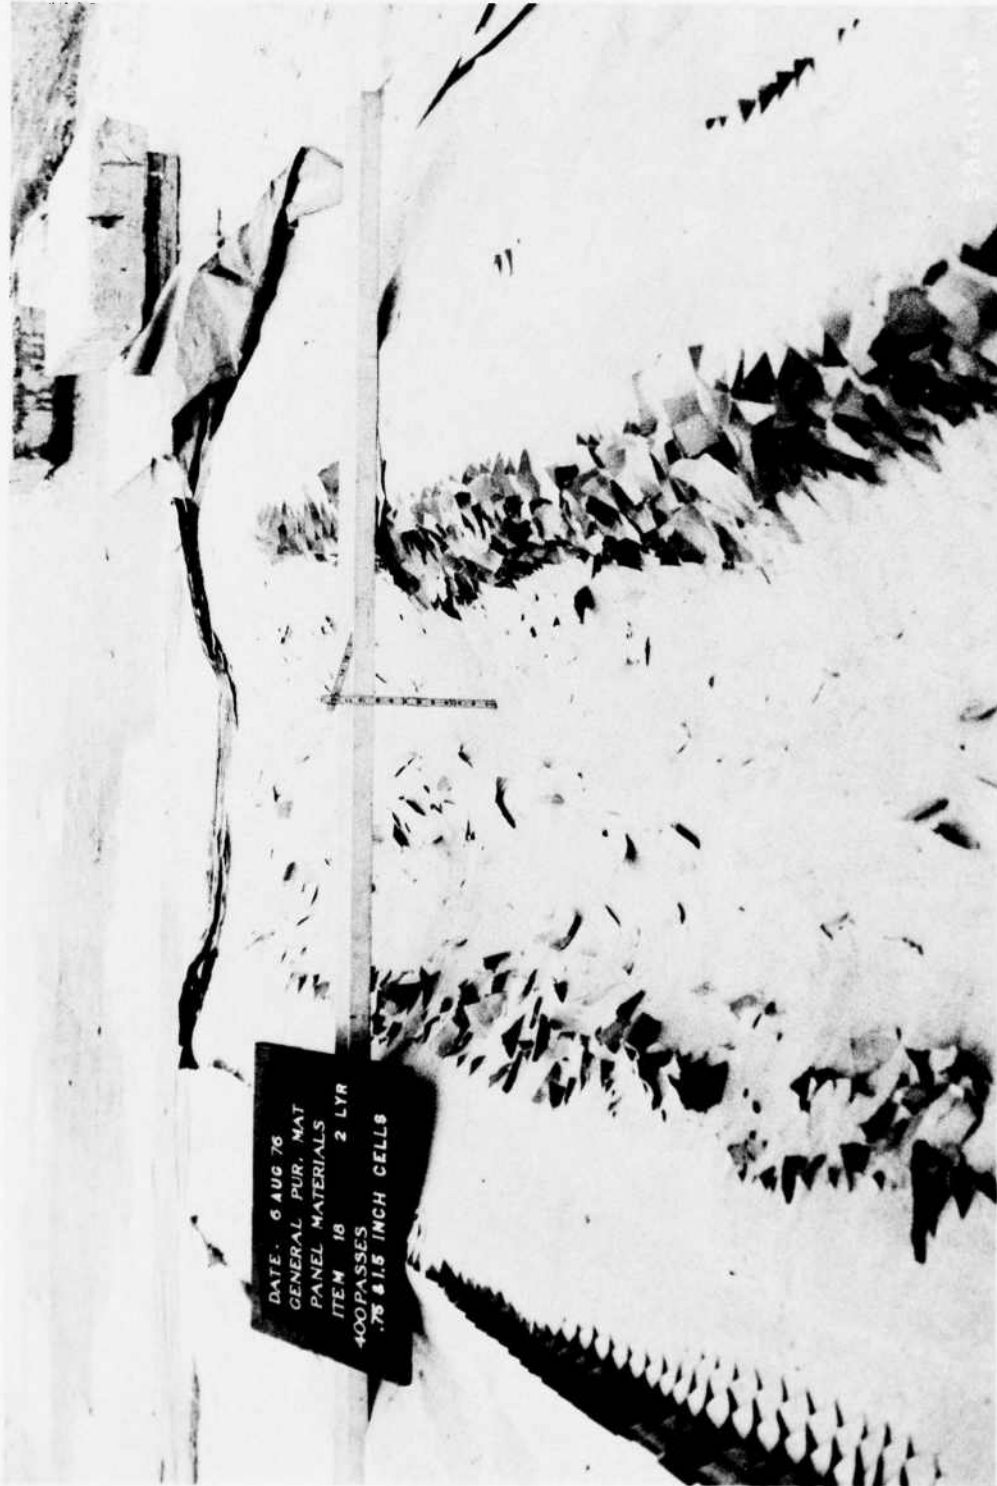
Photo 54. Hexcel paper honeycomb core, item 18, double layer of 1-1/2-in. cells, considered failed after 400 passes of mixed vehicular traffic

76. At this point (400 total passes), the 1-1/2-in. honeycomb material was considered failed due to disintegration of the material, and it was no longer considered suitable for traffic (Photo 54). In comparison, the 3/4-in. honeycomb was still performing satisfactorily and in excellent condition (Photo 55). Thus, matting was placed over the failed material and traffic was continued on the 3/4-in. material. After 500 total passes, there was some indication of failure along glue lines in the 3/4-in. cells in the top layer, although it was not critical at this time. However, after 1000 passes, four glue lines had failed as indicated by separations of the ribbons. The rut depth between the outside edges of the honeycomb and the center was as much as 4-1/2 in. However, this was due primarily to the curl up of the edges in the nontraffic areas. After a total of 2000 passes of the mixed traffic of the 1/2-ton pickup and the 1-1/2-ton truck, the rut depth had increased to approximately 9 in. on the 3/4-in. cell material, and both layers were turning up along the outside edges. The previously failed three or four bond lines tended to relieve some of the stresses in the honeycomb and these areas were still performing satisfactorily. Except for the outside edges which had not been trafficked and were curling up and losing the sand in the voids, the core was performing satisfactorily (Photo 56). Trafficking was discontinued at this time with the 1-1/2-ton truck. Profile data (Plate 16) indicate that the honeycomb had continued to embed in the sand to a maximum of 6-3/4 in. or for an average of approximately 5 in. For information purposes, eight additional passes of the original 5-ton truck with a 40,000-lb payload were applied to the section, and the honeycomb showed no change or additional distress due to this loading. Additional traffic was not applied as examination of both layers of the honeycomb was desired. The examination revealed that the bottom layer was contoured to the top and that breaks were similar in both layers but to a lesser degree in the bottom layer.
