U. S. NAVAL AIR ENGINEERING CENTER

NAEC-ENG-7934

FINAL REPORT

LONG-TERM WEAR AND IMMERSION TESTS
OF POLYMERIC COATINGS

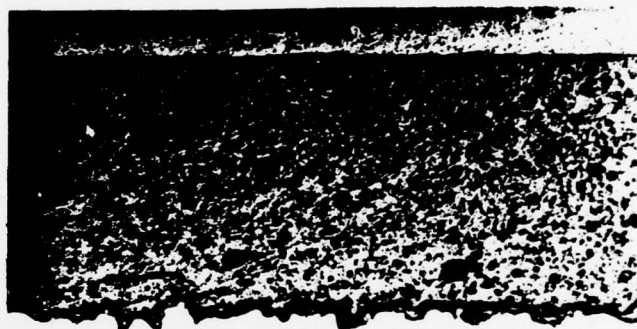
FIGURE 12. SECTIONS OF NYLON 11 IMMERSION SPECIMENS.

3. **Metallographic Examinations.** All of the immersion specimens were sectioned and a piece of each specimen was mounted in plastic for metallographic examination. No blistering, cracking, debonding or other coating deterioration was observed during microscopic examination. Typical sections of each coating are shown in Figures 12-15. It was possible to determine polymeric coating and substrate coating thicknesses by microscopic examination, these data are given in Table VII along with the total substrate plus polymer coating as based on thickness measurements on ground specimens and on coated specimens before the immersion test. Slight differences in total coating thickness as determined by the two techniques are attributed to variations in coating thickness and to metal removed by abrasive blasting of the surfaces before application of the flame-sprayed nickel-aluminide coating (generally around 0.001-in. thick).
