CIVIL ENGINEERING LAB (NAVY) PORT HUENEME CALIF  
FRACTURE TESTS WITH AN ELECTROHYDRAULIC PULSER.(U)  
DEC 76 T A SHUGAR, R J ODELLO  
CEL-TM-51-76-19

<sup>6</sup> FRACTURE TESTS WITH AN ELECTROHYDRAULIC PULSER.

## CIVIL ENGINEERING LABORATORY

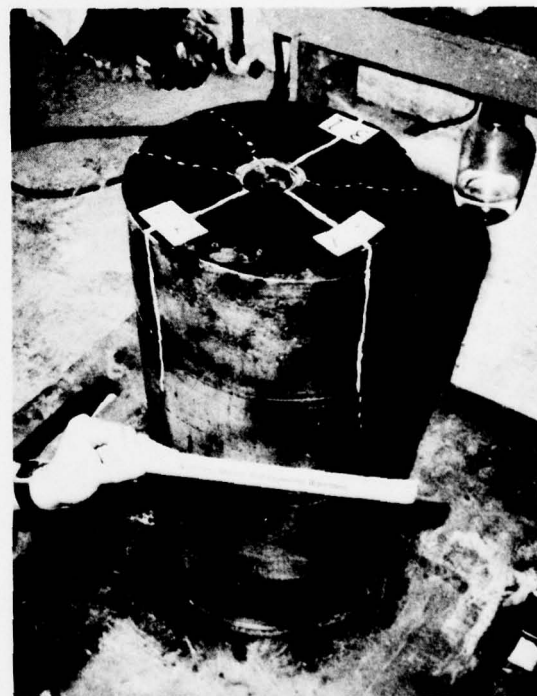
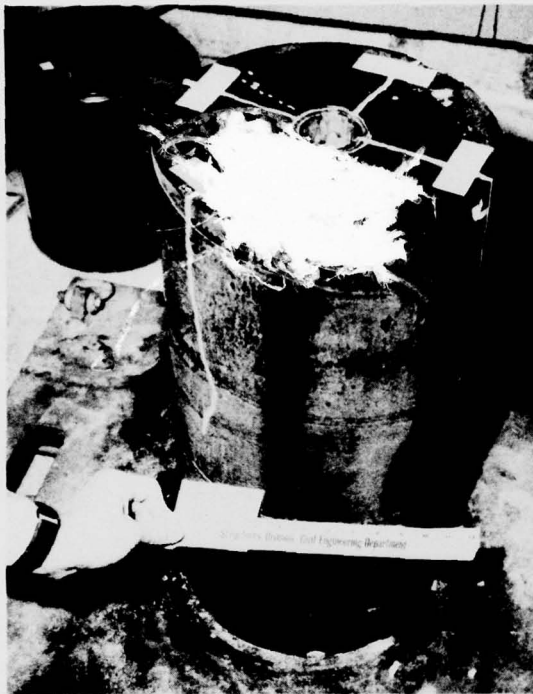
Figure 4. Fractured Hydrostone Specimens-Initial Experiments

The four fractured test specimens are shown in Figure 4. All the fracture modes were characterized by radial cracks, exclusive of desirous spall crack (circumferential) failure. These results demonstrated that while the electrohydraulic pulser was capable of fracturing test specimens, the fracture damage was neither sufficiently rigorous nor of the desired mode. It was believed that the stress wave produced by the electrohydraulic pulser would produce fractures similar to those reported in Reference 1 where chemical explosives were employed with hydrostone specimens.

An energy comparison between the two methods was made to ascertain whether the electrohydraulic method and the chemical explosive method were comparable in potential energy. The applicable electrohydraulic system parameters are 45 microfarads capacitance at 17,000 volts. Then the potential energy for the system is  $1/2 CV^2$  where C is the capacitance and V is the voltage; or 6,500 joules of stored energy. The series C and D hydrostone cylinders of Reference 1 corresponded closely in size and shape with the present cylinders (Figure 1). All these cylinders (a total of five) were fractured with a stress wave produced by lengths of detonating cord explosive (PETN) detonated in the holes at the top of the cylinders. These tests are summarized in Table 2. Energy equivalence was based on the data of Reference 4. All five cylinders sustained both radial and spall (circumferential) fracture surfaces and sustained damage far more extensive than that shown in Figure 4.

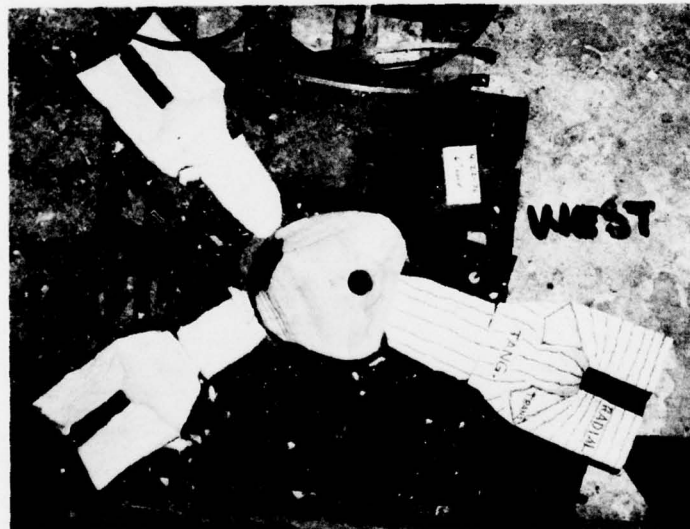
Figure 5. Fractured Hydrostone Specimens-Improved Pulser

The fractured test specimens, numbered 5 through 7, are shown in Figure 5. By comparing these failures, especially that of number 5, with the previous failures, it is apparent that more energy is being delivered to the test specimens. The extent of fracture in specimens 5 through 7 exceeds that which was seen in the previous four specimens.

The hole depth was successively increased from 50mm (2 in.) to 150mm (6 in.), and finally to 300mm (12 in.) to obtain a fracture behavior pattern associated with the hole depth parameter. In these hydrostone specimens the depth of the hole apparently controls the depth of radial fracture surfaces. As can be seen clearly in specimens 6 and 7 the radial fracture surface extends to the bottom of the hole. The fracture surface then changes to a tangential surface further down in the specimen. A transitional fracture zone separates the two types of fractured surfaces.

The tangential fractures shown in Figure 5 are reminiscent of the circumferential spall fractures obtained in Reference 1, but are not the same. True circumferential spall fractures occur on a cylindrical surface, symmetrical about the specimen axis. Therefore, true circumferential fractures are rotationally symmetric and tend to reduce the cylindrical specimen diameter. By contrast, tangential fractures are not rotationally symmetric and tend to "square" the cylindrical specimen.

Though the fractures depicted in Figure 5 are extensive, the mode of fracture is still dominated by radial cracks. In an attempt to determine why these results are different from those presented in Reference 1 where circumferential cracking was also present, the following discussion is given. A thorough analytical investigation was beyond the scope of the project.

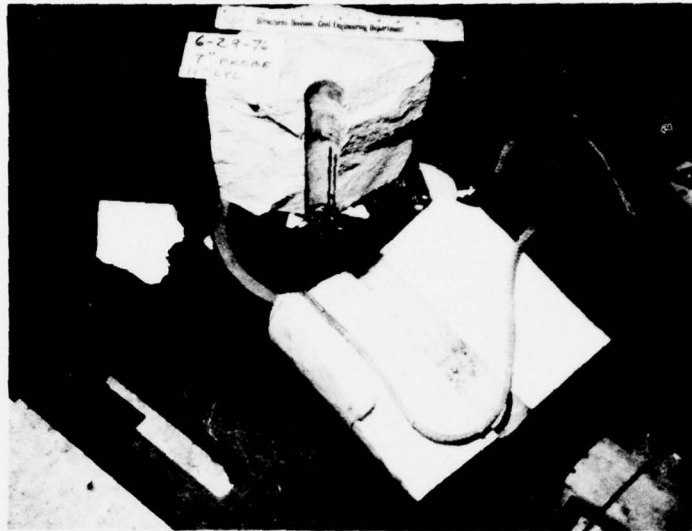
Figure 7. Fractured Hydrostone Specimens-Linear Source

Two tests were conducted to determine the effect of having a more or less linear spark discharge within the hole. The objective was to produce a normally incident stress wave. A 50mm (2 in.) diameter hole was drilled the full depth of each specimen. Steel rods, 3.2mm (1/8 in.) in diameter, were welded to electrode plates and inserted into the holes to create a 75mm (3 in.) linear spark gap. The holes were filled with deionized water. In both tests the specimens failed along radial lines with no evidence of circumferential spalls. Figure 7 shows the fractured test specimens and the electrodes. Here again it is seen that the radial fractures extend to the depth of the hole and the impulsive loading results in a rather uniform bisection and trisection of specimens 8 and 9, respectively.

2. Pulse Duration. The test results and circuit analysis both indicate that the stress pulse duration for the pulser tests was much longer than for the detonating cord tests. The measured pulse duration for the electrohydraulic system was 40  $\mu$ sec, while the estimated duration of the blast pulse from the detonating cord was only 10  $\mu$ sec. In the two tests in which the spark was initiated along the axis of a hole running the entire length of the specimen, only radial cracks were formed. So even when the stress wave is permitted to approach the free surface at a normal angle, the pulse duration is too long to produce a net tensile pulse of sufficient strength to cause spalling. The failure mode shown in Figure 7 is more characteristic of static failure than stress wave fracturing.
