Report No. CG-D-62-77

## FIRE PERFORMANCE OF INTERMODAL SHIPPING CONTAINERS

Randall Eberly  
Merchant Marine Technical Division  
Office of Merchant Marine Safety,  
U.S. Coast Guard Headquarters  
Washington, DC 20590

Final Report

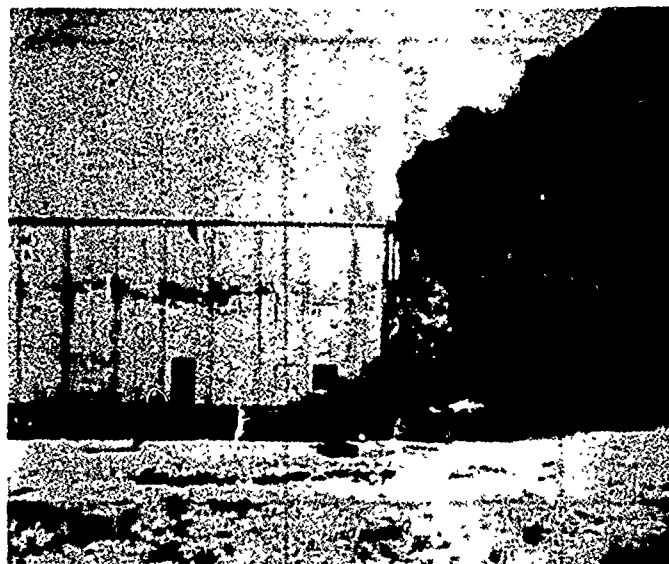
**Figure 9 — Test Number Four**

Detailed test data for Test 4 is contained in Appendix B. Test 4 was planned as a one-minute exposure. Unfortunately, immediately after ignition, a wind shift caused most of the fuel to move to the rear side of the test pan. Because of this, a ten-minute exposure of the container doors occurred. Although not part of the test plan, Test 4 provided an opportunity to evaluate the container doors and locking systems. Post-test examination revealed all doors to be still operable; however, extra effort was required to secure the locking rod cams in their keepers because the locking rods had bowed outward. No failure of hinges occurred and all door gaskets were charred but not totally destroyed, therefore, leakage of flame into the containers did not occur. The aluminum container's plymetal door outer panel of aluminum sheet had melted off and the plywood core was charred.

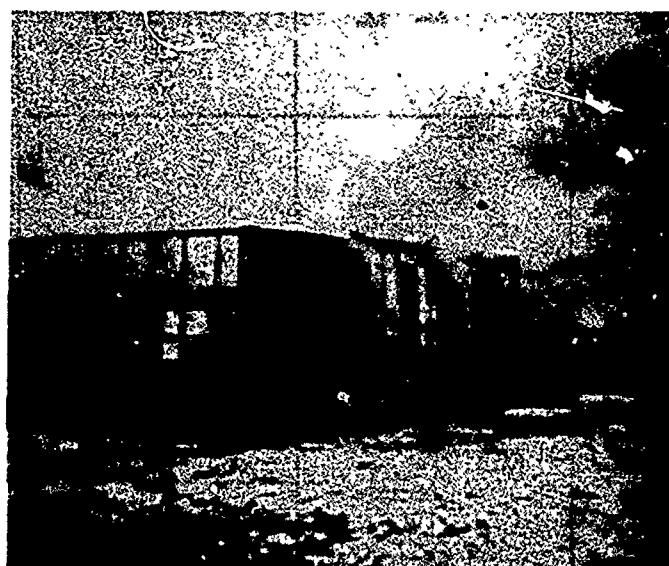
**Figure 10 — Condition of Container Doors  
After Test Exposure**

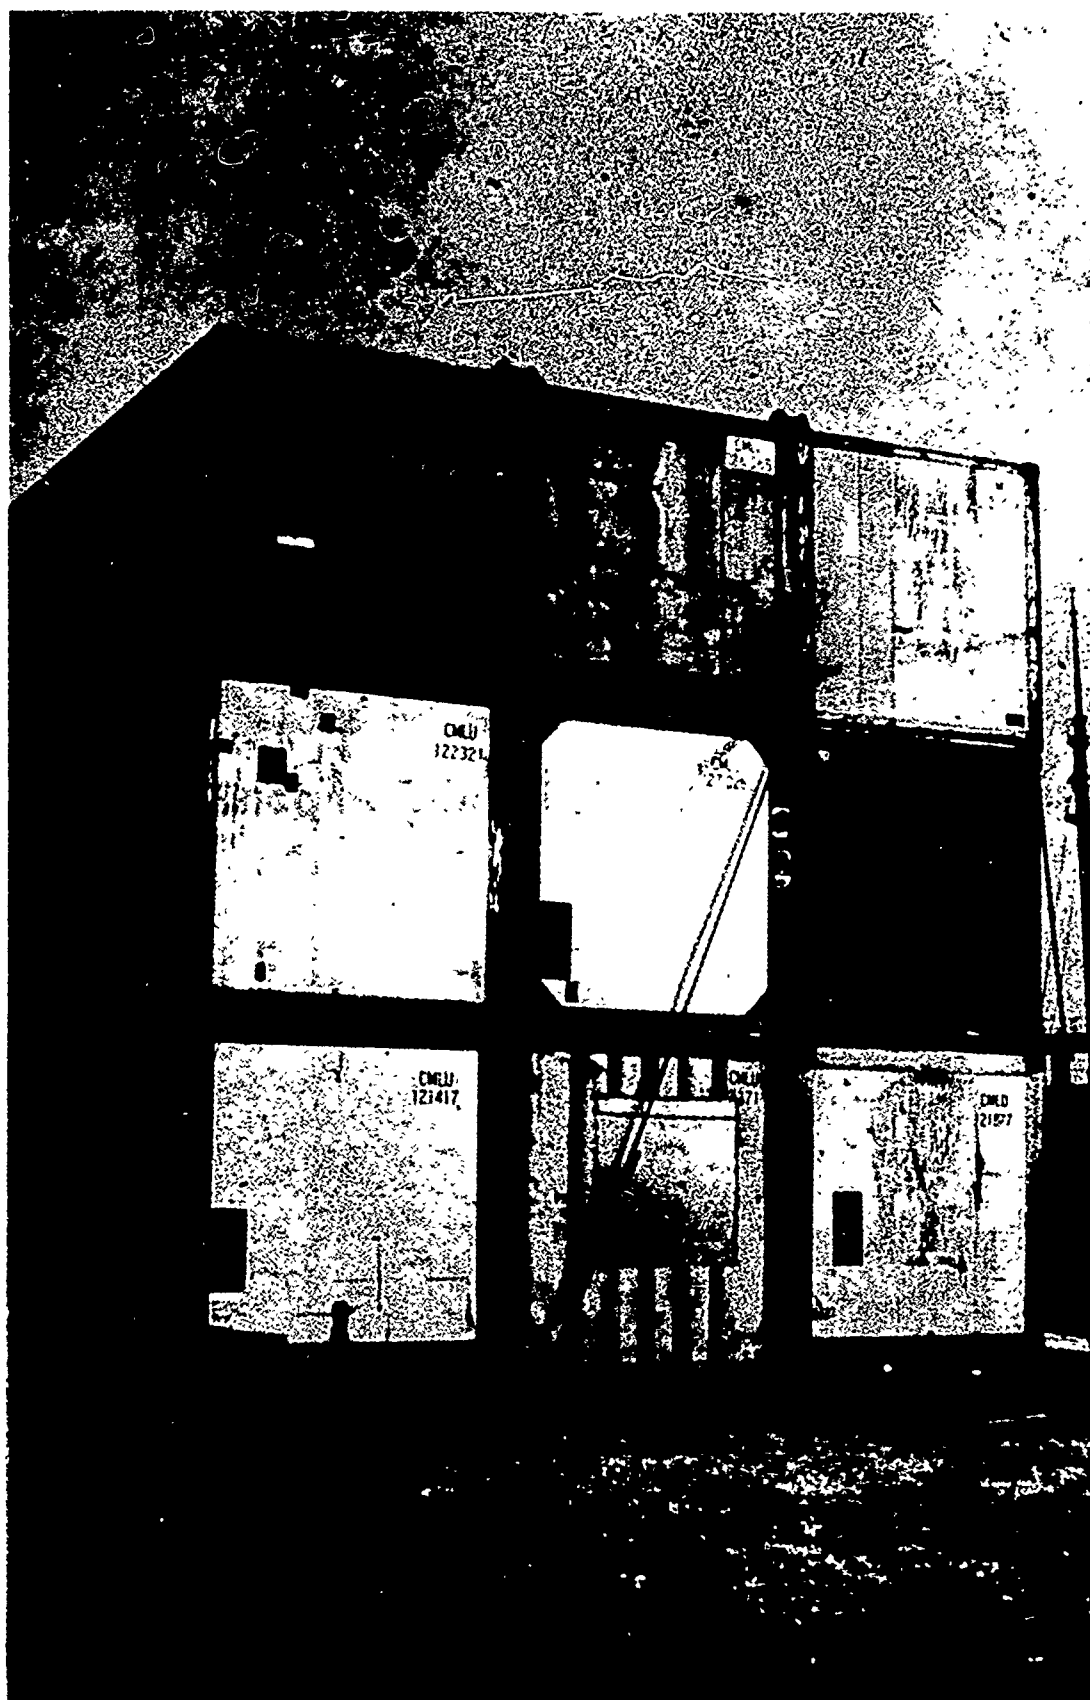
**Figure 12 — Three-by-Three Array Test Six**

Test 6 was intended to simulate a full-scale container stack exposure with the wooden floors of the containers exposed to the pool fire. Nine containers were stacked in a three-by-three array shown in Figures 11 and 12. The water level in the test pan was lowered to approximately nine inches below the floorboards of the first row of containers. Sufficient fuel was then added to allow an exposure of approximately twenty-five minutes. The containers, their respective materials of construction, and time-temperature graphs for Test 6 are listed in Appendix B.

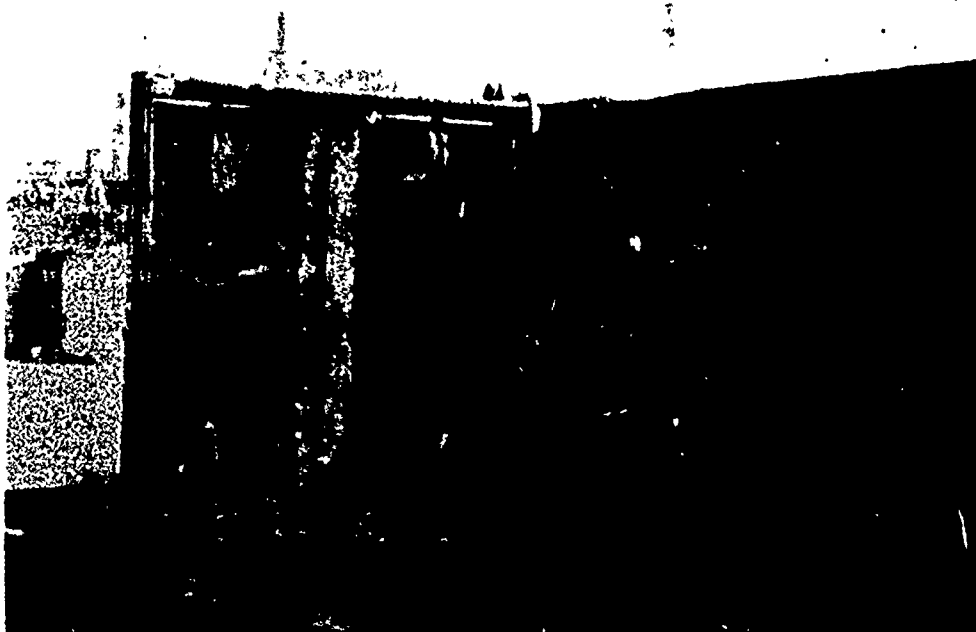
**Figure 13 — Melted Aluminum Components**

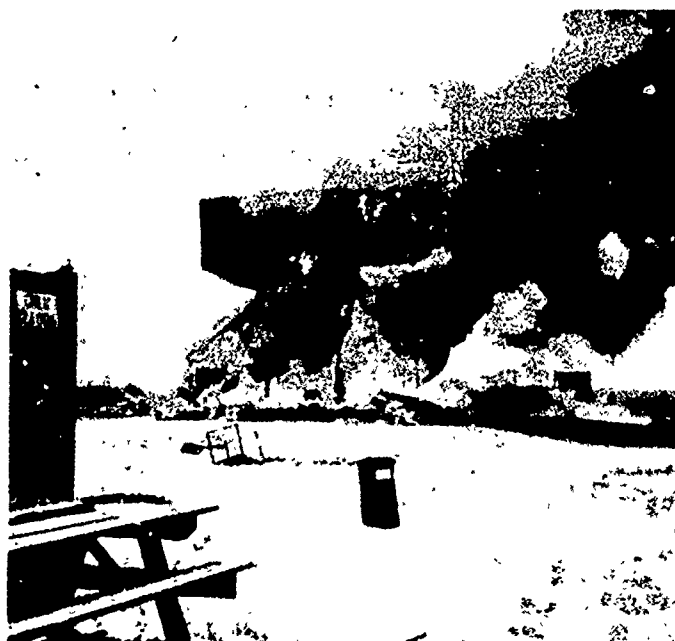
**Figure 15 — Containers Held in Place  
by Bridge Fittings**

E. The stacking and lashing fittings currently used provide an adequate amount of structural stability under fire conditions. In Test 6, the bridge fittings maintained the top row of containers in position even though the bottom end containers had collapsed (Figure 15).
