BELL HELICOPTER TEXTRON FORT WORTH TEX
AH-1S HIGH-SURVIVABLE TRANSMISSION SYSTEM.(U)
OCT 77 D J RICHARDSON

USAAMRDL-TR-77-30

AH-1S HIGH-SURVIVABLE TRANSMISSION SYSTEM

Final Report for Period October 1975 - August 1977

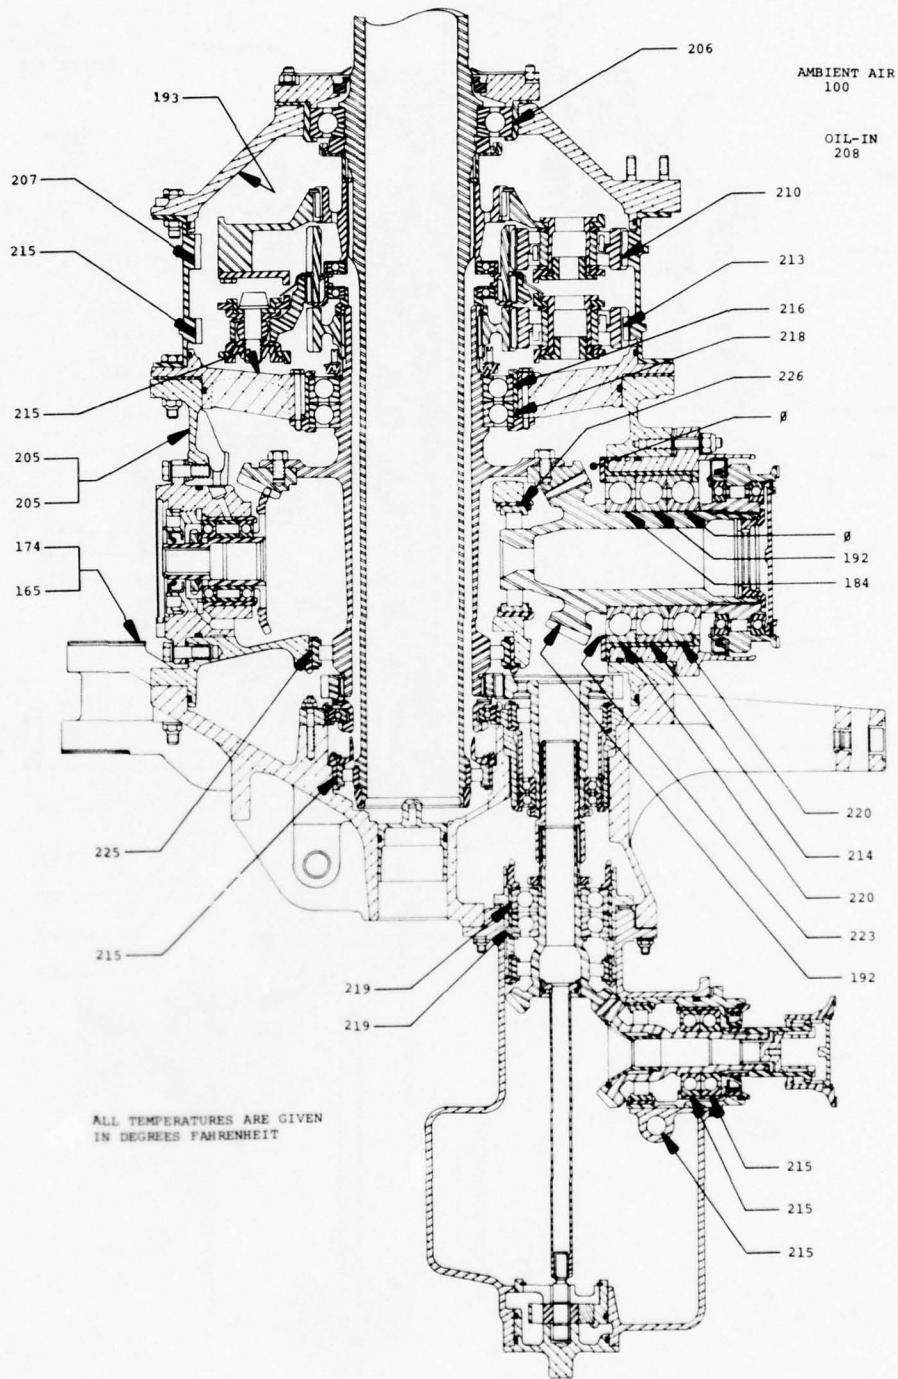
Figure 4. Stabilized temperatures for transmission number 1 at 208°F oil-in, 950 hp (step 1 of Table 4).
