## The MIT Lincoln Laboratory Pulsed Plasma Thruster

R.J. Vondra, *MIT Lincoln Lab, Lexington, Mass.*

Key Biscayne, Florida / November 14-17, 1976

# A FINAL REPORT ON THE LES-8/9 PULSED PLASMA THRUSTER\*

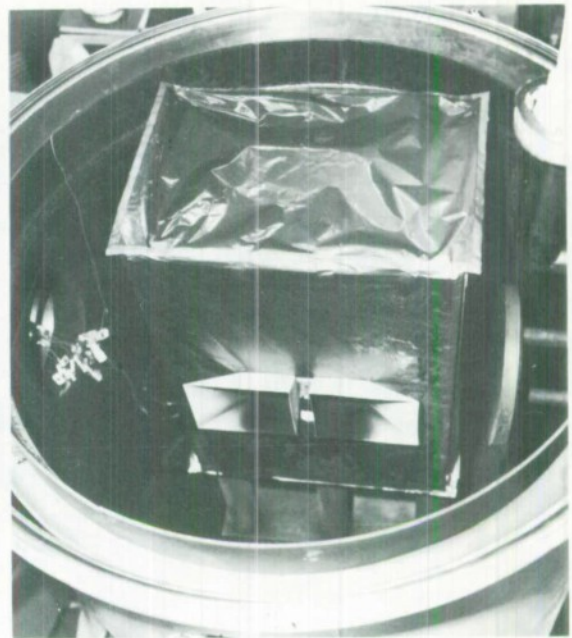
Fig. 3. Thruster life test setup in the vacuum chamber. The thruster is attached to a decagon structure inside a thermal blanket enclosure. The nozzle horns are seen protruding through the blanket.

Figure 3 shows the test arrangement in the vacuum tank. The test was designed to reproduce the thermal environment of the satellite and space operating conditions. The PPT was attached to a portion of a LES-8/9 decagon structure which contained heater resistors to represent the heat dissipation of surrounding electronics. The nozzles with horns attached protruded through a thermal blanket as shown in Fig. 3.
