6 WINTER EARTHWORK CONSTRUCTION IN UPPER MICHIGAN.

10 W.M./Haas, B.D./Alkire and J.E./Dingeldein

11 Nov [redacted] 77

By  
CORPS OF ENGINEERS, U.S. ARMY  
COLD REGIONS RESEARCH AND ENGINEERING LABORATORY  
HANOVER, NEW HAMPSHIRE

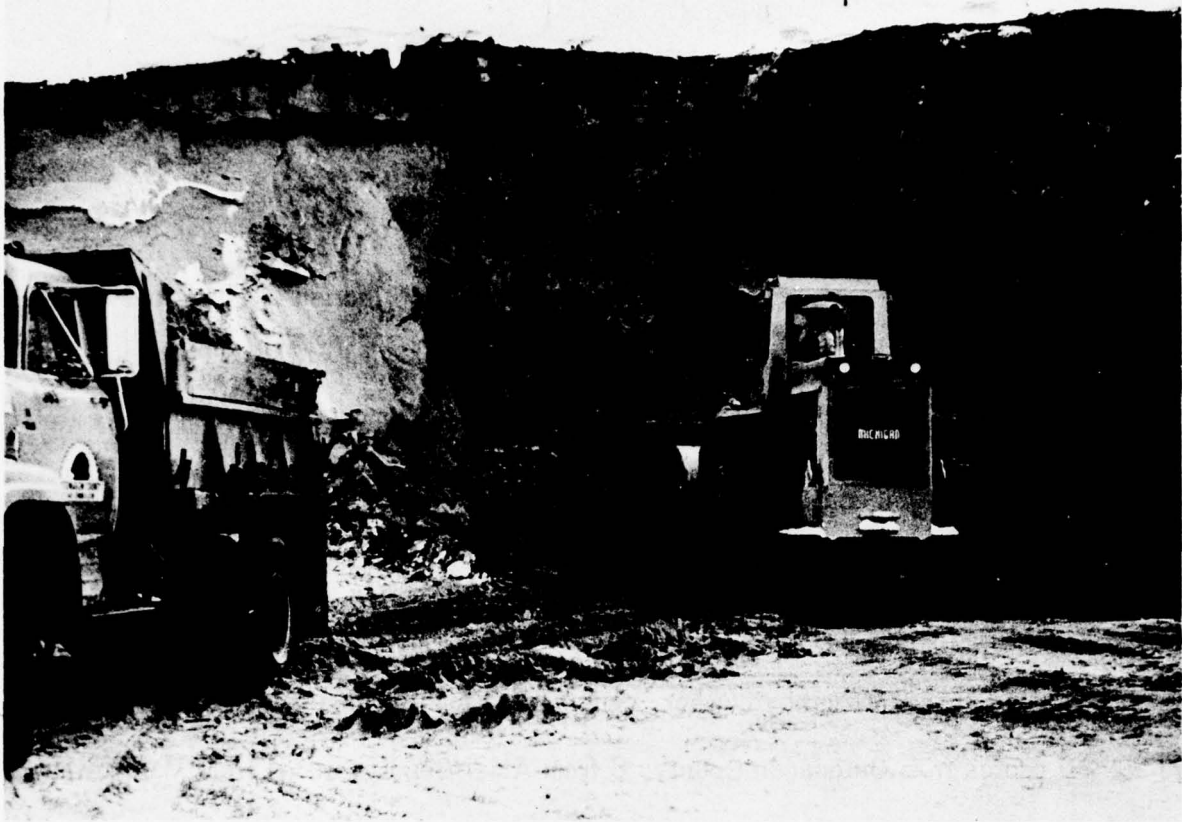
1. Ontonagon County. Loader working in Simar pit. Note height of working face, and type of dump truck used for hauling.

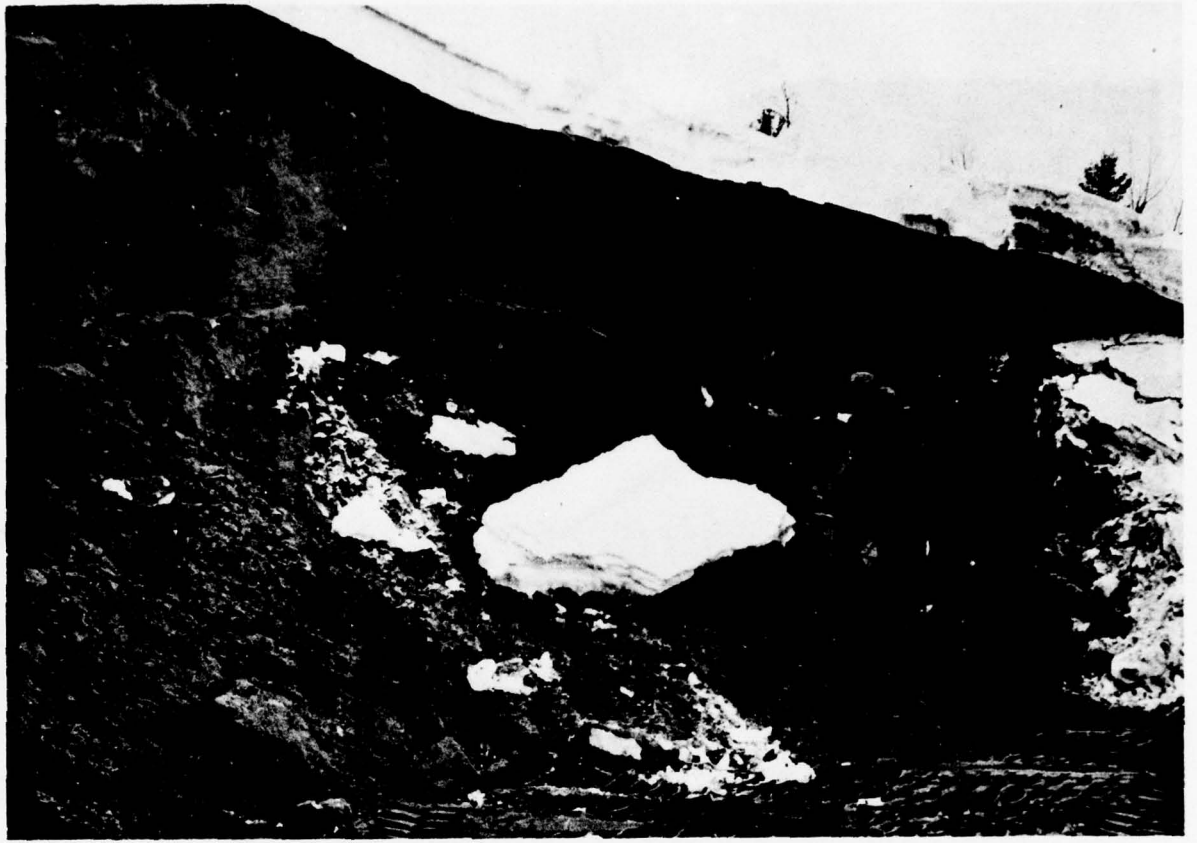
2. Ontonagon County. Simar Pit. Slab of snow-covered frozen soil has fallen into pit.

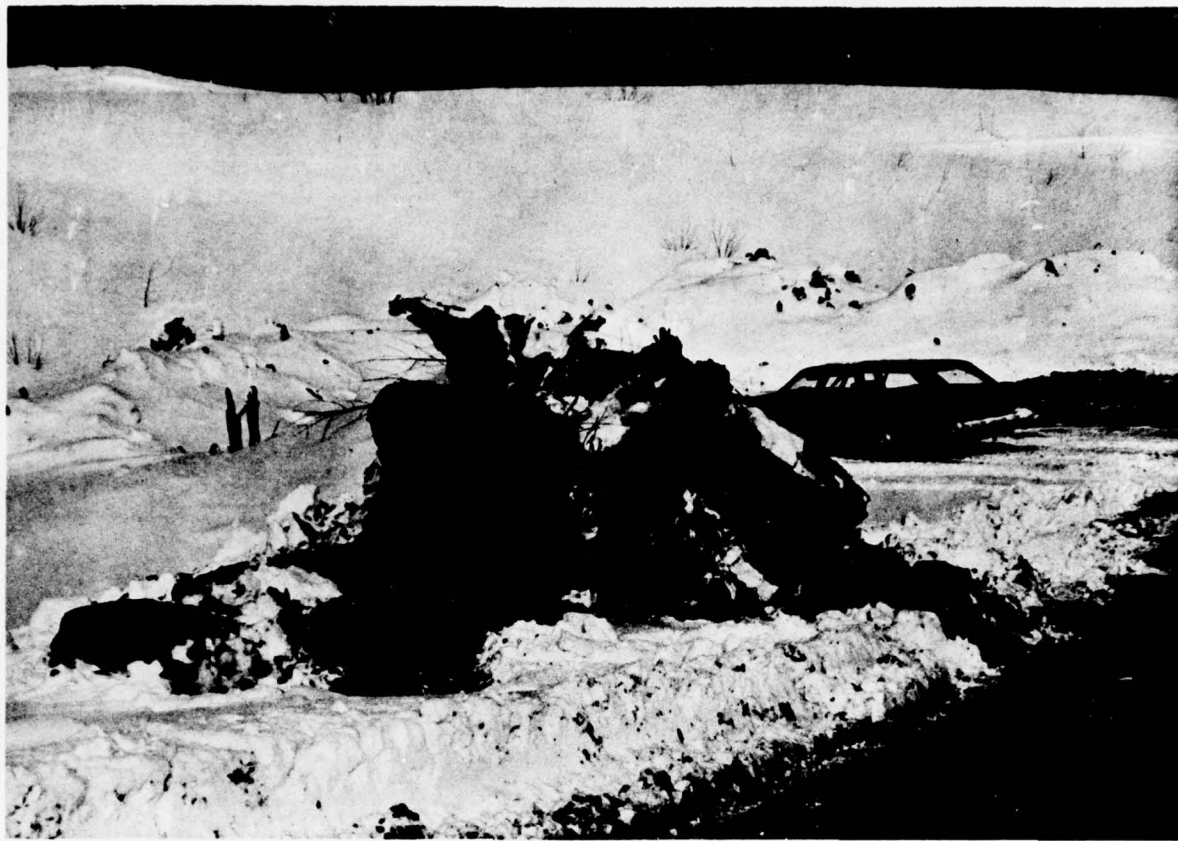
4. Ontonagon County. Simar Pit. Pile of frozen soil which was removed from the loading area.

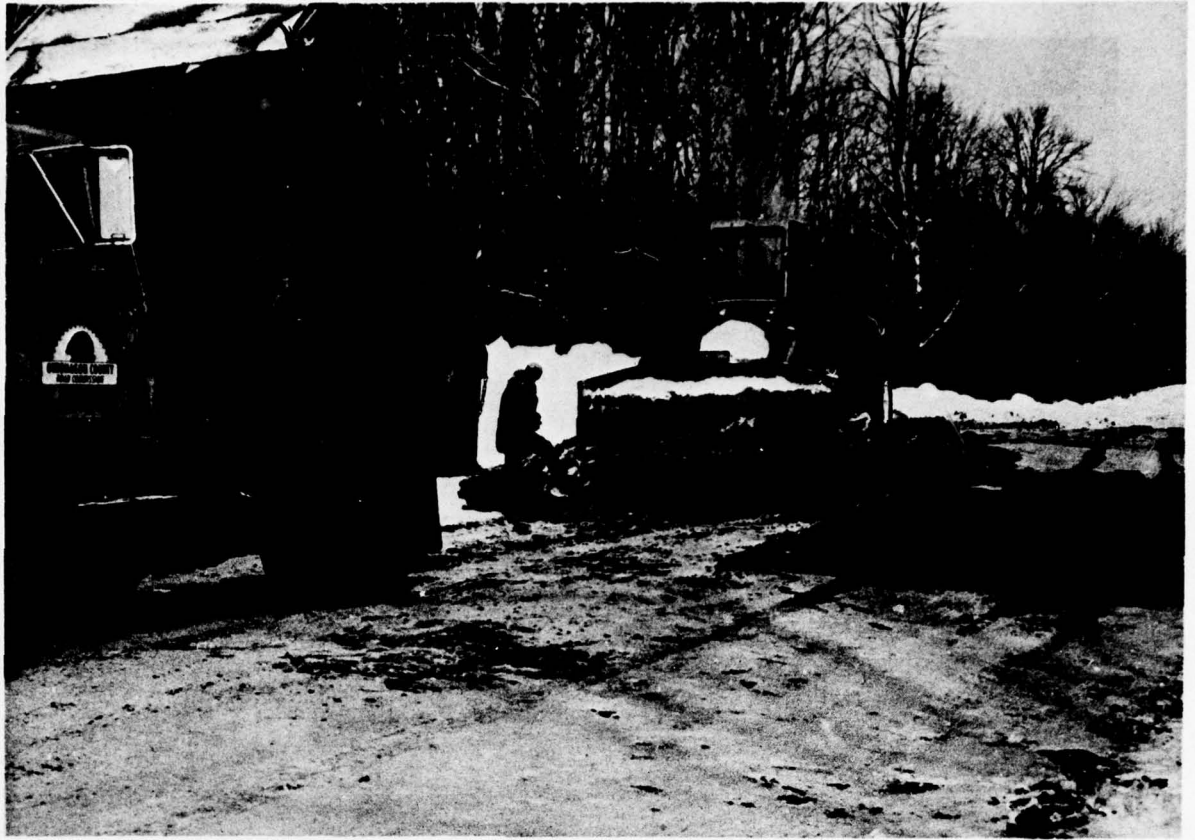
5. Ontonagon County. North Firesteel Road. Spreading of fill with rubber-tired dozer. Note ramp to accommodate occasional local traffic.

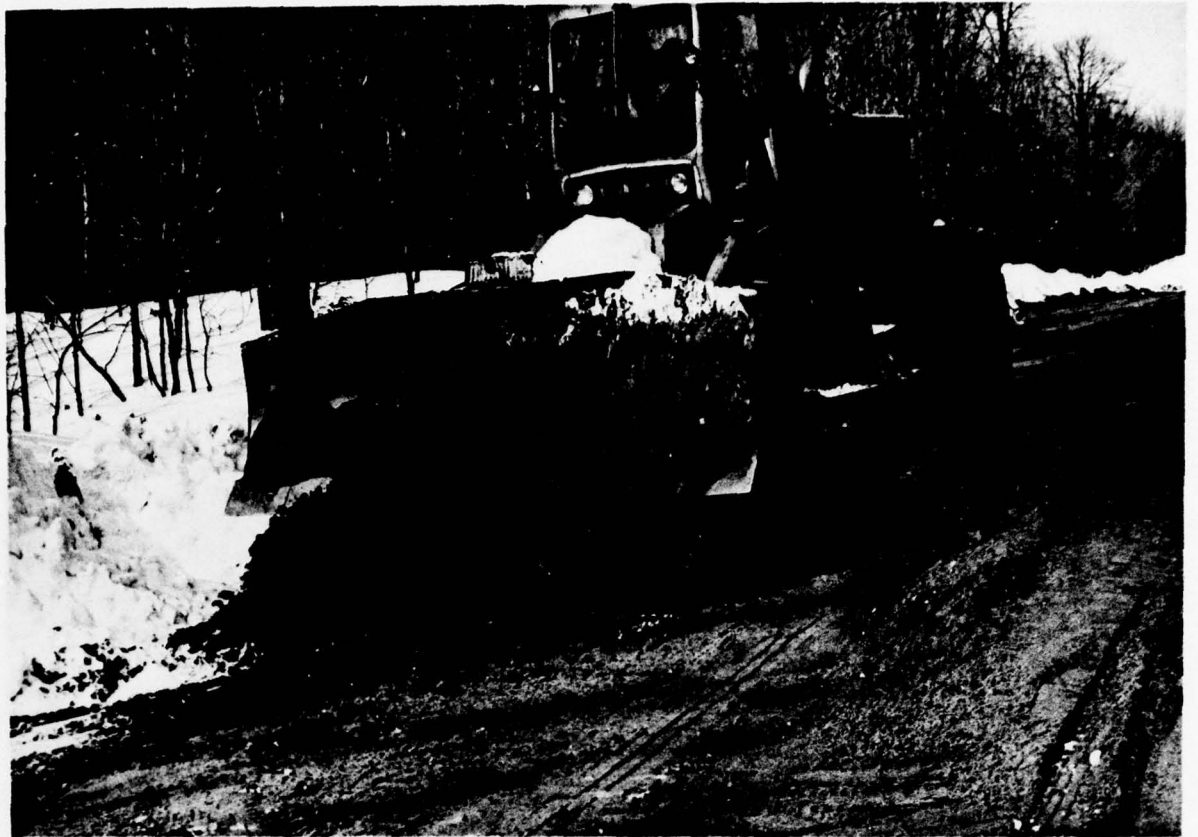
6. Ontonagon County. North Firesteel Road. Another view of spreading and compaction of fill.

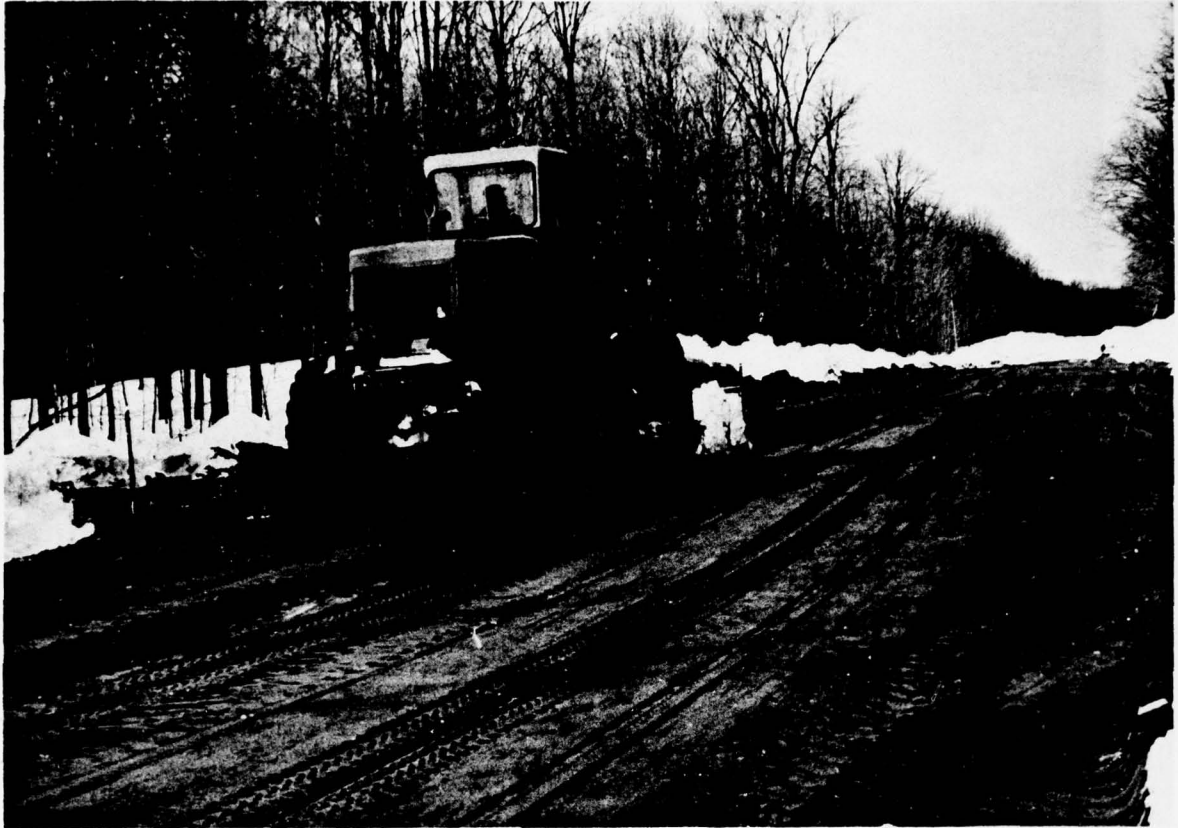
7. Ontonagon County. North Firesteel Road. Back blading and final compaction at end of the working day. Low overnight temperatures freeze fill, creating stable roadway by the next morning.

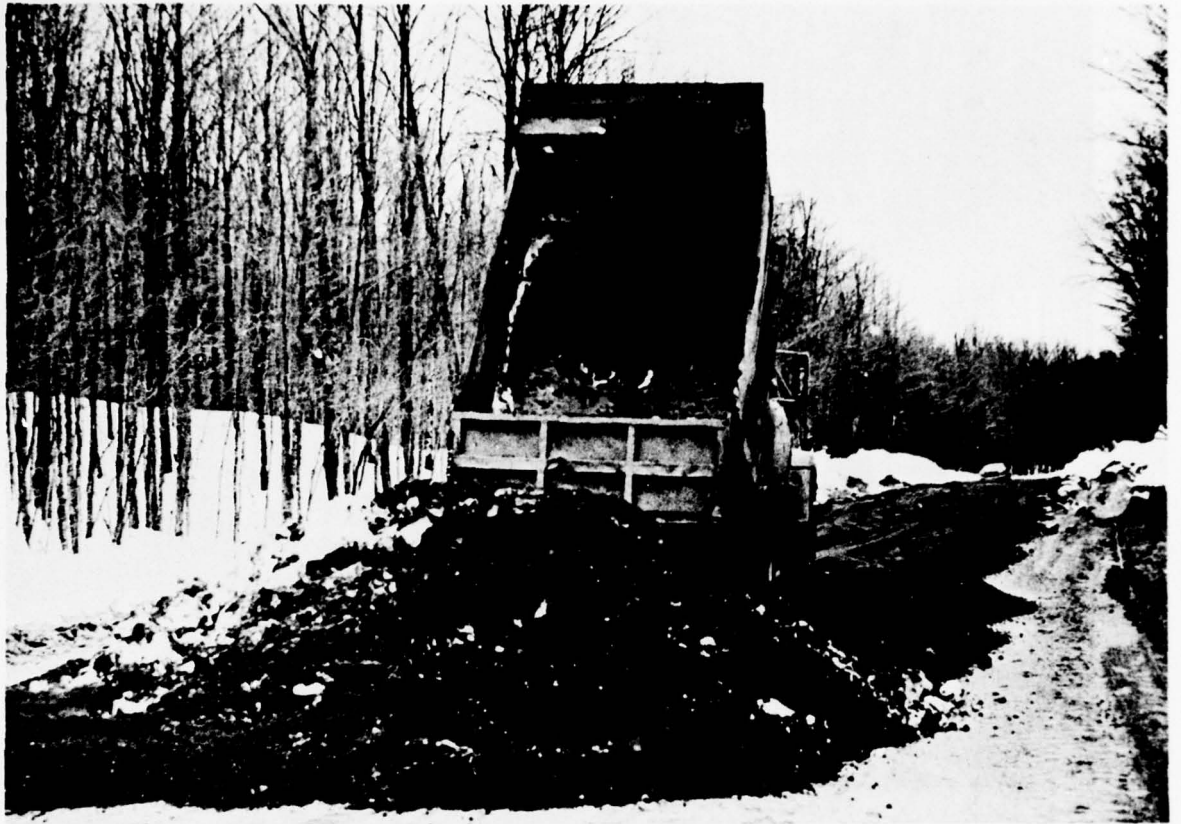
8. Ontonagon County. North Firesteel Road. Sand fill will not bear traffic upon thawing, so gravel surfacing is placed before thawing begins. Gravel is hauled from stockpiles built up the previous summer. Note that considerable snow is included with the gravel.

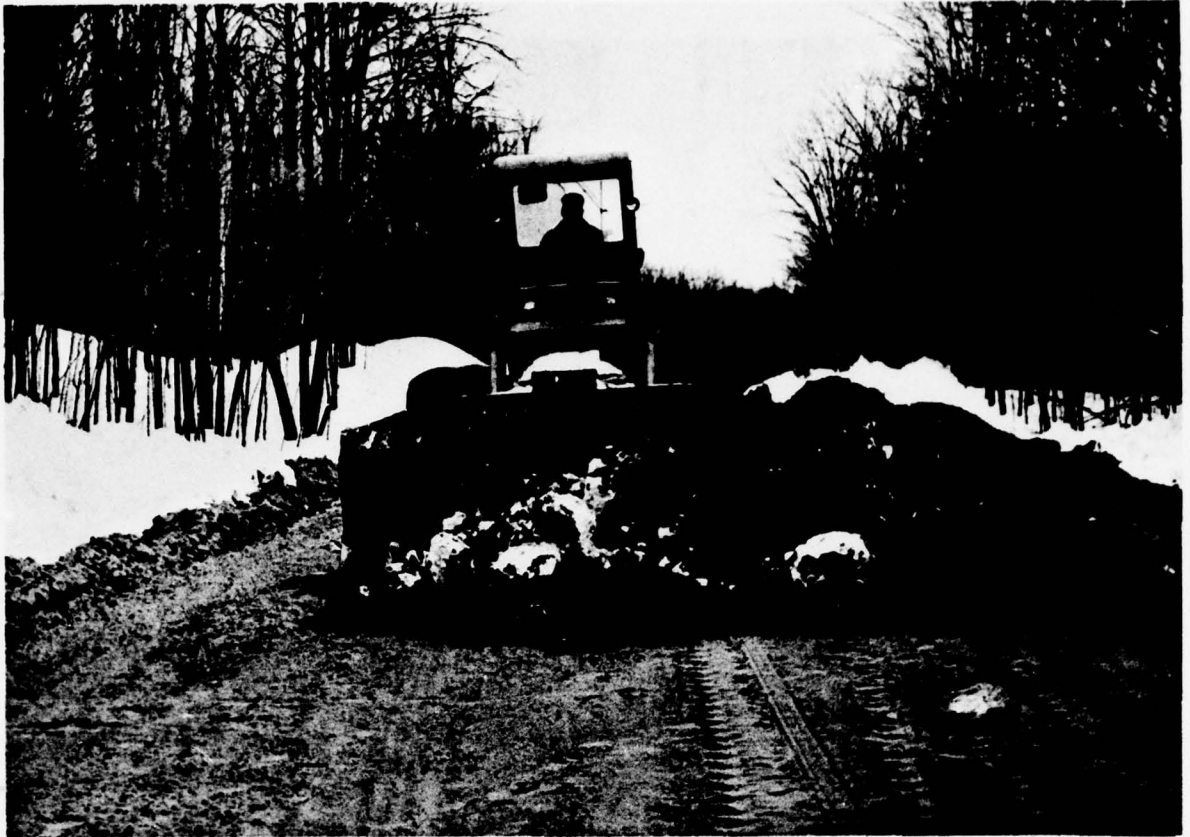
9. Ontonagon County. North Firesteel Road. Spreading and compaction of gravel with rubber-tired dozer.

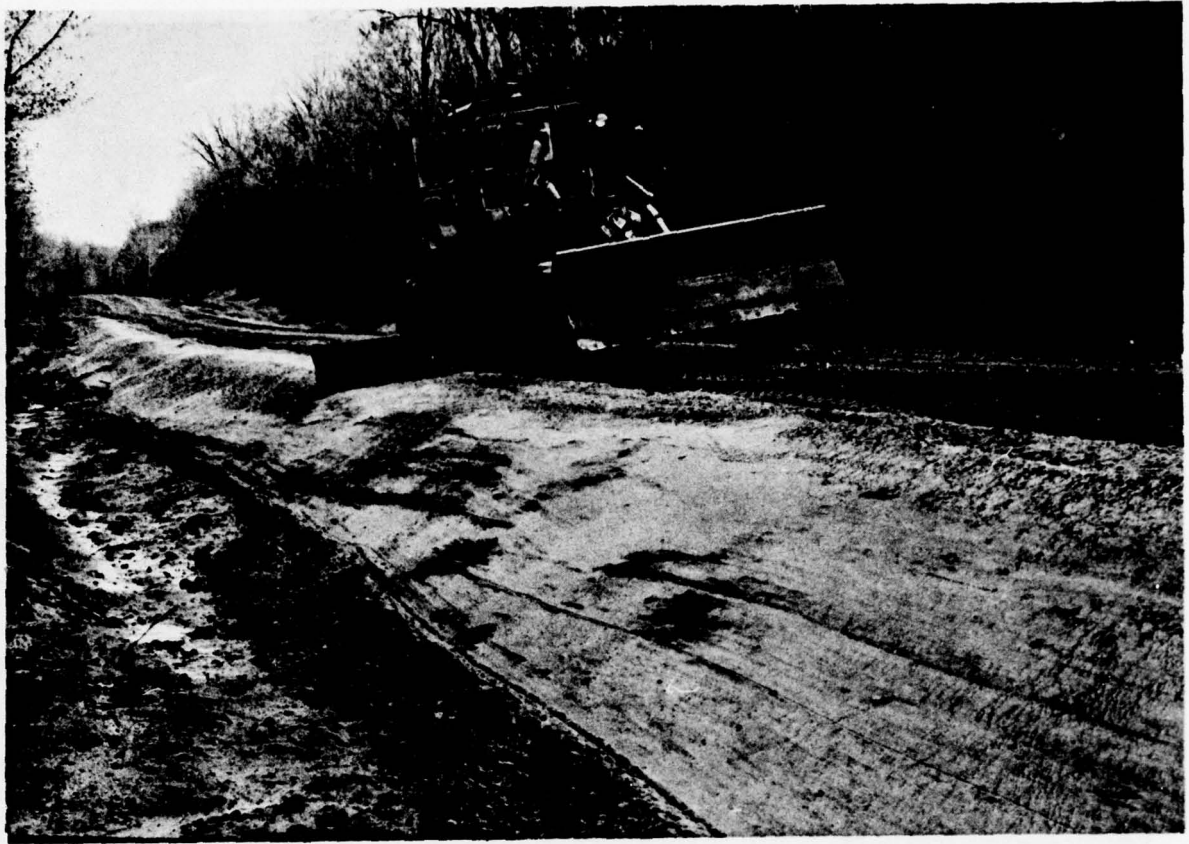
11. Ontonagon County. North Firesteel Road. Second grader in slope finishing team shapes shoulder of sand fill without disturbing gravel. The blade of this grader is specifically adapted to this purpose.

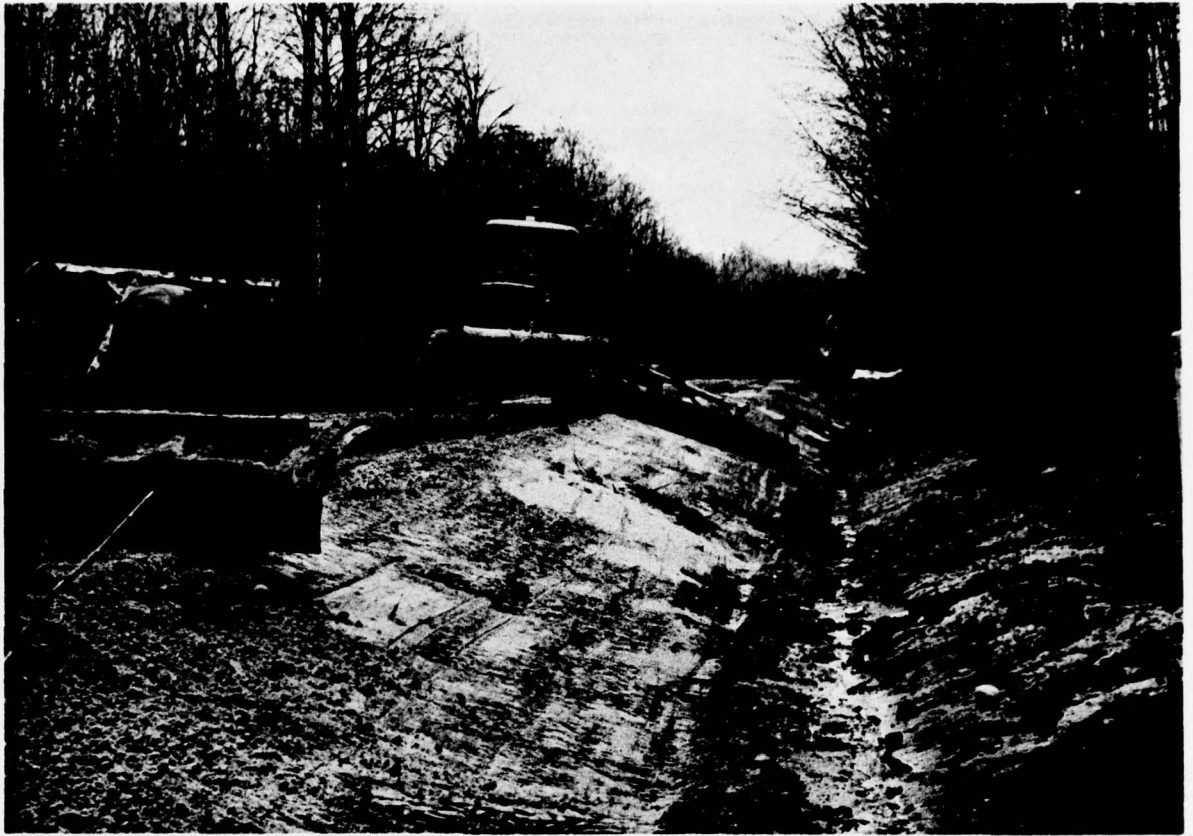
12. *Ontonagon County. North Firesteel Road. Another view of slope finishing grader team. Shaping is considered complete after two passes of team.*

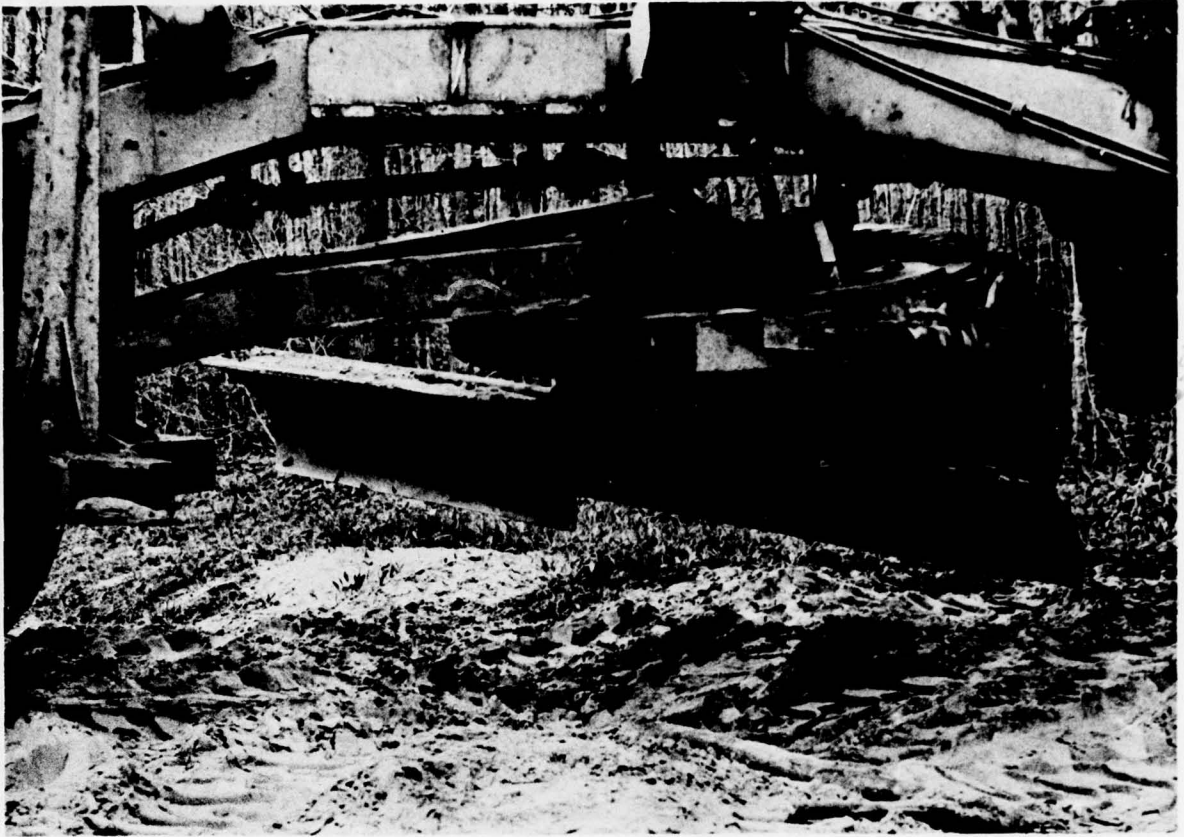
13. Ontonagon County. Detail of blade on second grader of slope finishing team. This arrangement permits shaping the shoulder of the fill without disturbing the gravel traffic course.

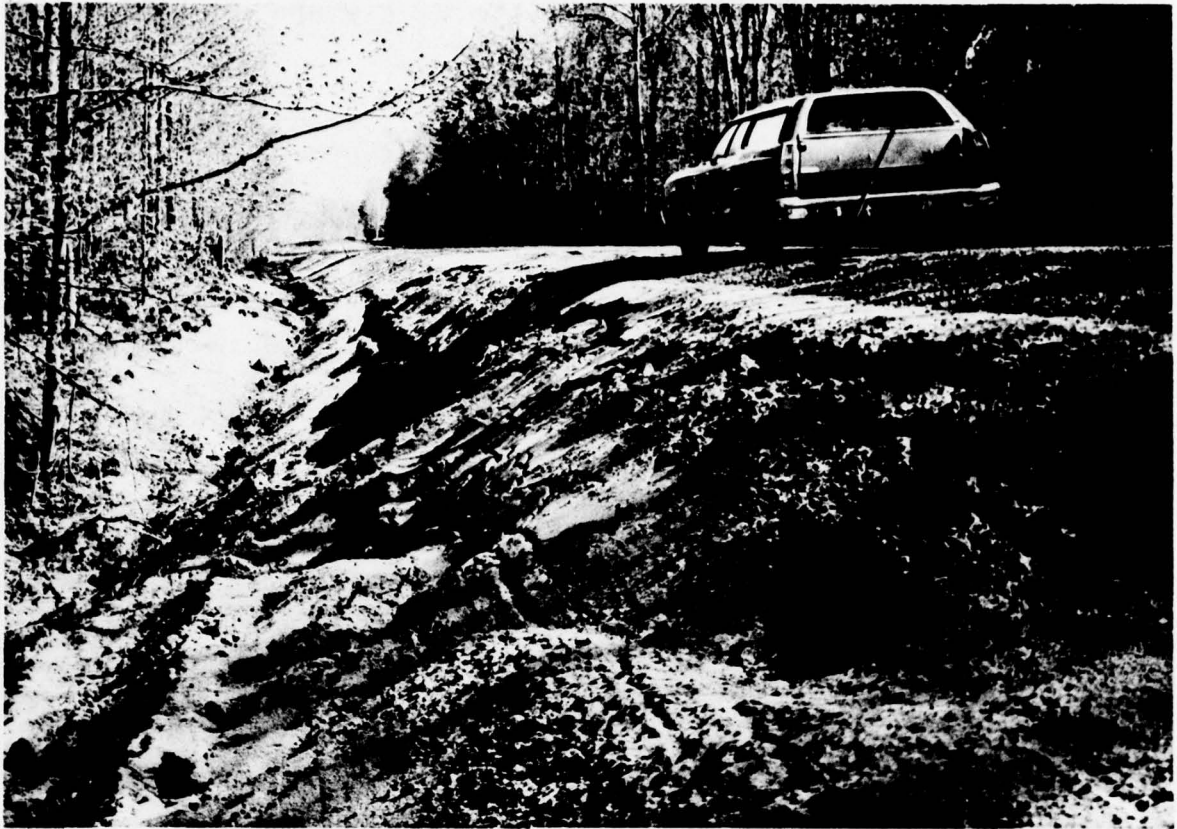
15. Ontonagon County. North Firesteel Road. Slumping of slope, probably due to thawing of frozen soil or incorporated snow. It should be noted that compaction of this part of the fill is difficult due to the construction methods.

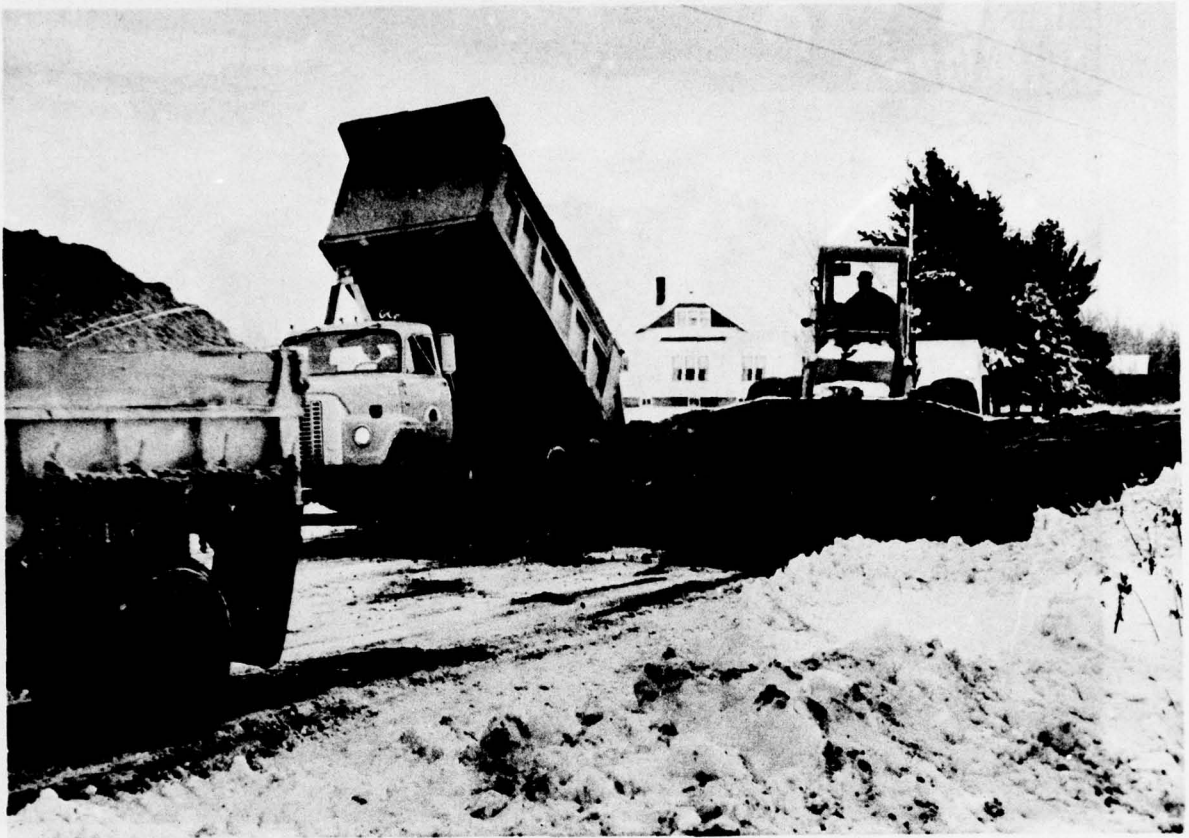
17. Ontonagon County. Wagner Road. General view of hauling, dumping, spreading and compacting.

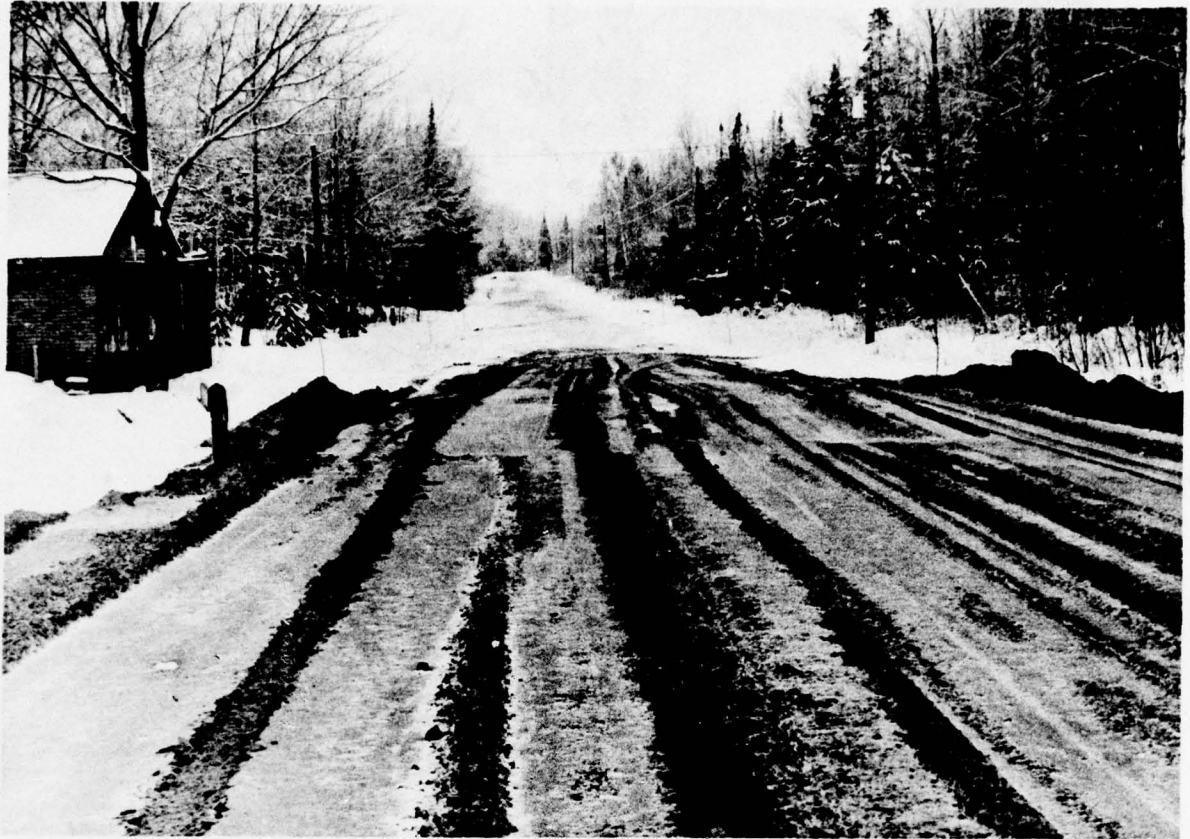
19. Ontonagon County. Cherry Lane. Typical ramp constructed at end of each day's operation. Compacted sand freezes quickly enough that cars and small trucks have little difficulty travelling on fresh grade.

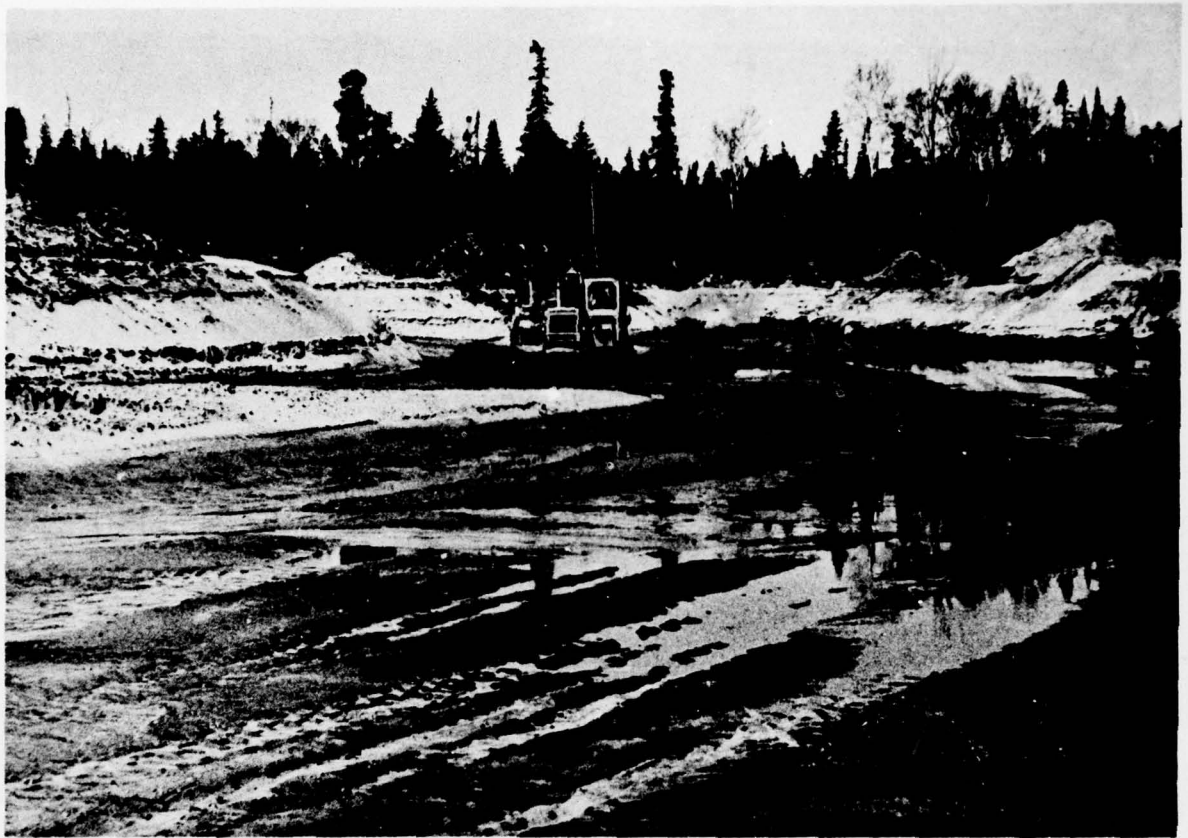
21. Alger County. State Road 28. Although this photo was taken in June 1976, it illustrates the problem of a high ground-water table in the borrow pit which was one of the factors limiting the continuation of earthwork construction through the winter on this project.

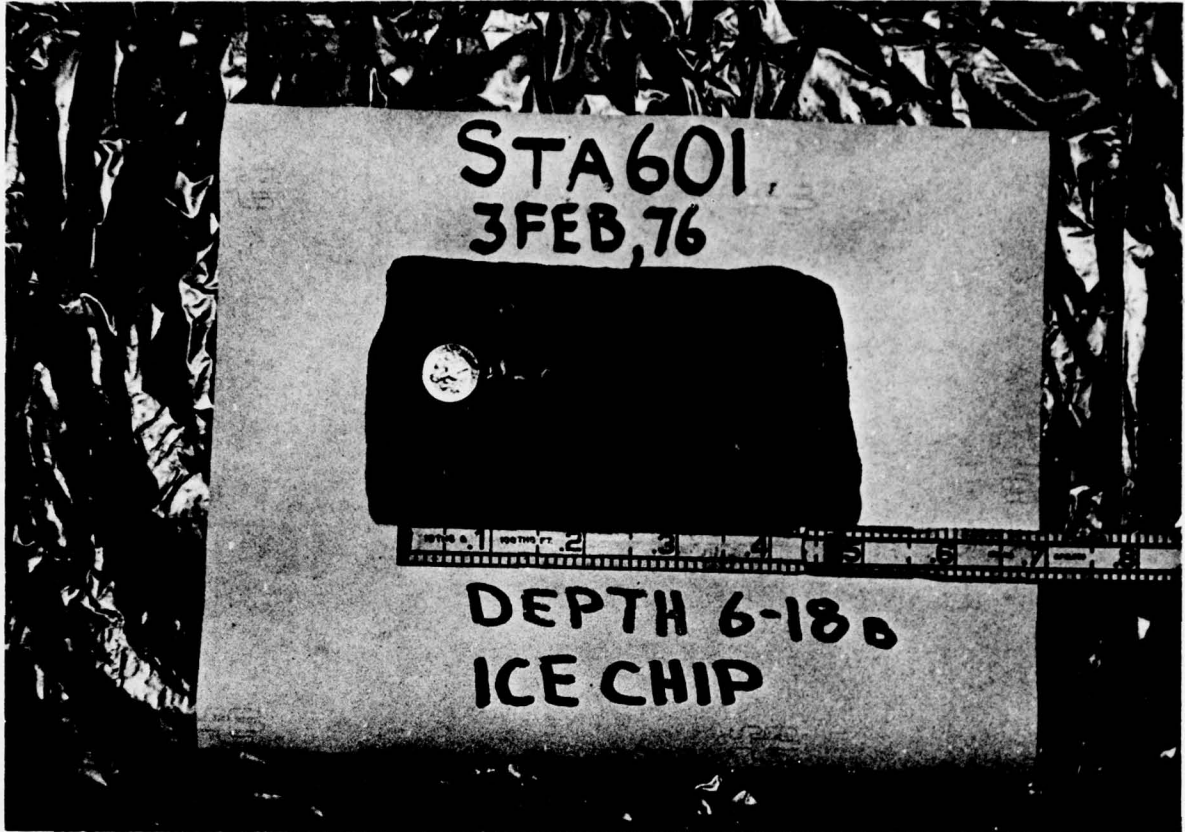
23. Alger County. State Road 28. Close-up of core showing ice chip incorporated into compacted soil.

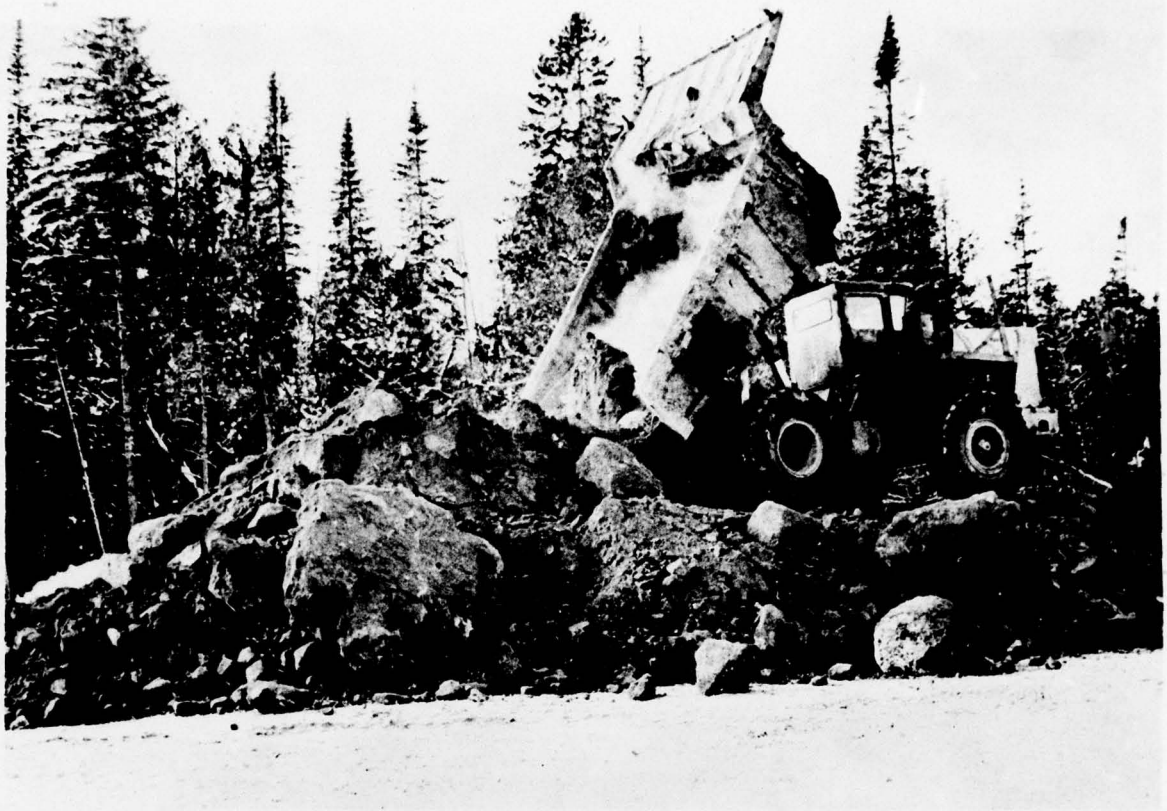
25. Alger County. State Road 28. Placing bouldery clayey soil in zone outside of structural core. Although this soil is not frozen, it was excavated, hauled and placed during the winter, and illustrates how frozen soil could be handled and utilized if necessary.

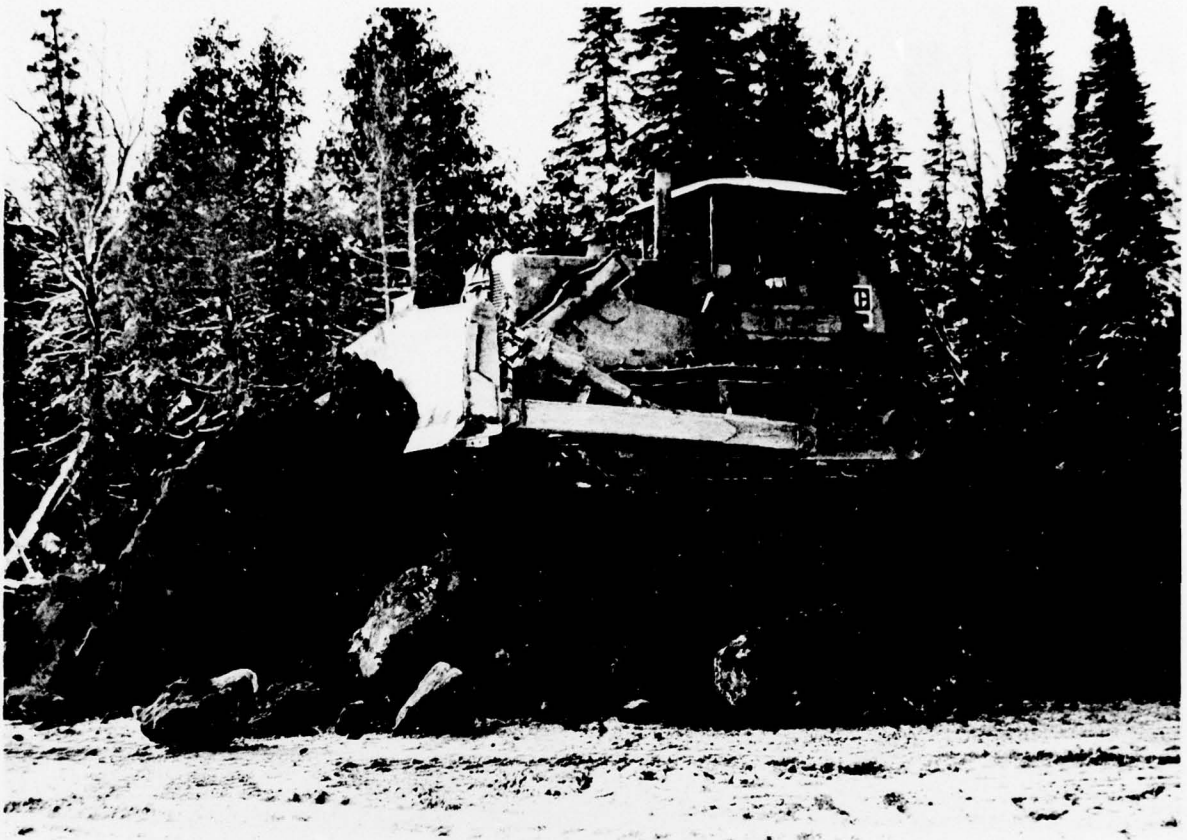
26. Alger County. State Road 28. Spreading bouldery clayey soil (see also Photo 25). Although this soil was not frozen during excavation and placement, the boulders can be considered to act like frozen soil chunks in the fill. Possibilities exist for the formation of large void spaces in the fill.

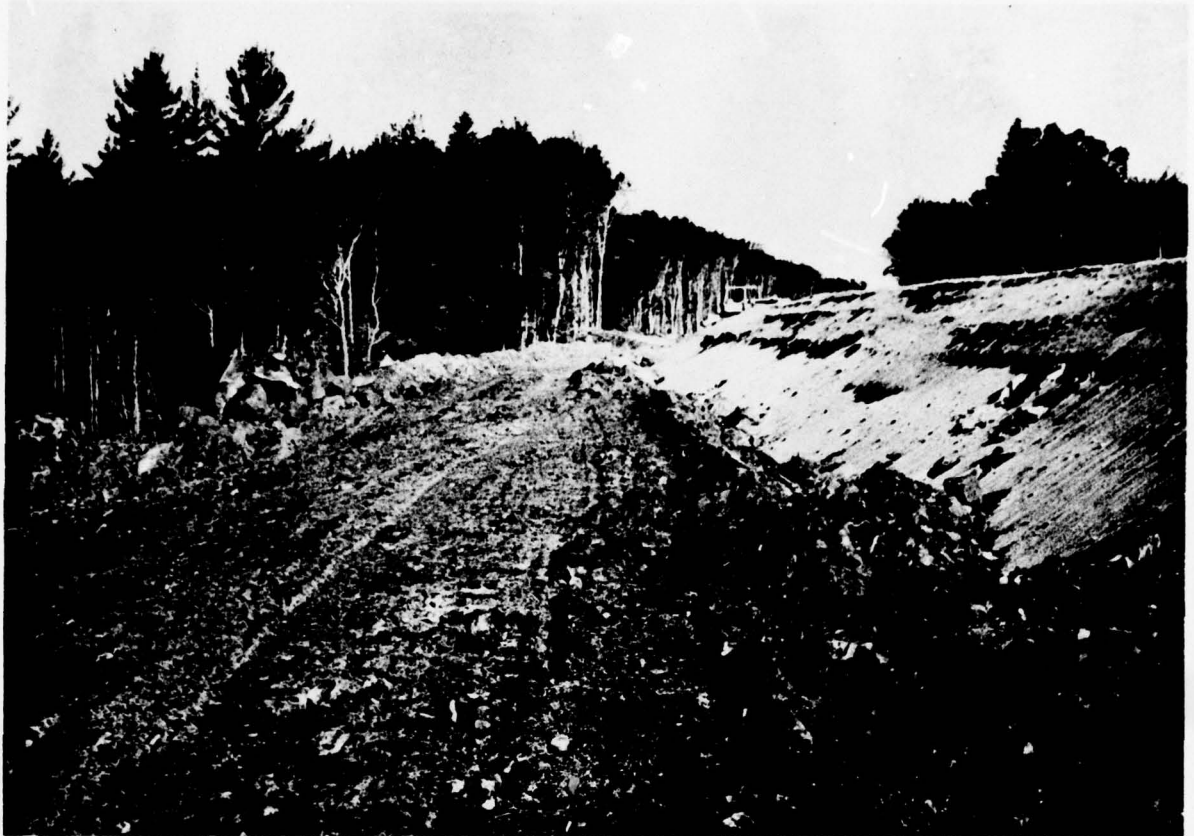
27. Alger County. State Road 28. This photo, taken in summer, illustrates the use of a structural core of sand in the embankment, flanked by less desirable soil in the slope zone. This bouldery clayey soil was placed unfrozen during the winter (see Photos 25 and 26), subsequently froze, and then was compacted and shaped after thawing. Photo taken in June 1976.

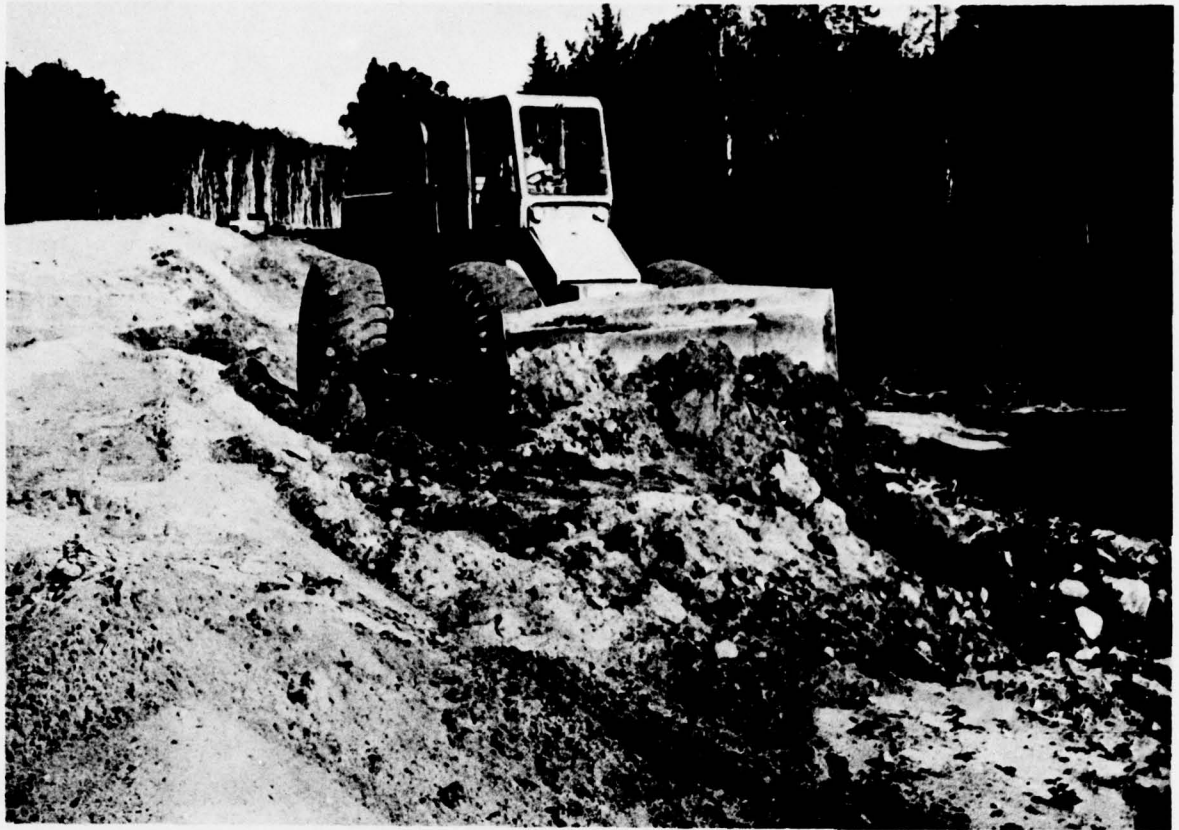
28. Alger County. State Road 28. Large rubber-tired dozer compacting soil in slope zone outside of structural core of sand. See also Photos 25, 26 and 27. Photo taken in June 1976.
