Thermonuclear Damage to Wall Materials in a Dense Plasma Focus

L. RAYMOND, G. M. MOLEN, G. G. COMISAR, and C. T. YOUNG
Materials Sciences Laboratory
The Ivan A. Getting Laboratories
The Aerospace Corporation
El Segundo, Calif. 90245

15 December 1977

Interim Report

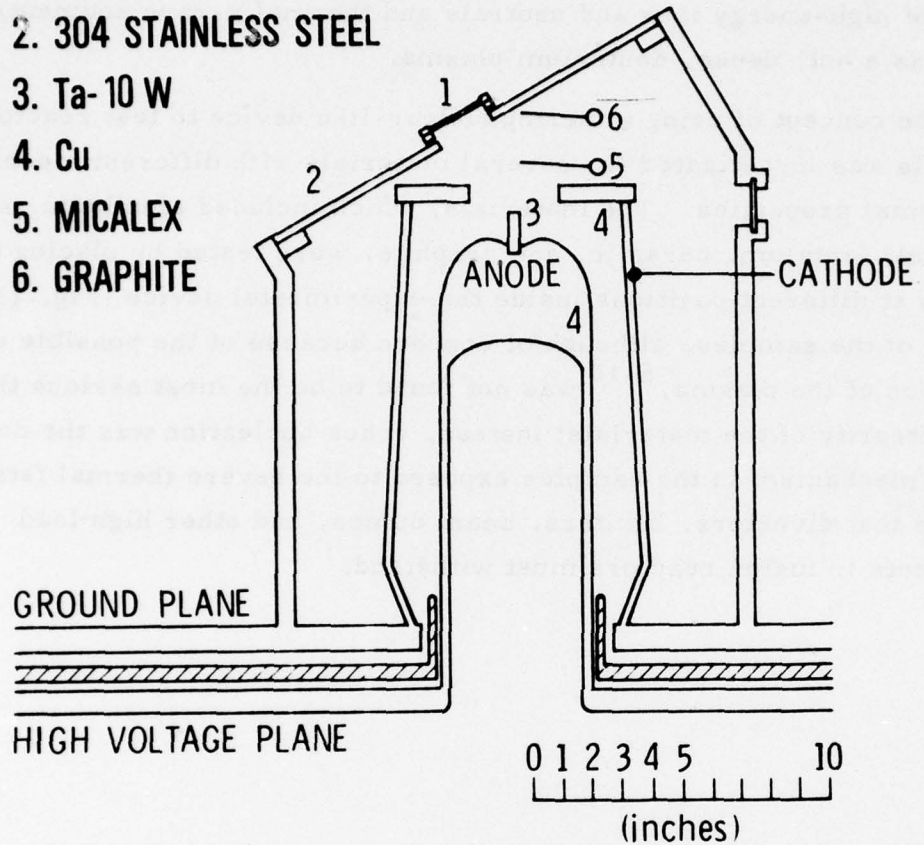
Fig. 1. Mark V Dense Plasma Focus and Designation of Test-Sample Locations

- 1. 6061 Al
- 2. 304 STAINLESS STEEL
- 3. Ta-10 W
- 4. Cu
- 5. MICALEX
- 6. GRAPHITE

The Mark V 140-kJ DPF is a pulsed plasma source with a repetition rate of 1 discharge/min. Typical operating parameters are static fill pressures of 2 to 5 Torr D_2 , bank voltages of 15 kV (corresponding to 80 kJ

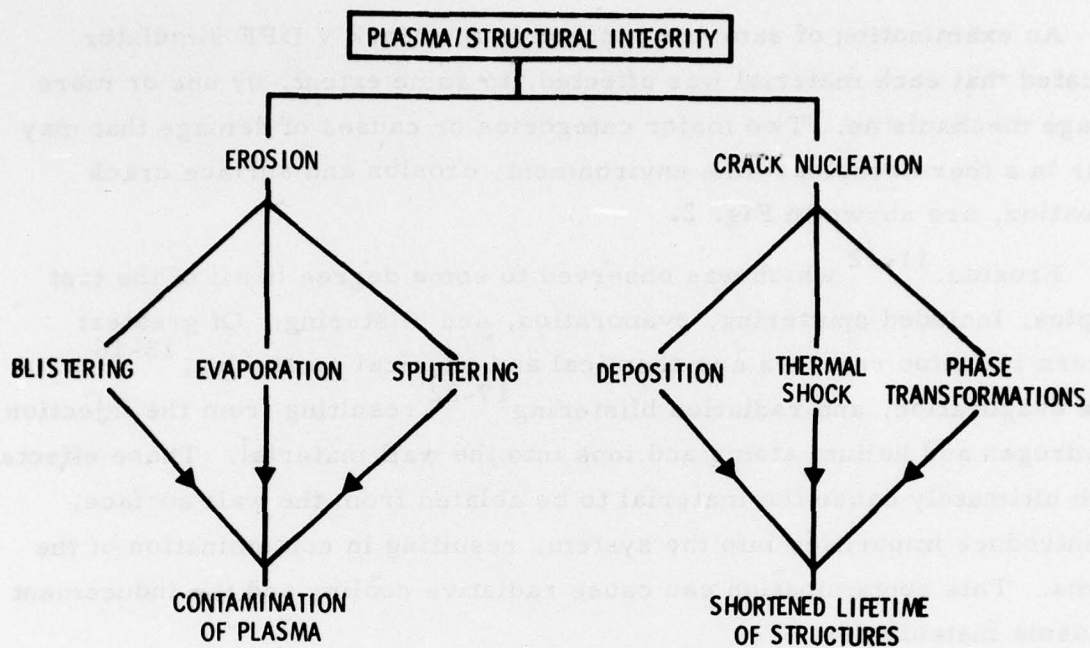
Fig. 2. Surface Damage Effects in First-Wall Materials for Fusion Reactors

An examination of samples exposed in the Mark V DPF simulator indicated that each material was affected, to some extent, by one or more damage mechanisms. Two major categories or causes of damage that may occur in a thermonuclear-like environment, erosion and surface crack nucleation, are shown in Fig. 2.

Erosion,¹¹⁻¹² which was observed to some degree in all of the test samples, included sputtering, evaporation, and blistering. Of greatest concern in fusion reactors are chemical and physical sputtering,¹³⁻¹⁶ pulse evaporation, and radiation blistering¹⁷⁻²² resulting from the injection of hydrogen and helium atoms and ions into the wall material. These effects, which ultimately cause the material to be ablated from the wall surface, can introduce impurities into the system, resulting in contamination of the plasma. This contamination can cause radiative cooling and the inducement of plasma instabilities.

Surface crack initiation was found to be a significant cause of damage in the test samples. Molten metal deposition, thermal shock, and phase transformation were found to be possible causes of surface crack formation in materials exposed to the plasma environment. Shrinkage cracks form when a molten metal deposit, which has splattered onto the metal surface, cools and thus solidifies and contracts, causing cracks to form and propagate into the substrate metal surface. Surface cracks resulting from thermal shock are commonly observed in ceramics, wherein the steep thermal gradients that occur in brittle and nonheat-conductive materials result in large stress gradients. Strain-induced martensitic transformation in the austenitic stainless steels can increase the magnetic permeability and cause volumetric changes, which produce surface stresses that result in crack initiation. Also, the freshly transformed martensite will become susceptible to hydrogen stress cracking.

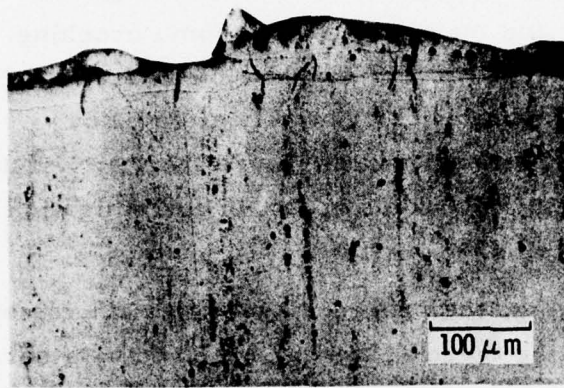
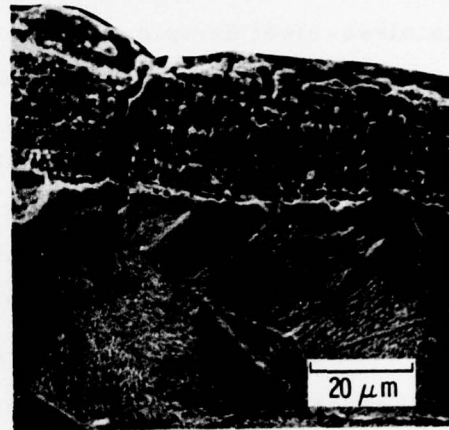
Fig. 3. Surface Crack Initiation in (a) Aluminum and (b) Stainless Steel Caused by Molten Metal Deposition

Examination of the surface and the transverse aluminum section (Fig. 3) indicated that metal removal by molten-metal transfer and evaporation were the major damage mechanisms. Intergranular cracks were observed in the core material up to depths of 20 μm .

Most of the surface of the nonmagnetic, austenitic, 304-grade stainless steel plate is covered by a deposit of molten stainless steel that has magnetic properties (Fig. 3). A magnetic particle inspection indicated that the areas with the highest magnetic intensity coincided with the areas with the largest degree of molten metal accumulation. Cracking, initiated in the molten surface layers, penetrated 20 to 25 μm into the base steel plate.

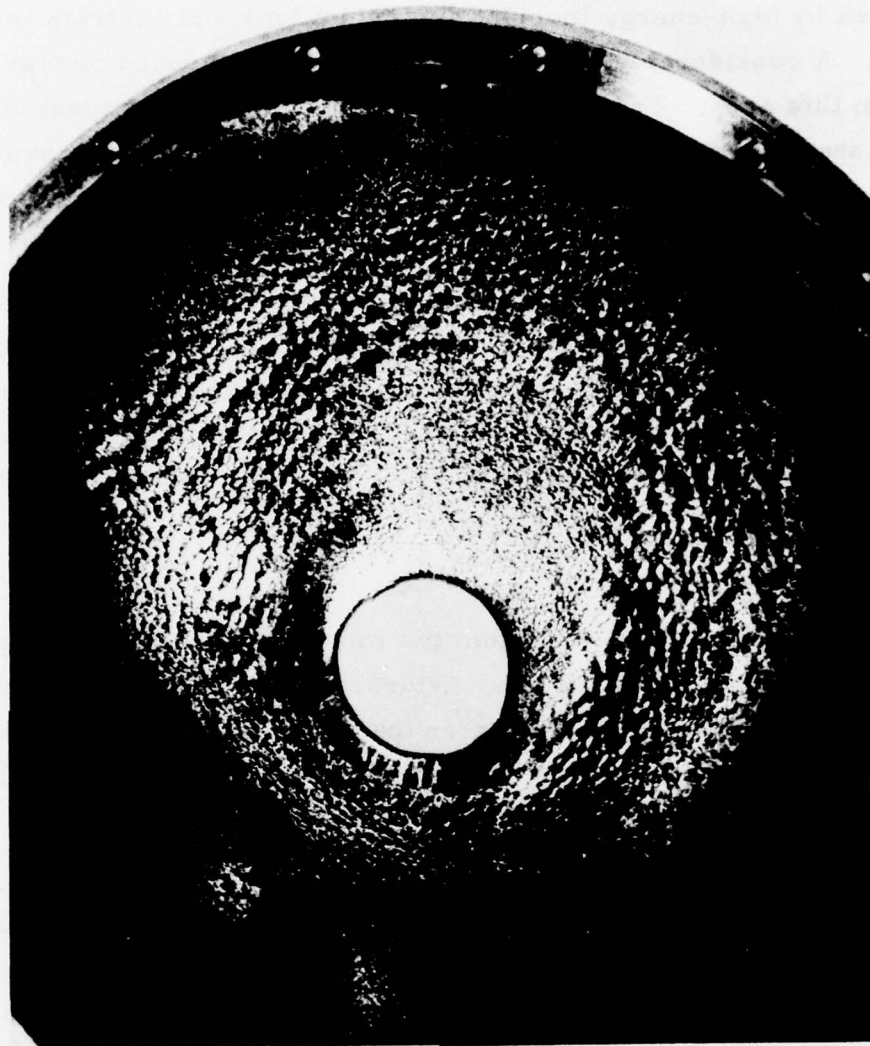
Fig. 4. Ablated Region Above Center Hole Surrounded by Areas of Molten Metal Deposition on Stainless-Steel Plate After 4000 Discharges

Near the center of the plate (Fig. 4), the portion of the surface that was ablated by high-energy incident deuterium ions and neutrals is non-magnetic. A considerable amount of the base metal eroded or transferred away from this area. Traces of nickel impurities, a constituent of 304 stainless steel, were found in other parts of the experimental chamber by means of the ion microprobe mass analyzer (IMMA), indicating that some evaporation also occurred.

Localized melt zones were found between the molten metal deposit and the base material. No apparent grain growth, as a result of heating, occurred in these areas; thus, it can be inferred that these zones were not subjected to temperatures greater than 815°C in reheatings after the initial melting. Shrinkage cracks occurred in the columnar grain of the localized melting areas.

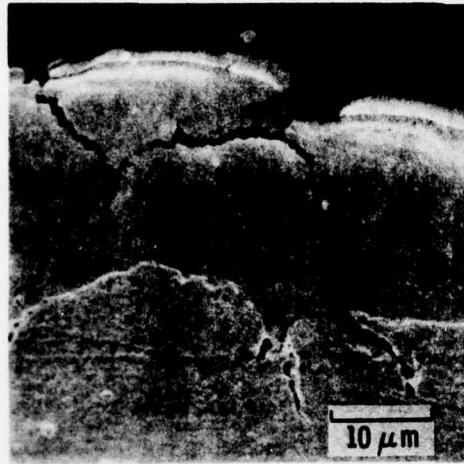
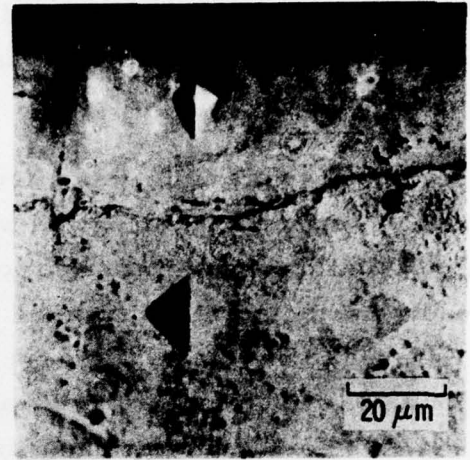
Fig. 5. Surface Cracking and Increased Hardness in Molten Metal Surface Layers in Tantalum Rod After 500 Discharges

The side of the tantalum pin had a molten metal deposit 20 to 30 μm deep, which corresponds to the electrical skin depth of 28 μm calculated from the known discharge current of the DPF. Shrinkage cracks penetrating 10 to 20 μm into the base material were evident. An increase in hardness (from 85 Rockwell B to 42 Rockwell C) from the base material to the molten surface layers was attributed to the presence of nickel and copper impurities in the molten deposit. The surface cracking in the tantalum and the difference in size of the hardness penetrators are shown in Fig. 5.

The top surface of the tantalum pin was in contact with the plasma pinch and subsequent shock waves. Evidence of melting indicated that the surface attained a temperature greater than 3050°C. No molten metal deposits or surface cracks were observed on the top surface, which was physically deformed by the effects of temperature and pressure.

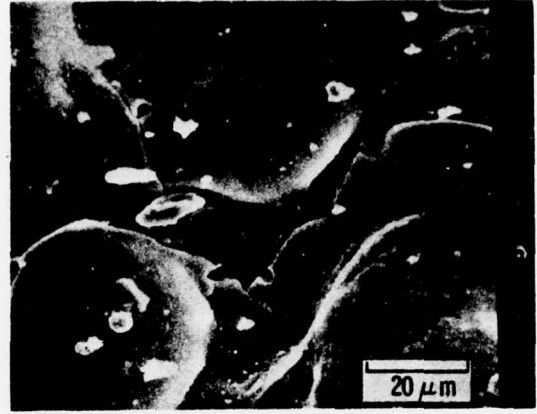
Fig. 6. Surface Cracking in Ceramic as Result of Thermal Shock After 20 Discharges

Thermal shock was the cause of much of the damage in the Micalex sample. Surface cracking to the ceramic plate from this damage mechanism is shown in Fig. 6. It was also determined that the glassy phase of the ceramic had melted and crazed as a result of high-temperature pulsing.

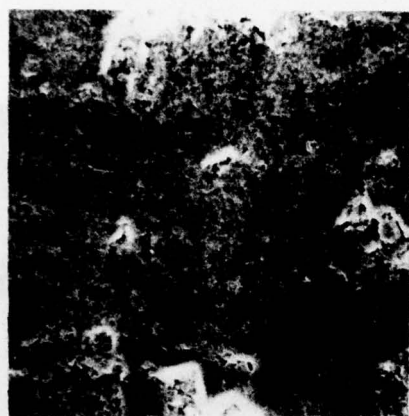
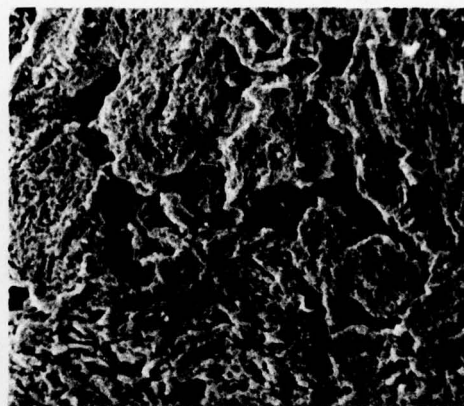
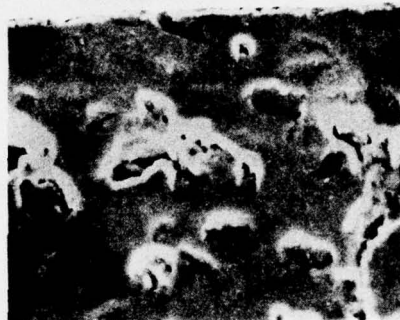
Fig. 7. Sputtering in Graphite Liners with Grain Boundary Cavitation After Single Discharge

The graphite liner was affected primarily by erosion, which was the result of surface sputtering and which caused grain-boundary cavitation. This cavitation, resulting from ion etching by an incident deuteron beam, produced some surface cracking. In this case, the surface cracking was considered to be minor, although it could eventually cause spallation of the graphite particles into the plasma. The surface of the graphite is shown in Fig. 7 before and after exposure.

SURFACE

TRANSVERSE
SECTION
BEFORE EXPOSURE

TRANSVERSE
SECTION
AFTER EXPOSURE

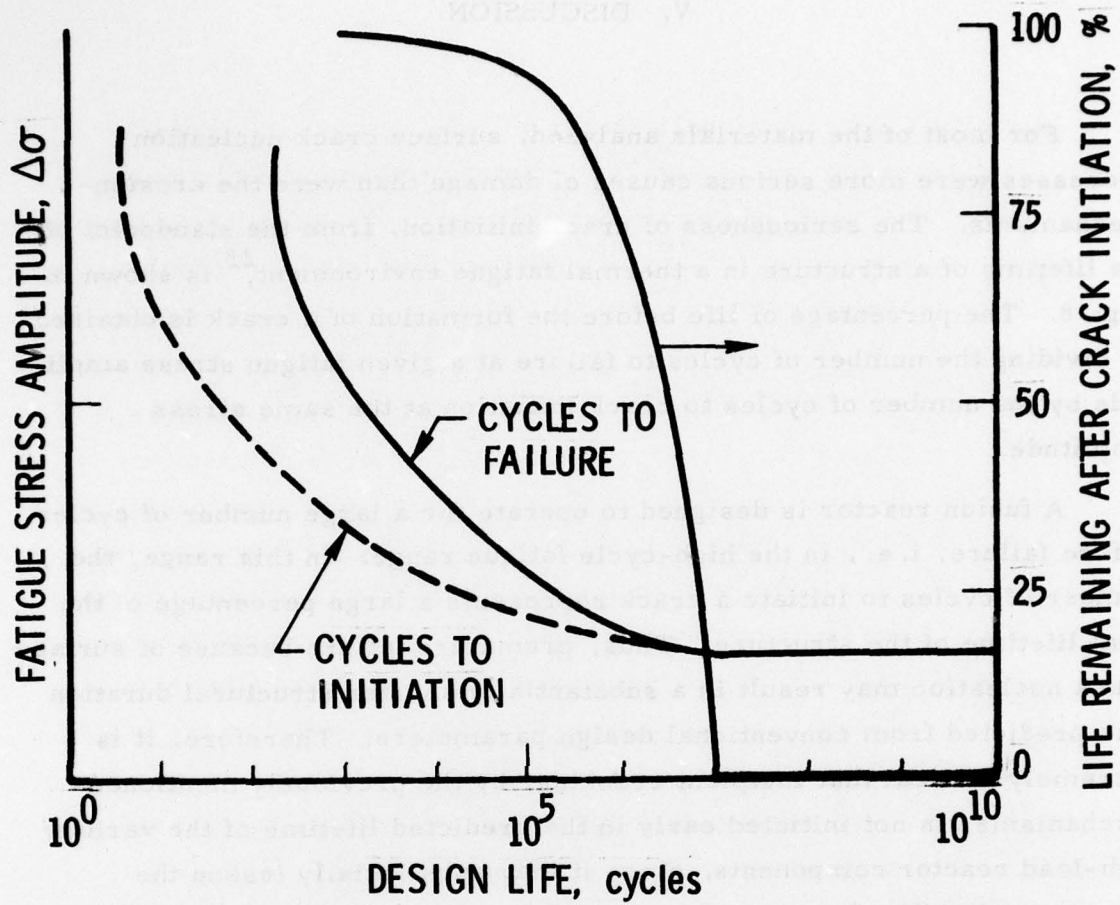
Fig. 8. Effect of Crack Initiation on Structural Lifetime in Thermal-Fatigue Environment

For most of the materials analyzed, surface crack nucleation processes were more serious causes of damage than were the erosion mechanisms. The seriousness of crack initiation, from the standpoint of the lifetime of a structure in a thermal fatigue environment,²³ is shown in Fig. 8. The percentage of life before the formation of a crack is obtained by dividing the number of cycles to failure at a given fatigue stress amplitude by the number of cycles to crack initiation at the same stress amplitude.

A fusion reactor is designed to operate for a large number of cycles before failure, i. e. , in the high-cycle fatigue range. In this range, the number of cycles to initiate a crack represents a large percentage of the total lifetime of the structure. Thus, premature failure because of surface crack nucleation may result in a substantially shorter structural duration than predicted from conventional design parameters. Therefore, it is extremely critical that incipient cracking, by the previously mentioned mechanisms, is not initiated early in the predicted lifetime of the various high-load reactor components, since it may substantially lessen the reactor availability because of increased downtime required for more frequent replacements.
