THESIS

Galvanic Aspects of
Aluminum Sacrificial Anode Alloys
in Seawater

Jon Richard Cummings

December 1977

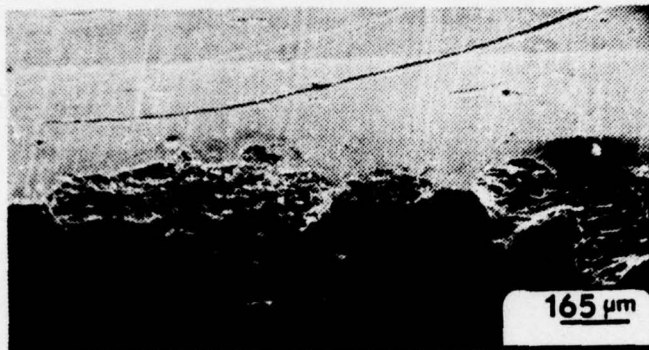
Figure 34

GI-0.25 (50X) Corroded area on the edge of a Galvalum[®]I specimen immersed for fifteen minutes

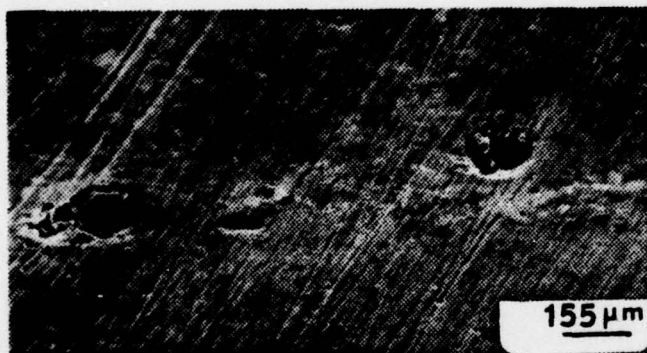
Figure 35

RII-0.25 (65X) Pitting on broad surface of Reynode[®]II specimen immersed for fifteen minutes

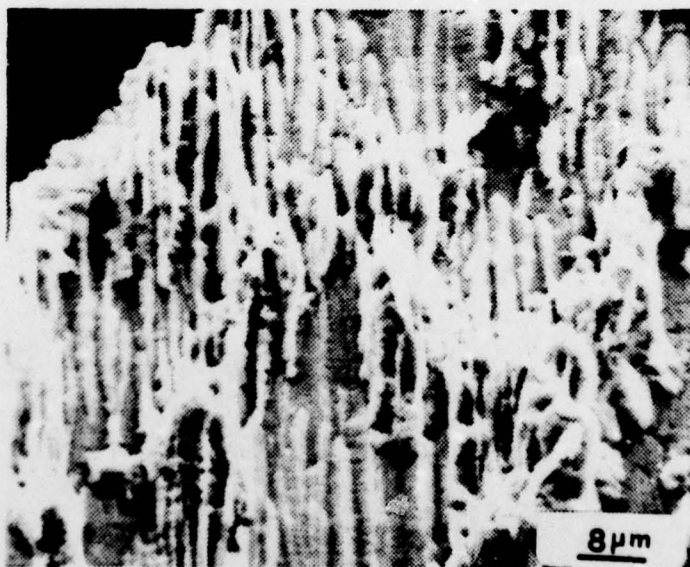
Figure 53

GI-12 (1200X) Galvalum® I twelve-hour immersion specimen showing buildup of corrosion product on spines of the herringbones

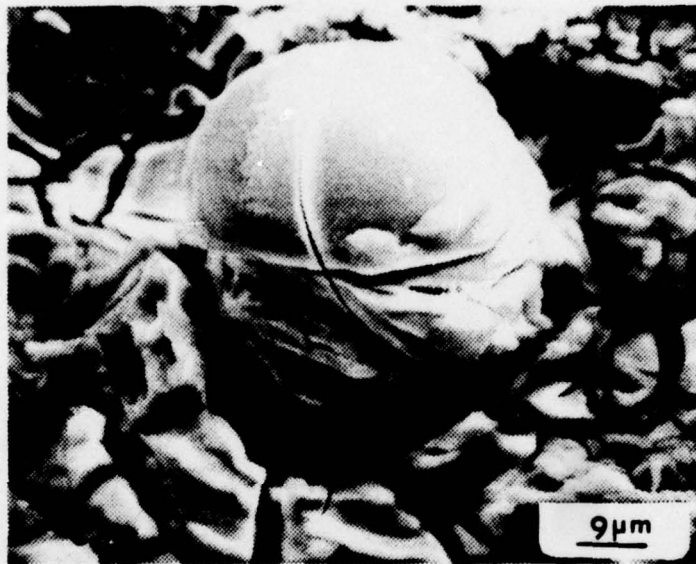
Figure 63

GI-96 (1150X) Corrosion product outcropping
on the Galvalum[®]I ninety-six-hour immersion specimen

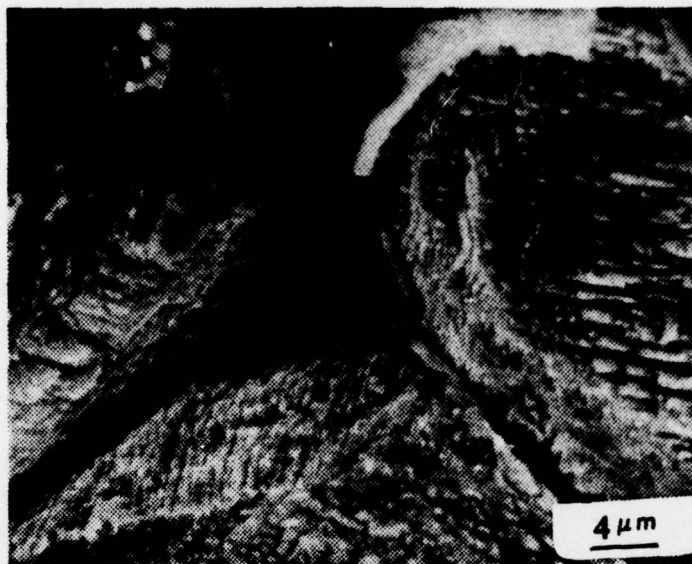
Figure 102

KA90-24 (2400X) Intergranular corrosion evidenced
in KA-90[®] twenty-four-hour immersion specimen
