HARRY DIAMOND LABS ADELPHI MD  
COMPONENT DAMAGE FROM ELECTROMAGNETIC PULSE (EMP) INDUCED TRANS--ETC(U)  
OCT 77 J R MILETTA  
HDL-TM-77-22

4. TITLE (and Subtitle) 6 Component Damage from Electromagnetic Pulse (EMP) Induced Transients 9	5. TYPE OF REPORT & PERIOD COVERED Technical Memo	
7. AUTHOR(s) 14 Joseph R. Miletta	8. CONTRACT OR GRANT NUMBER(s) 16 DA. 1W062118AD51

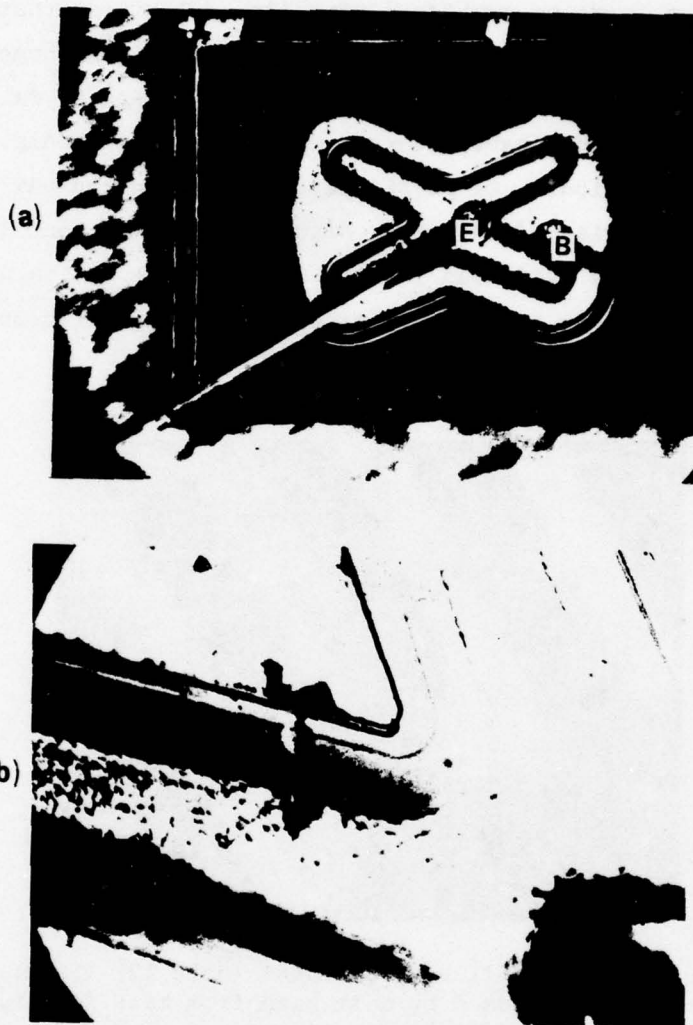
Figure 64. Raytheon 2N1132A transistor (unit 18) showing melt failure: (a) 80X and (b) 500X.

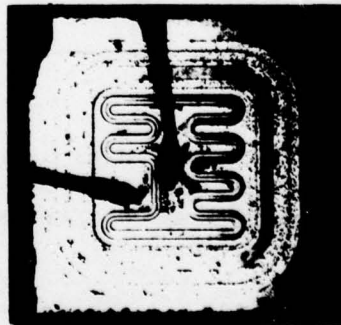
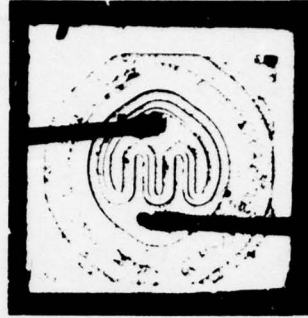
Figure 109 identifies the chip geometries observed microscopically (96X). The MOT and TI transistors each had their own consistent geometry, though transistors of both manufacturers bore two date codes. Test damage data on these transistors showed a consistent, relatively tight distribution about the established failure line. The

Figure 109. 2N1132 transistors (96X): (a) Motorola (date codes: 6917L, 6943T); (b) Texas Instruments (date codes: 7035B, 7040B); (c) Fairchild (date code: 124); (d) Fairchild (date code: 425); (e) Fairchild (date codes: 020, 740).

Figure 109 gives a good idea of the relative variation in size for the FSC devices. This variation could explain the larger spread about the damage line for the FSC transistors; transistor No. 71, which had the ring-dot geometry of figure 104, failed uniquely. Power levels up to 7.8 kW and current levels up to 50 A were sustained for the 2- $\mu$ s pulse E(+)-B without transistor failure. Other transistors failed at power levels of  $\sim$ 200 W. This transistor accounts for the train of no-failure points seen in figure 91.
