Report No. FAA-RD-78-28

TESTS OF CRASH-RESISTANT FUEL SYSTEM FOR GENERAL AVIATION AIRCRAFT

William M. Perrella, Jr.

INTERIM REPORT

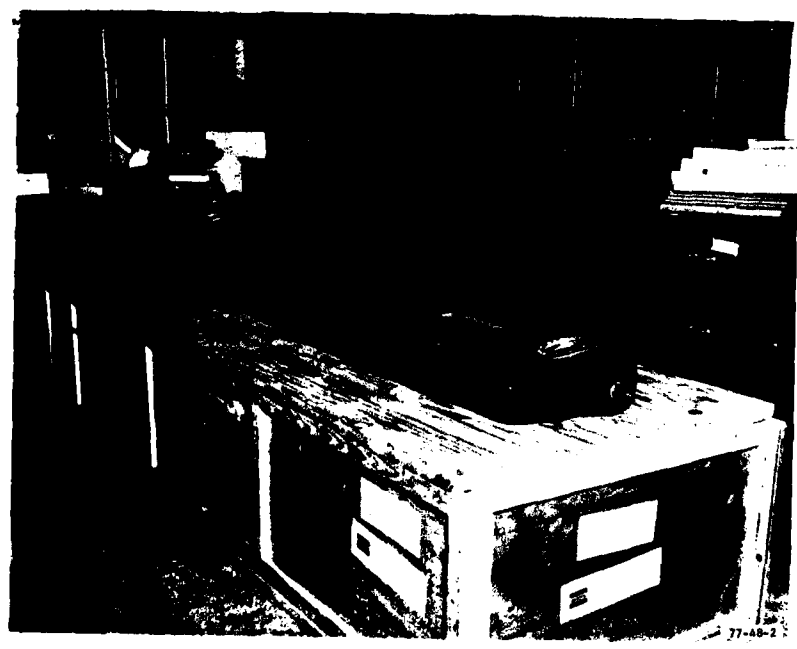
FIGURE 2. TWO-PLY FUEL TANK

As crash-resistant tanks are somewhat stiffer than standard bladder cells, they could not be installed in the opening in the wing normally used for that purpose. Figure 2 shows a two-ply tank, which is much stiffer than one of single-ply construction.

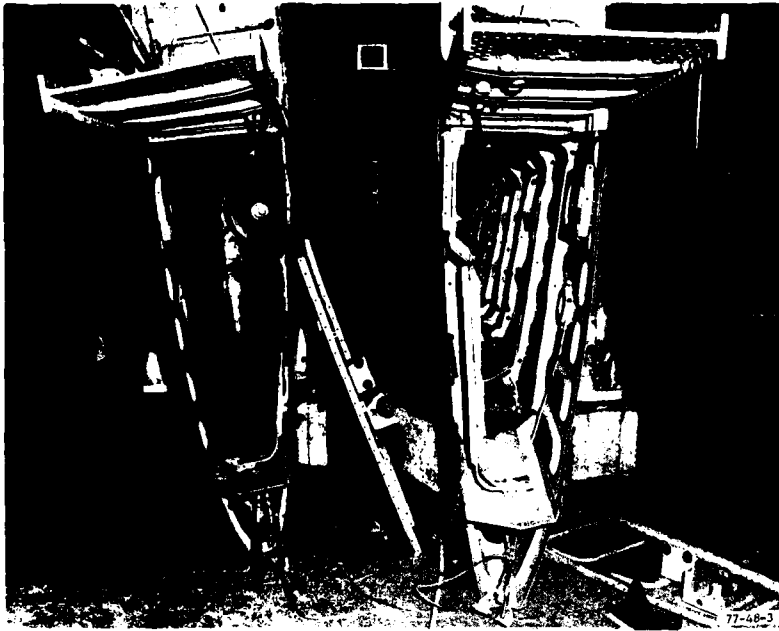
FIGURE 3. INSTALLATION OF TWO-PLY FUEL TANK

The crashworthy tanks were installed by removing the bulkhead rib at the wing root after the wing was removed from the aircraft. The tank was slid into the wing, after which the rib was riveted back in place, and the wing was reinstalled. Referring to figure 3, it is seen that the tanks occupy the wing leading edge, the most hazardous location. No modifications were done on the wing where the filler flange fitting, access, and gauge fittings were located. The frangible couplings (figure 4) were installed at the fuel outlet and vent fittings. As bulkhead ribs interfered with these fittings, 2-inch-diameter clearance holes were cut in the ribs. To provide a more severe operating condition for the couplings, aluminum tubing was used in lieu of the flexible tubing normally used for fuel lines. Actuating arms were installed to impact these lines when the arms contacted the ground during the crash (figure 5).

- ① EQUIV. TO MS33656-8
- ② EQUIV. TO MS33514-12 MOD.
- ③ EQUIV. TO MS33649-12

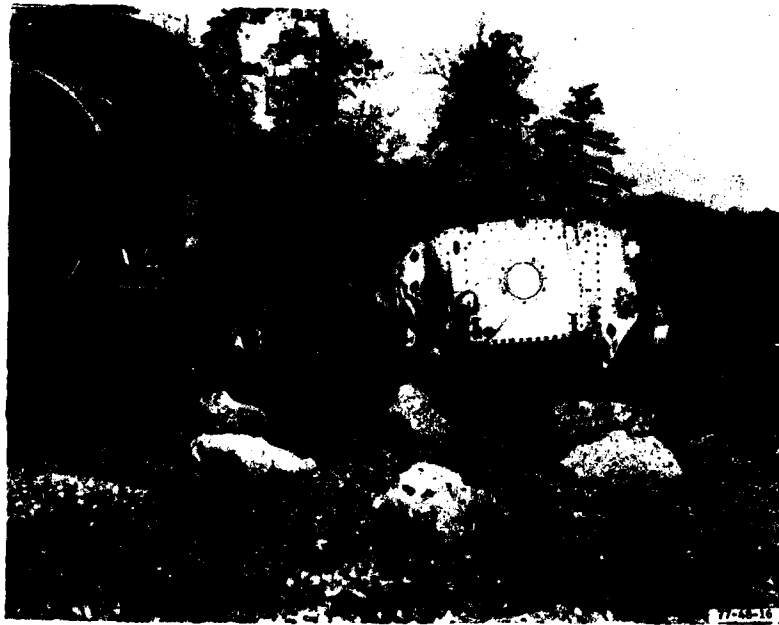
FIGURE 16. DAMAGE TO LEFT WING TWO-PLY FUEL TANK, TEST 1

Major results of the three crash tests are summarized in table 3. The first test evaluated three-ply and two-ply tanks. The left wing received the most severe impacts. It contained the two-ply tank, which, upon later visual inspection, was found to be undamaged. The self-sealing Aeroquip couplings all actuated with no leakage. The left wing was nearly torn from the fuselage, with only a small part of the spar web holding it (figures 16 and 17). Acceleration levels, shown in figure 18, show that this crash was survivable, with injury of the occupants likely if the standard aircraft seating and belts were used. The impact speed of the aircraft was 93-feet per second (ft/s).
