Special Report 78-7

# FRESH WATER SUPPLY FOR A VILLAGE SURROUNDED BY SALT WATER

POINT HOPE, ALASKA

Terry McFadden and Charles Collins

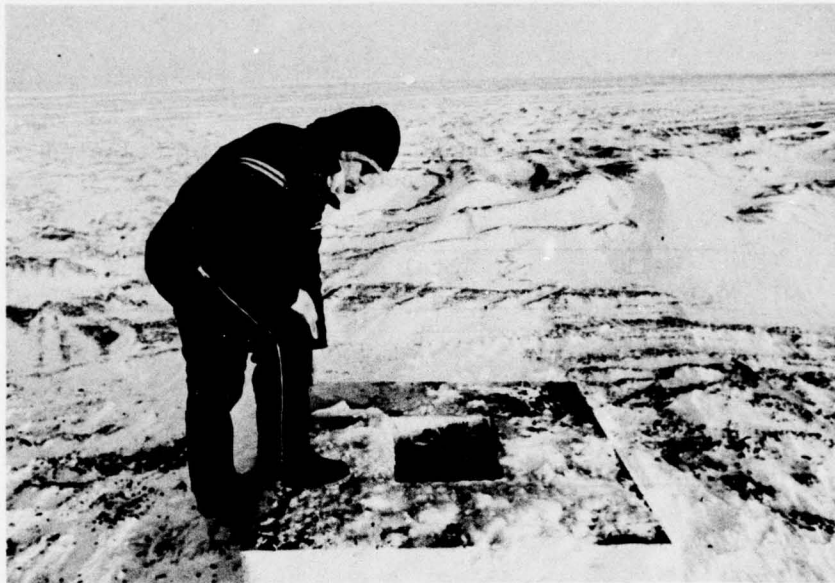
Figure 3. Surface water well in the gravel of the spit. Note well is enclosed to protect well from contamination.

On the basis of trip reports and visits to the village, it was determined that two possible water supplies might be developed. The first was the water which was known to exist in the gravel at a depth of approximately 3 ft (1 m) and was currently being used by the school and village for summer water supply (Fig. 3). The second was from small lakes which are located at the mainland end of the spit, a distance of approximately four miles from the village (Lakes 1 and 2, Figs. 2 and 4). The third was from Teshekpak Lake, a large lake located approximately six miles east of the village.

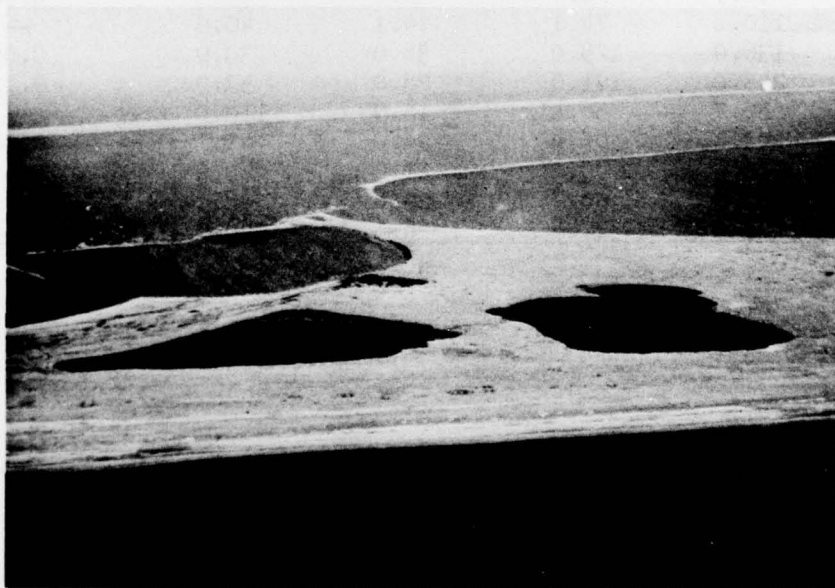
Figure 4. Small lakes at the east end of the spit.

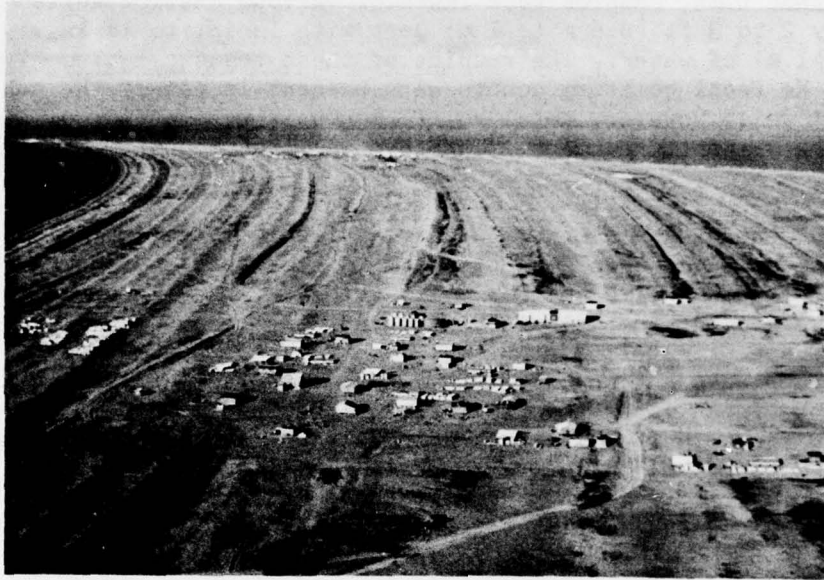
Figure 5. View of Pt. Hope spit showing gravel ridges.

The spit is composed of long gravel ridges which run parallel to the ocean (Fig. 5). Between these ridges are small channel-like depressions. The active layer in the spit is approximately the same thickness throughout the gravel areas of the spit. Thus, the surface of the permafrost table is parallel to the gravel surface, and is also composed of a series of ridges with small valleys or channels between them. These channels fill with water when the snow accumulated on the spit each winter melts during the summer.

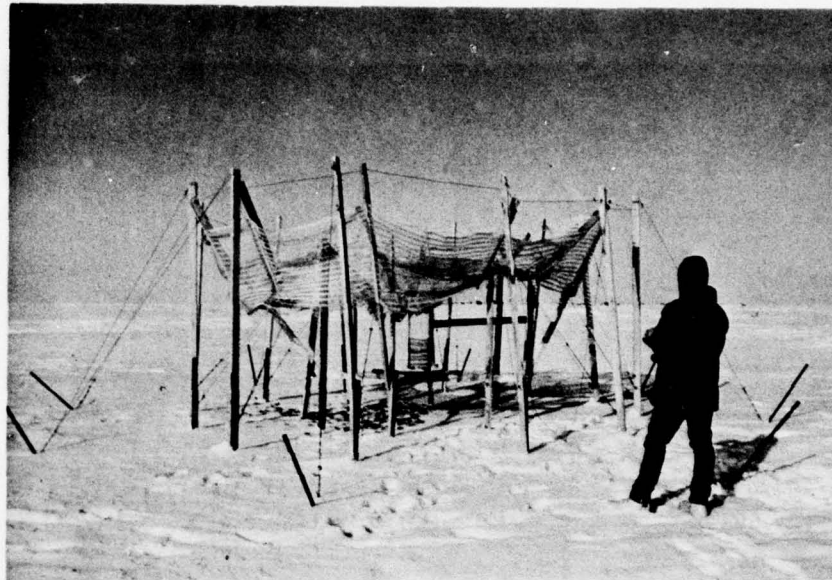
Figure 6. Wyoming snow gauge.

A preliminary investigation of the snow quantity in the vicinity of the village was done in May of 1976 to determine if snow melt water could be used to supplement the water supply. It indicated that adequate snow did exist in the area. This could be concentrated in a desired location with the use of snow fencing since blowing snow is common throughout this portion of Alaska. Since no adequate snowfall records were available for this area, a "Wyoming-type" snow gauge was erected at the site to give snowfall records for the winter of 1976-1977 (Fig. 6).

The "Wyoming" snow gauge was designed to measure snowfall in windy areas where blowing snow is a problem, and the results obtained from it gave a relatively accurate measurement of the snow available at this location. The total accumulation from 3 November 1976 to 20 April 1977, as measured by the gauge, was 1.39 in. (3.53 cm) of water equivalent.
