14 MERADCOM -  
Report 2237

6 INFRARED MOTION SENSOR EVALUATION

U.S. ARMY MOBILITY EQUIPMENT  
RESEARCH AND DEVELOPMENT COMMAND  
FORT BELVOIR, VIRGINIA

20. ABSTRACT (Continue on reverse side if necessary and identify by block number) This report describes the test program performed by MERADCOM to determine the performance and reliability of model 19-115 Infrared Intrusion Sensor (IRIS). Three commercial infrared sensors were included in the test program to establish a base for comparing the test data. Each sensor was subjected to detection, nuisance alarms, electromagnetic interference (EMI), and temperature to determine each sensor's operating effectiveness when exposed to these conditions. The report describes each test performed and gives detailed performance data for each sensor.

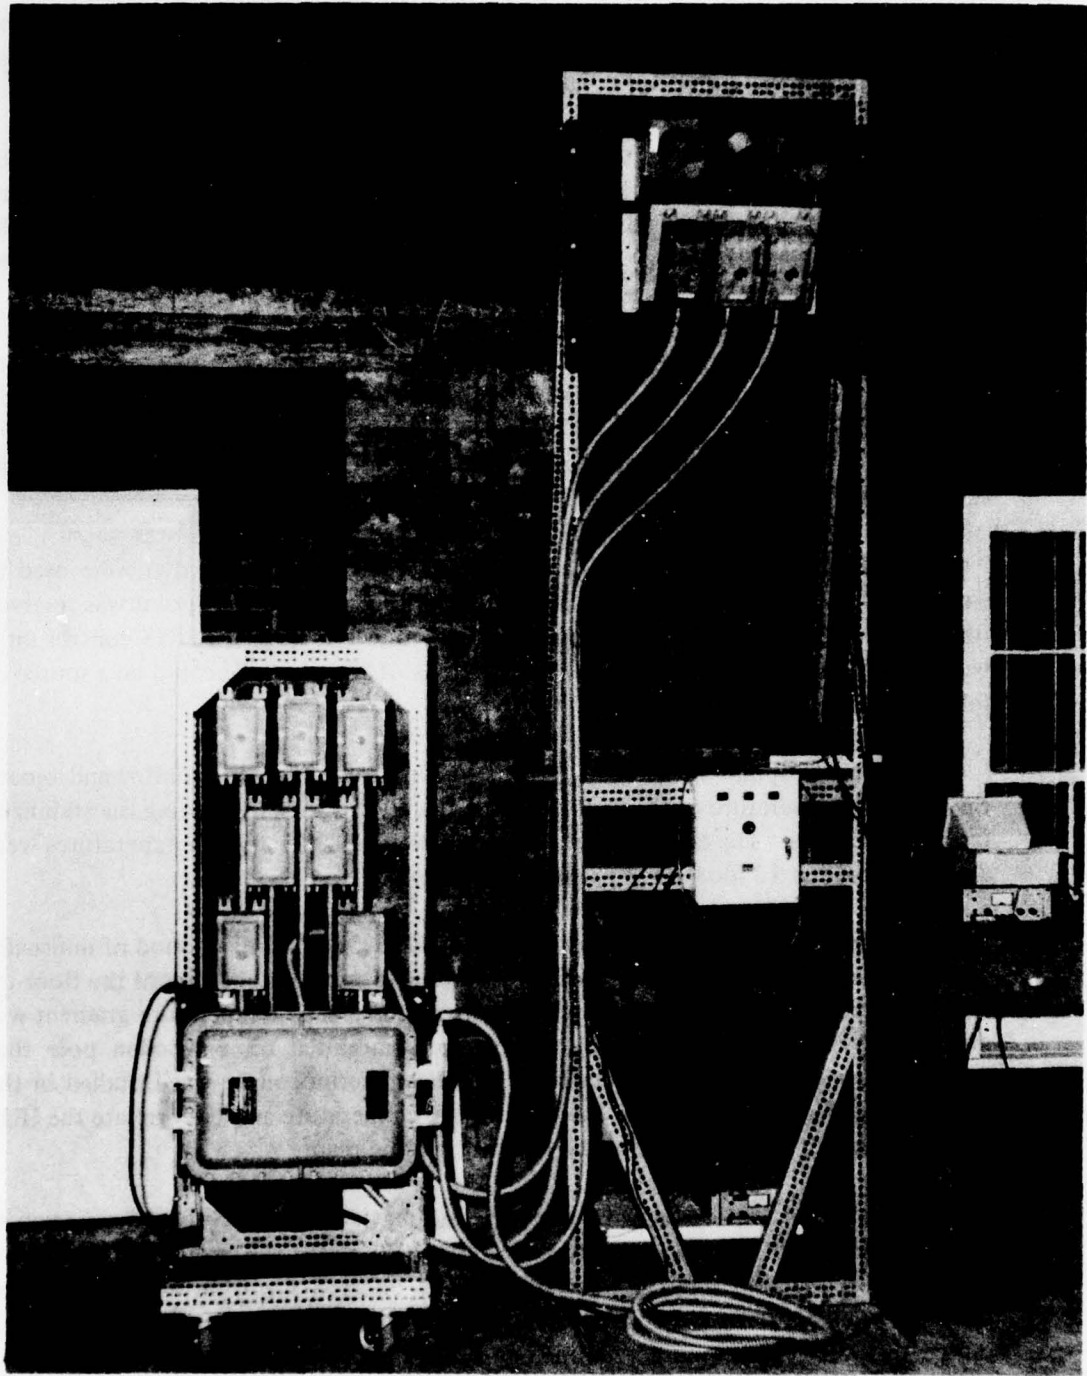
Figure 1. Sensor stand and cart test fixtures.

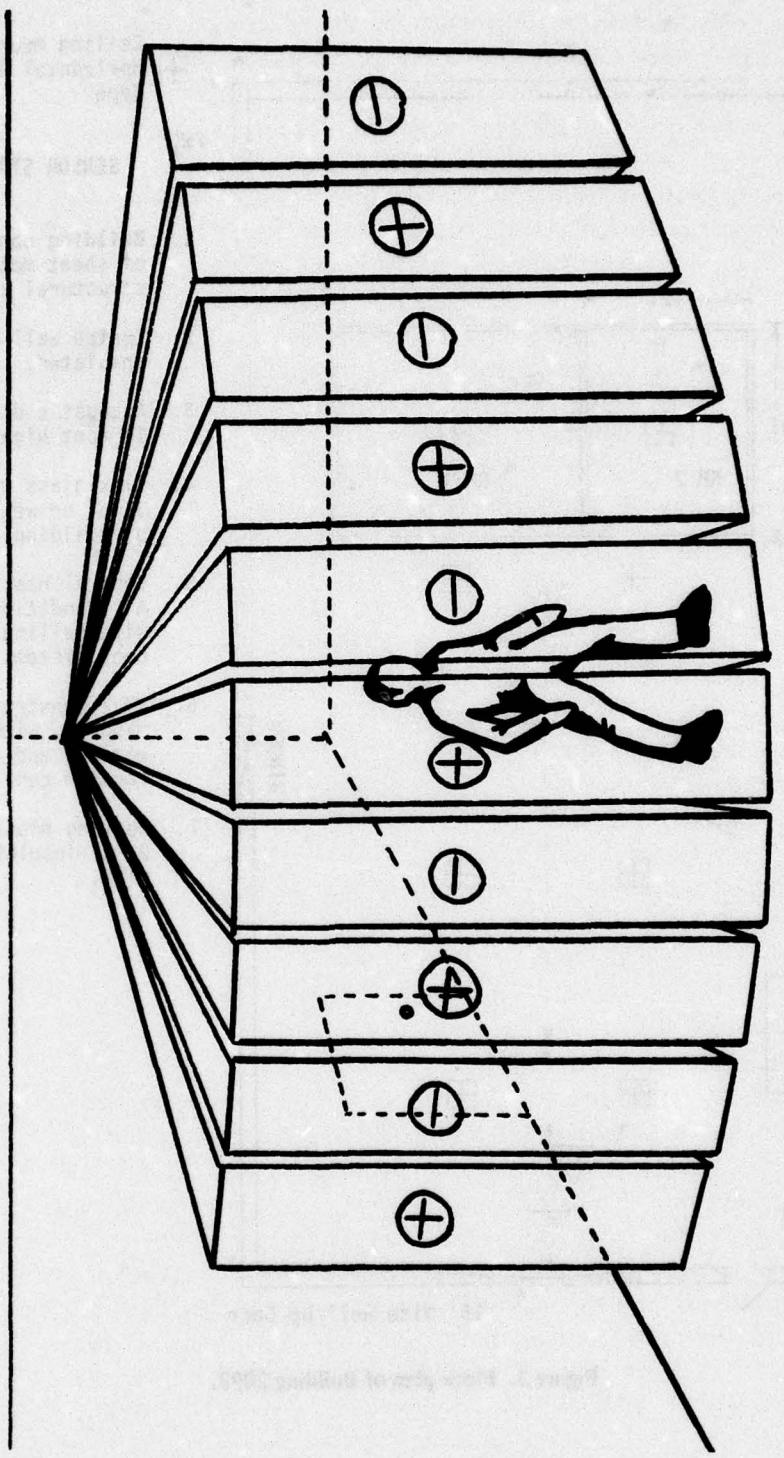
Figure 2. IRIS and Infralarm field of view.

This was a small room (12 ft by 15 ft); therefore, it should be noted that each IRIS/Infralarm horizontal field of view (see Figure 2) is approximately 6 inches in the area of the register. The register is a horizontally diffusing type (12 in. by 12 in.); therefore, air is exhausting simultaneously into adjacent sectors. Simultaneous irradiation of the series opposing thermopiles as used in IRIS/Infralarm sensors theoretically produces a zero output voltage.

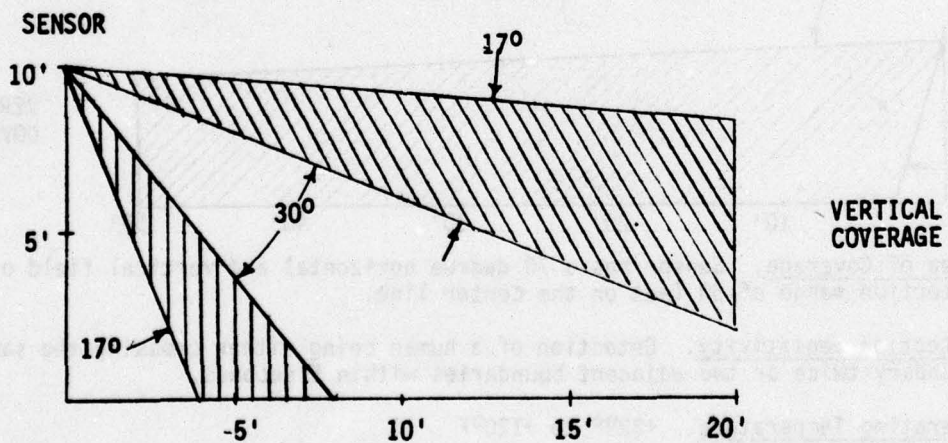
Figure 5. ADL Specifications. (Information extracted from the installation manual.)

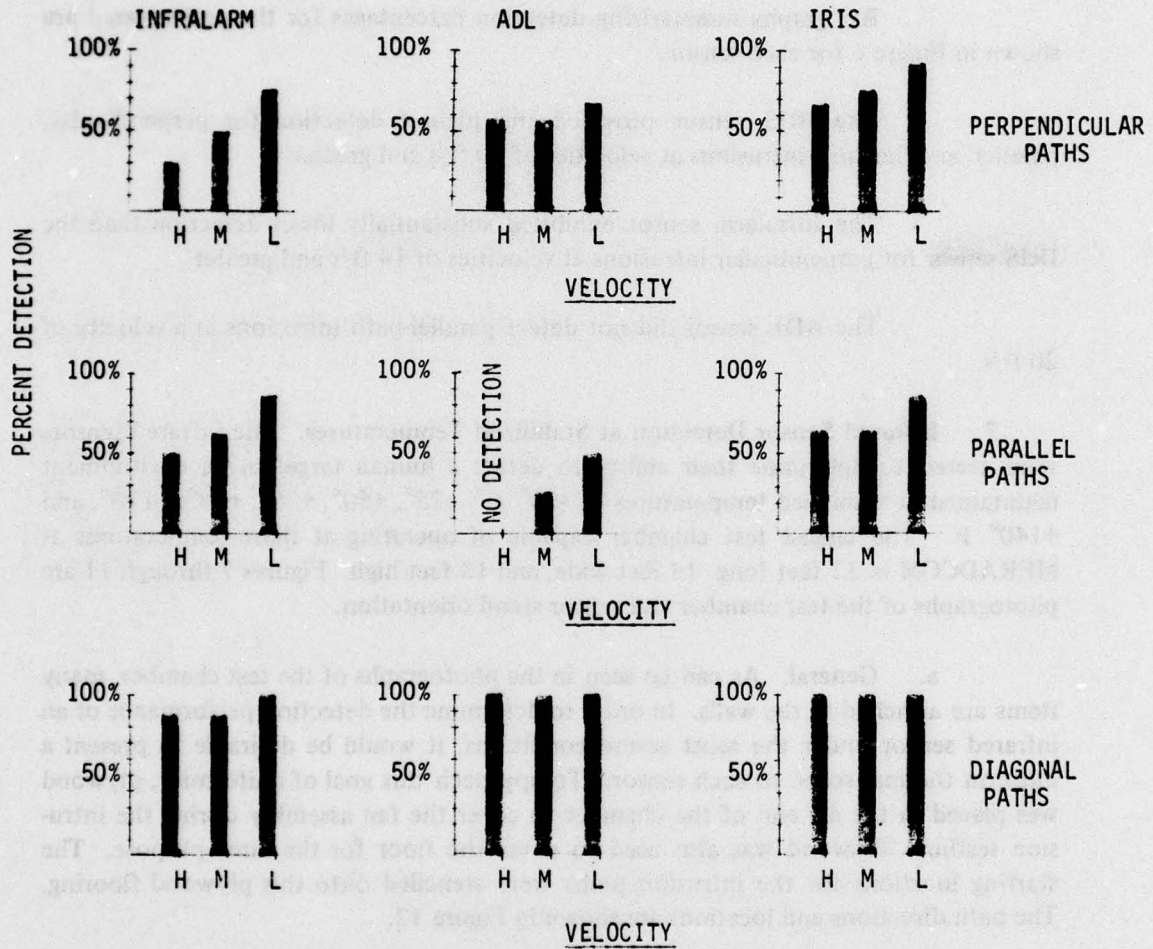
INTRUDER: Pat Kerfoot  
 5'5" - 135 lbs.  
 VELOCITY: High Speed (H) 20-23 ft/sec  
 Med. Speed (M) 14-16 ft/sec  
 Low Speed (L) 10-12 ft/sec

Figure 6. High-velocity intrusion test results.

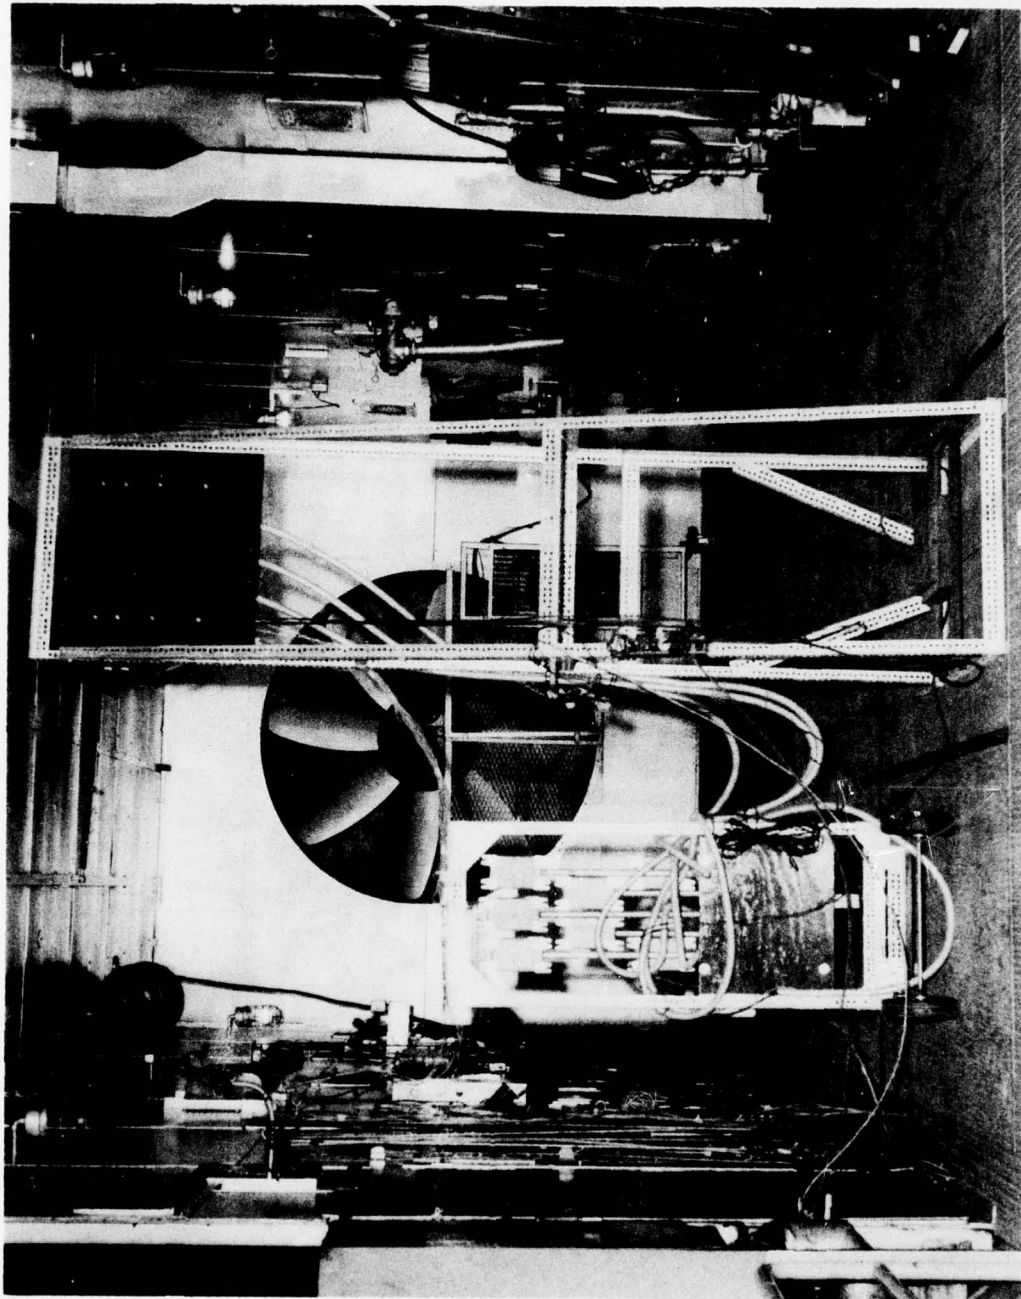
Figure 7. Environmental test chamber equipment layout.

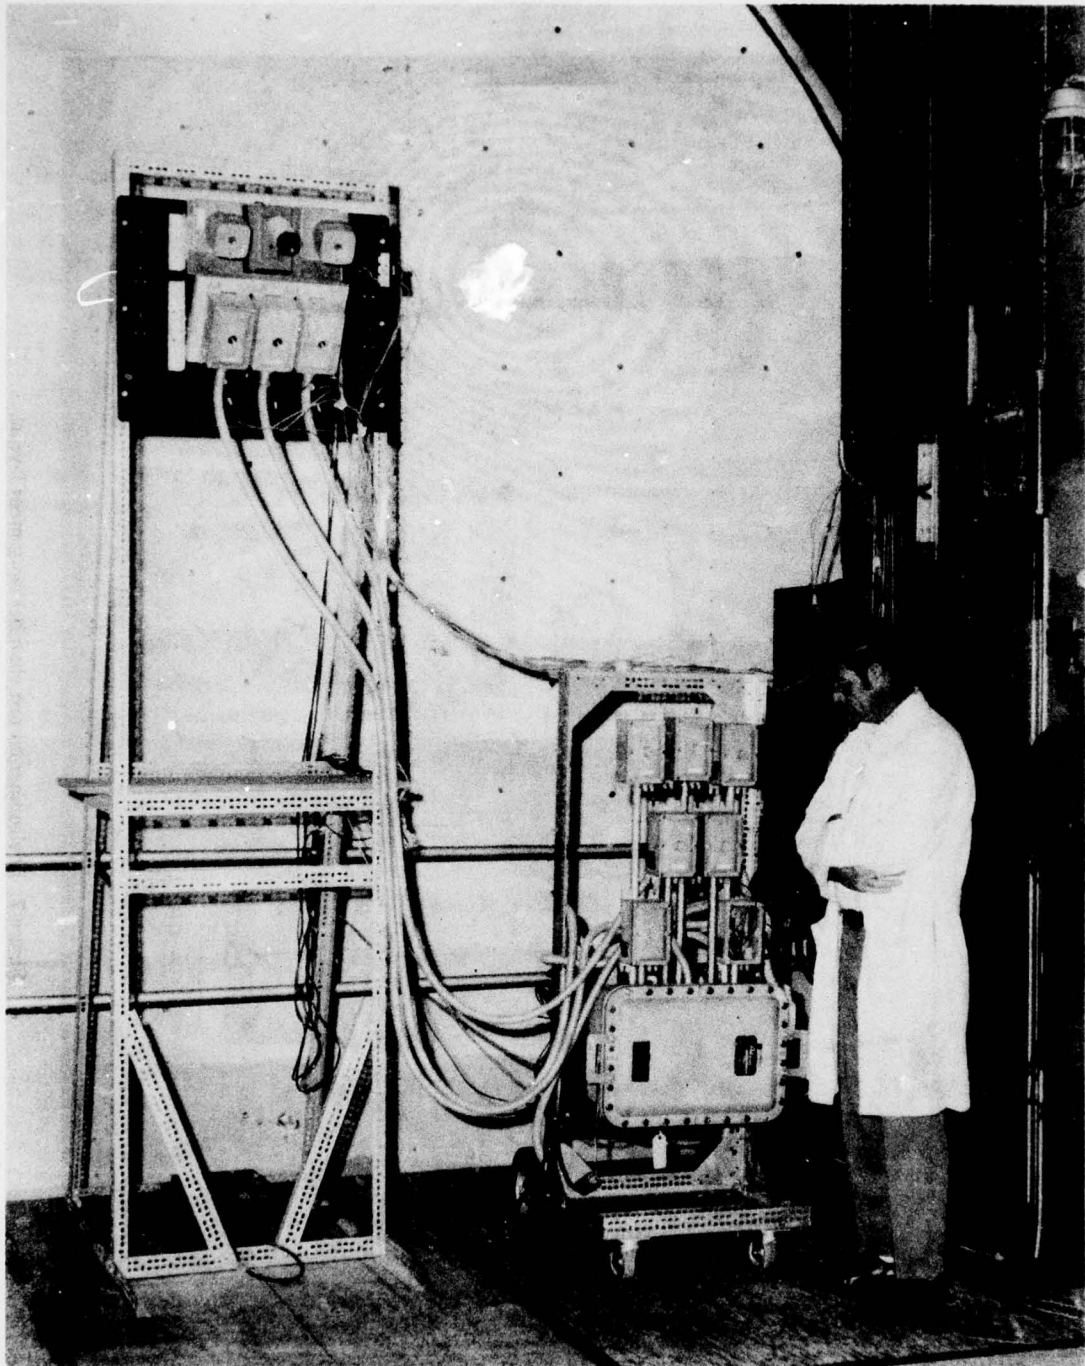
Figure 8. Forward end of environmental chamber.

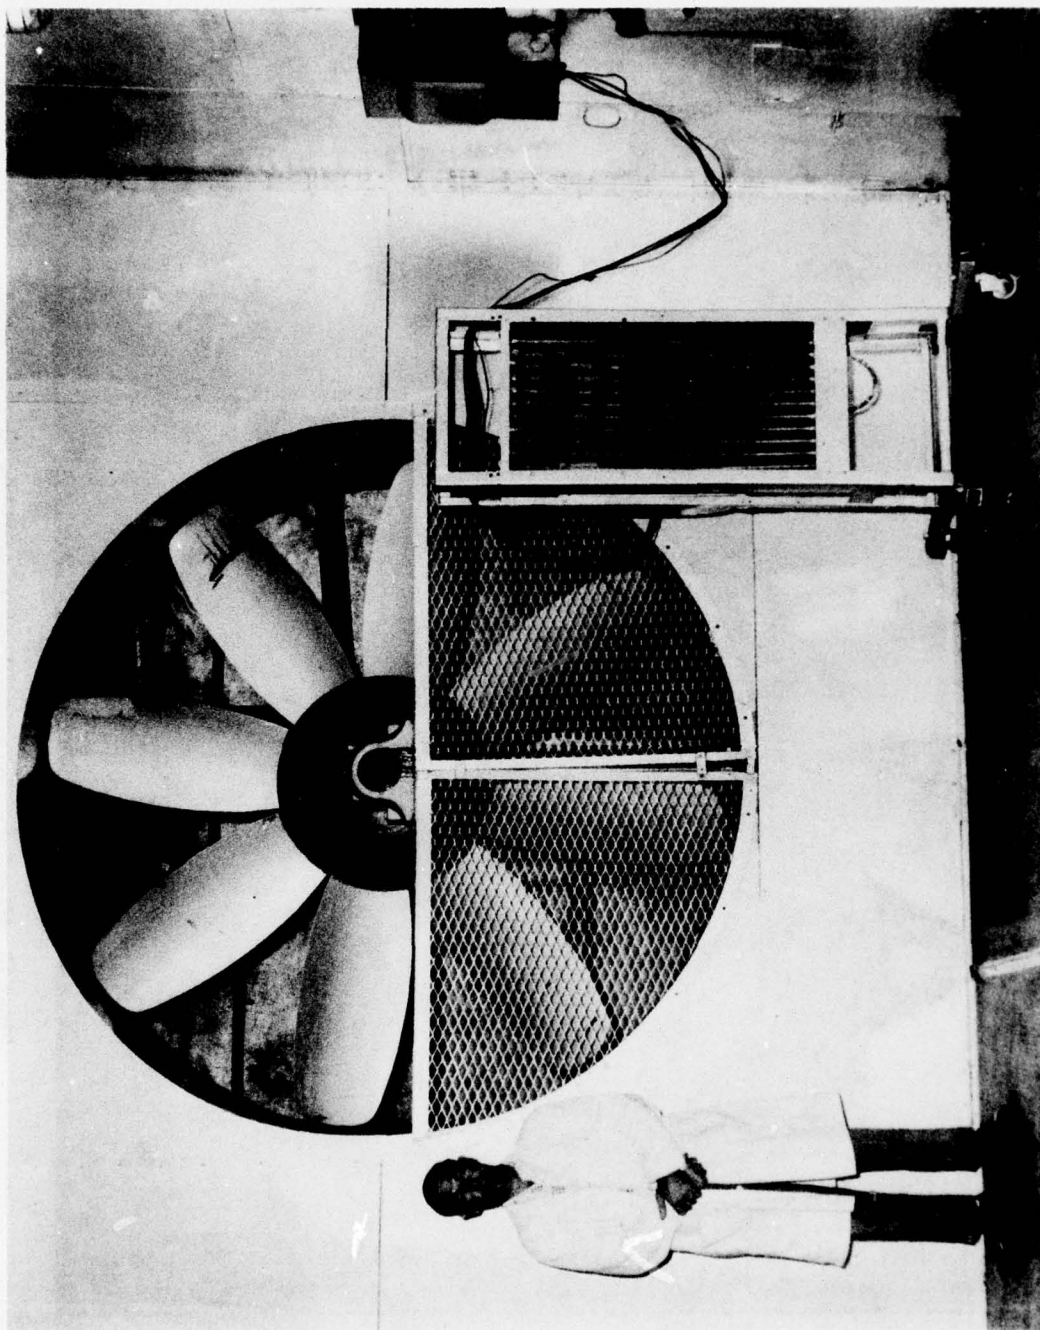
Figure 9. Environmental chamber 10-kW heater location.

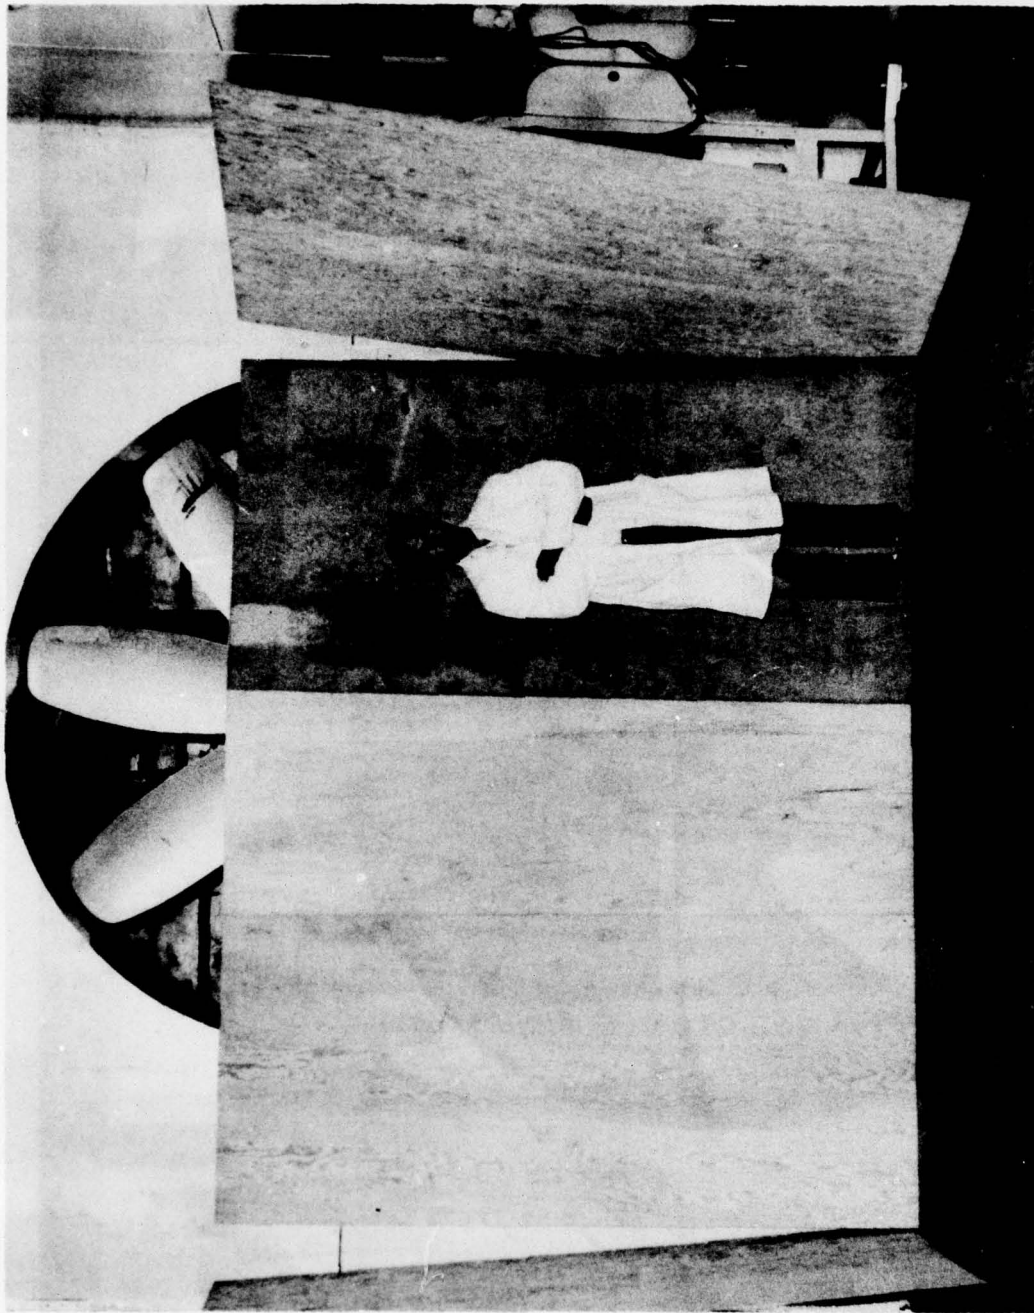
Figure 10. Aft end of environmental chamber prepared for intrusion testing.

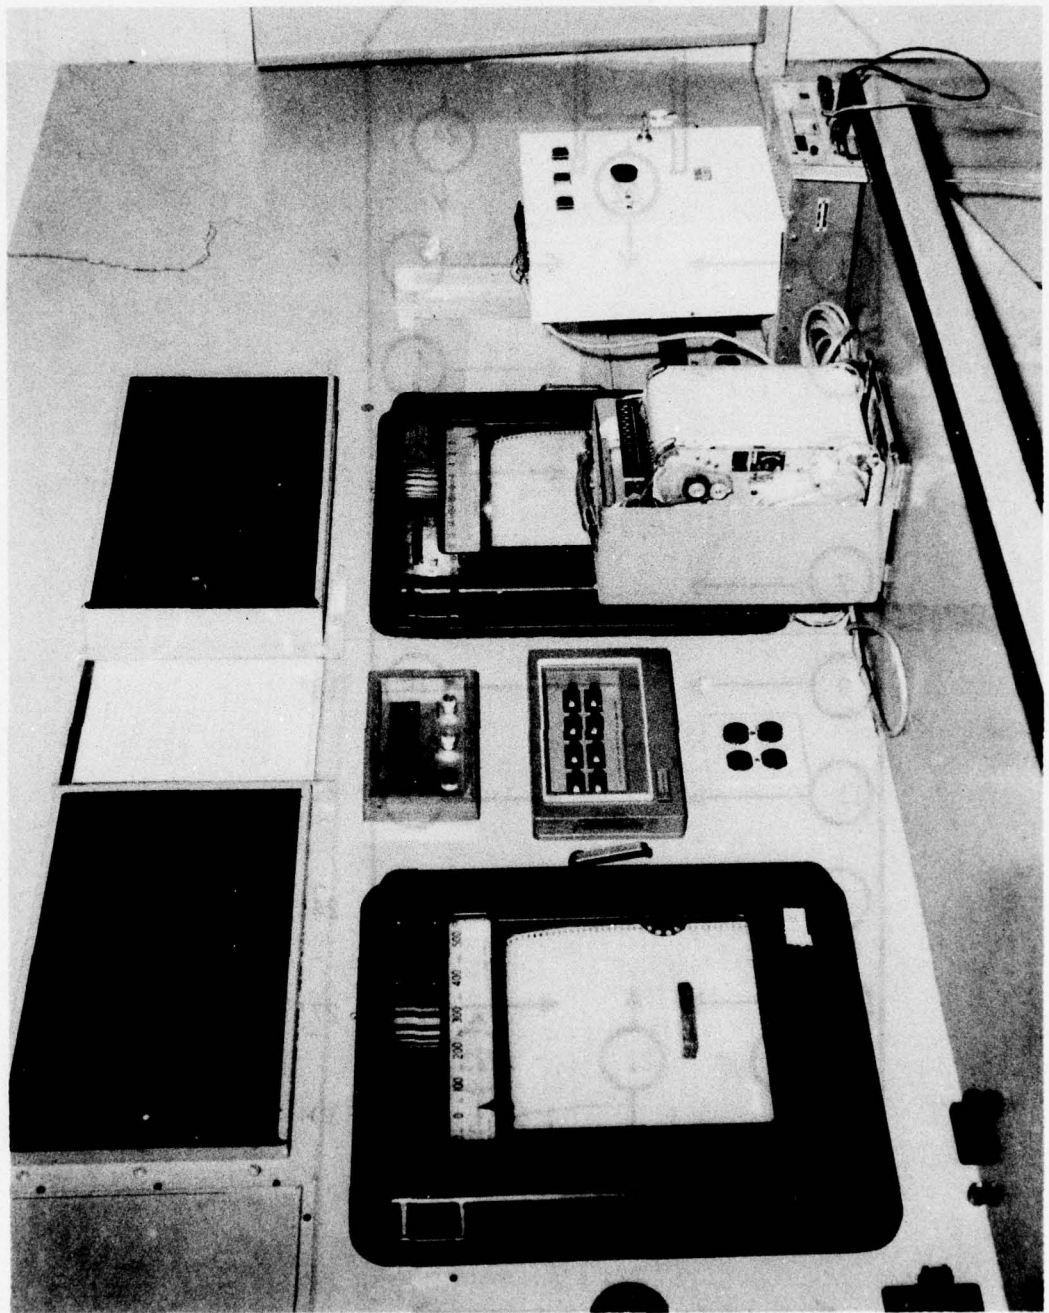
Figure 11. Environmental chamber temperature and alarm monitoring instrumentation.

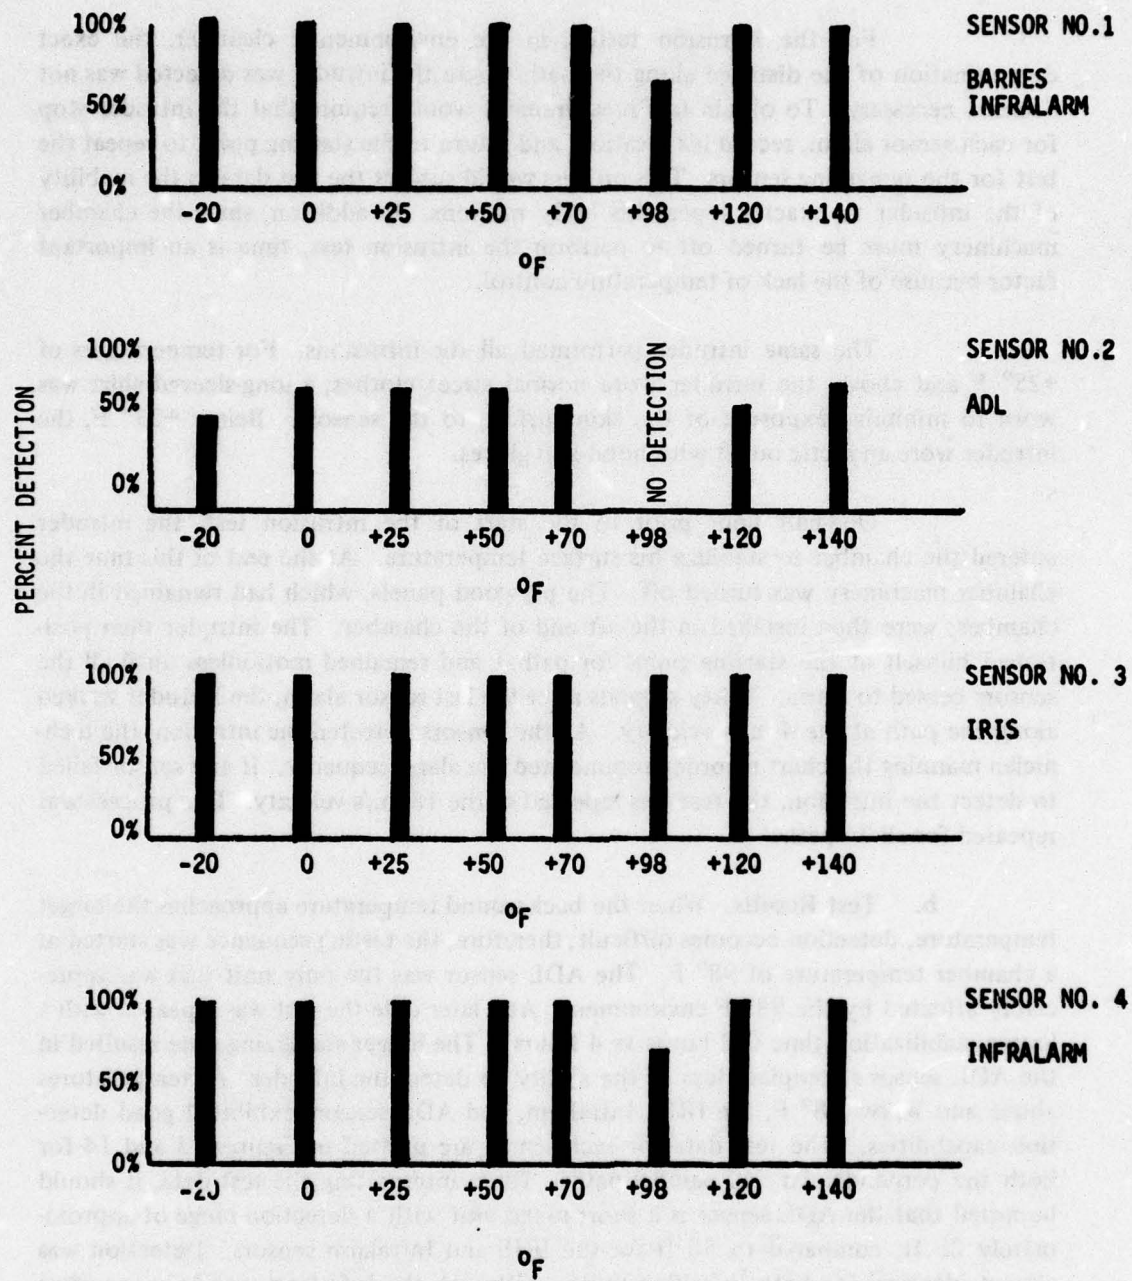
Figure 13. Environmental chamber test results for perpendicular intrusions.  
(Intruder velocity approximately 4 in./s)

**b. Test Results.** When the background temperature approaches the target temperature, detection becomes difficult; therefore, the testing sequence was started at a chamber temperature of 98° F. The ADL sensor was the only unit that was appreciably affected by the 98° F environment. At a later date the test was repeated with a longer stabilization time (12 hours vs 4 hours). The longer stabilizing time resulted in the ADL sensor's complete loss of the ability to detect the intruder. At temperatures above and below 98° F, the IRIS, Infralarm, and ADL sensors exhibited good detection capabilities. The test data for each sensor are plotted in Figures 13 and 14 for both the perpendicular and parallel paths. When interpreting the test data, it should be noted that the ADL sensor is a short-range unit with a detection range of approximately 20 ft, compared to 50 ft for the IRIS and Infralarm sensors. Detection was almost identical for both Infralarm units. Although the Infralarm was only specified for operation at temperatures between +32° F and +120° F, the sensor detection was not affected by the temperature extremes of -20° F to +140° F.

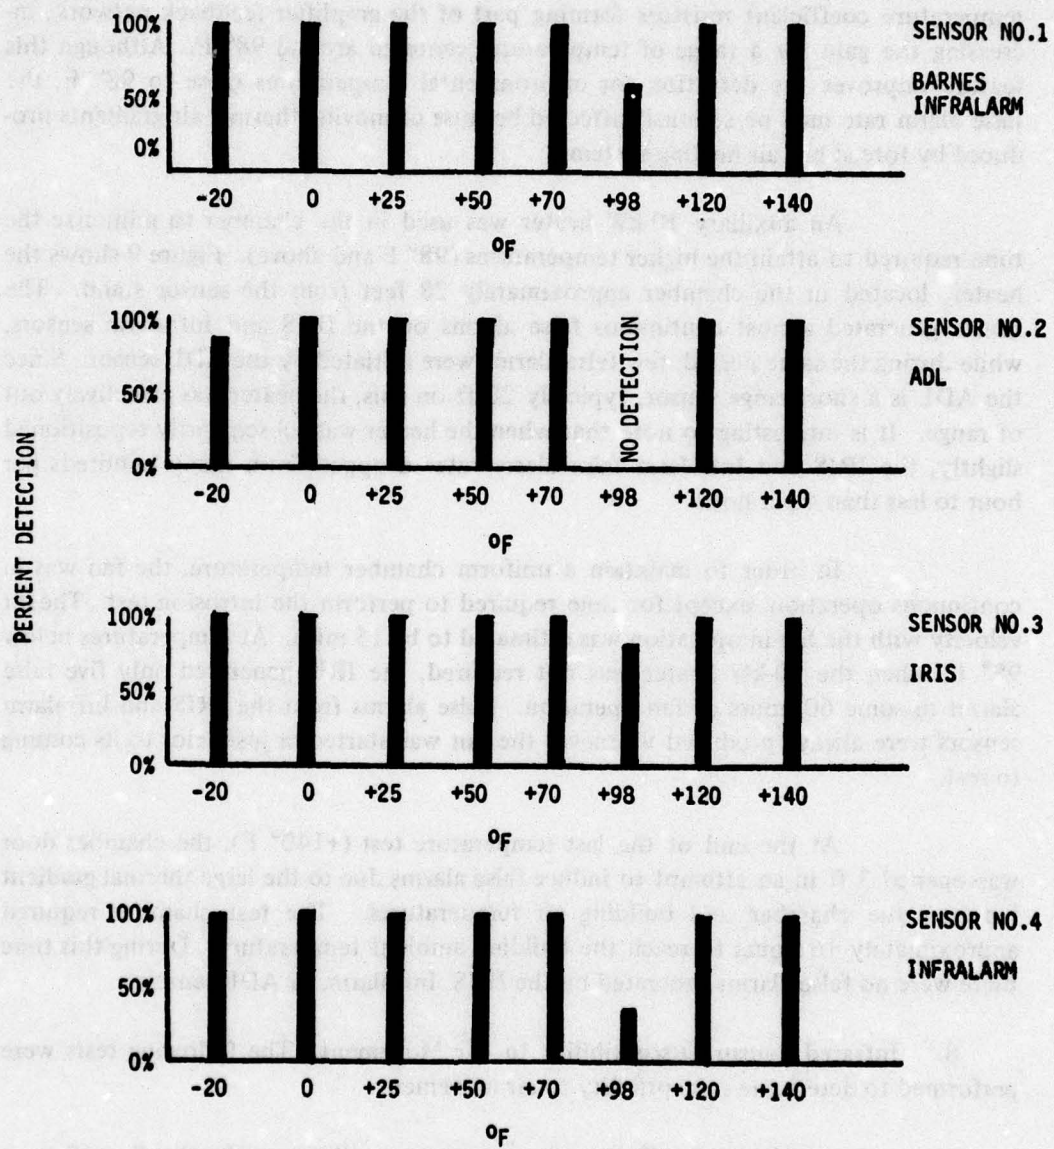
Figure 14. Environmental chamber test results for parallel intrusions.  
(Intruder velocity approximately 4 in./s.)

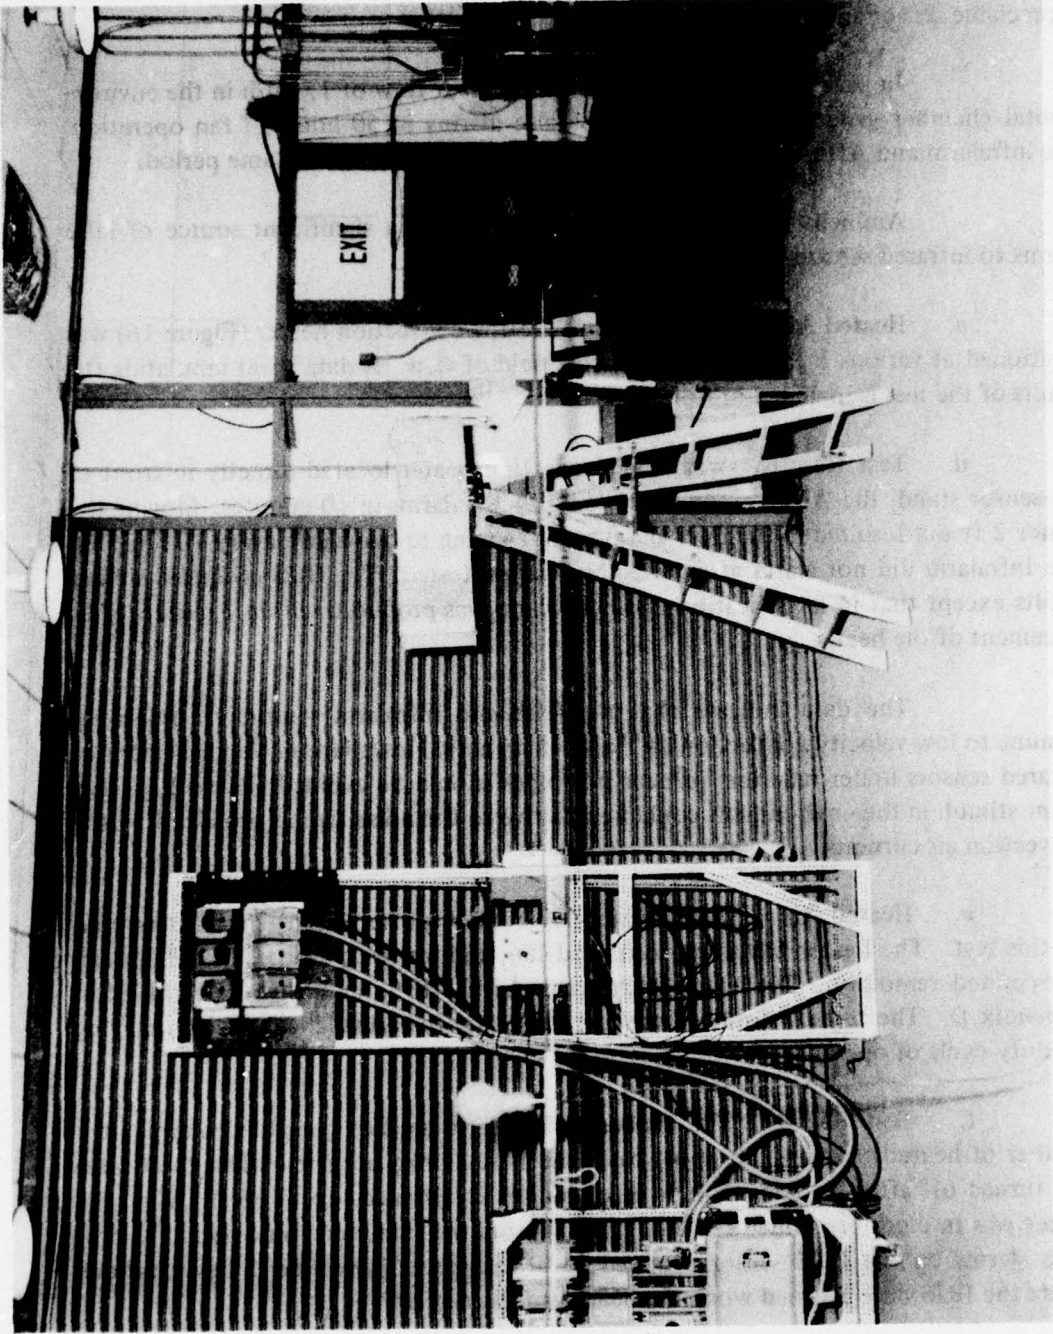
Figure 15. Testing sensors using a ducted fan.

a. **Ambient Air.** To test for sensor susceptibility to localized air flow, a ducted fan (Figure 15) was placed at various locations across the sensor field of view.

b. **Test Results.** The IRIS, Infralarm, and ADL sensors did not alarm to this stimulus. The test was repeated using a tripod-mounted IRIS sensor head, and no appreciable sensor analog response was noted.

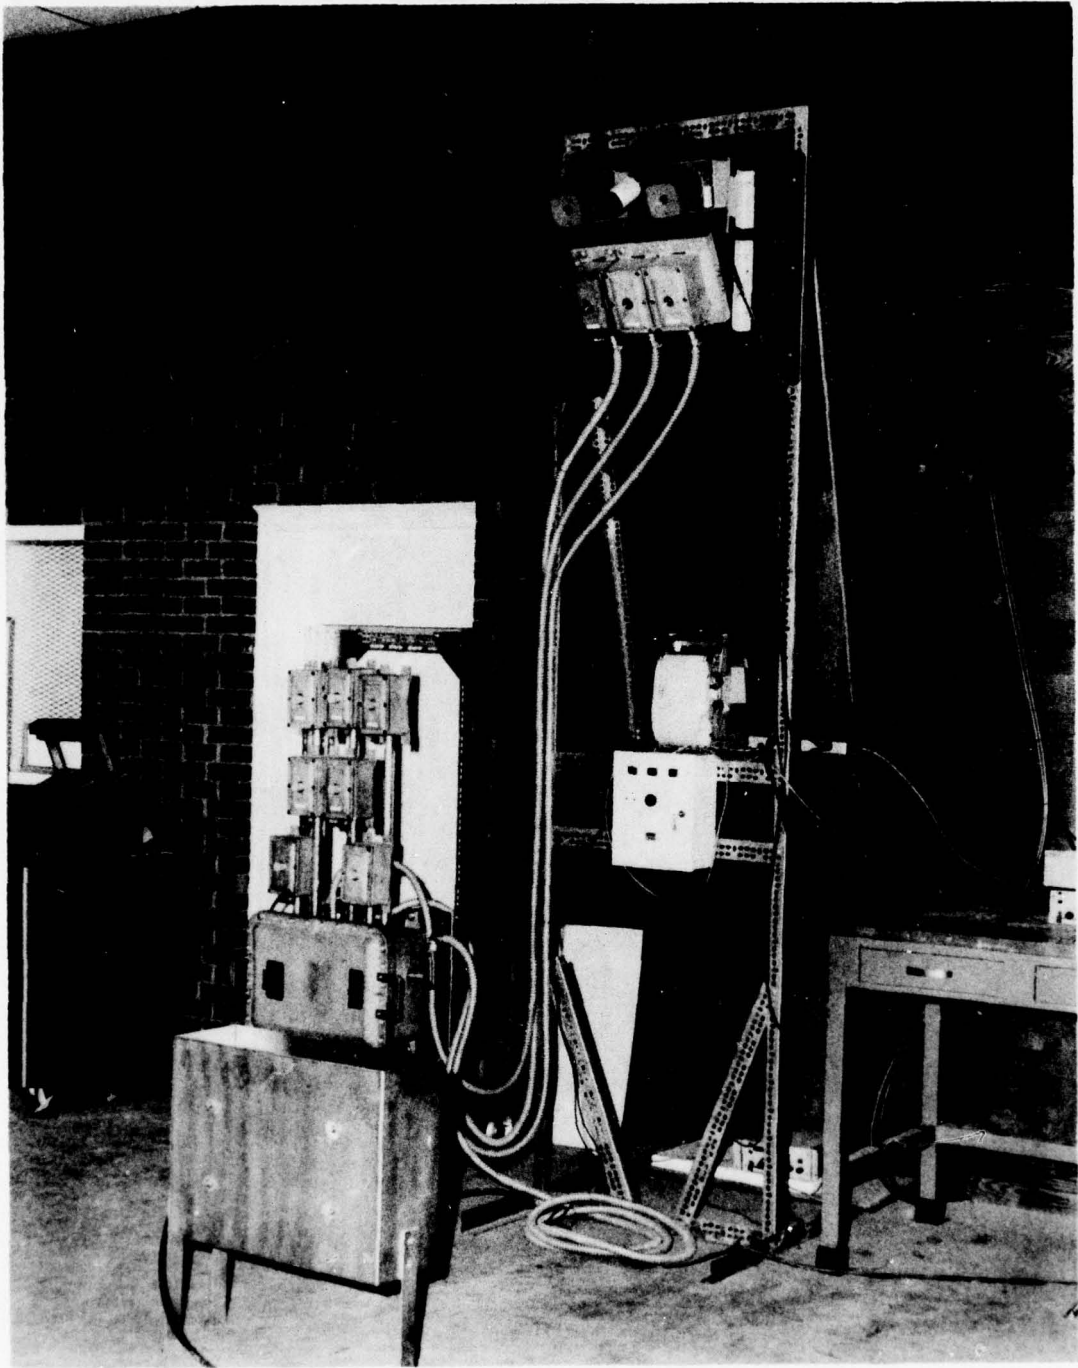
Figure 16. Testing sensors using a convection heater.

f. **Test Results.** The IRIS and Infralarm sensors generated alarms at a number of heater locations. In most cases the false alarms occurred when the heater was turned off after 7 to 25 seconds of operation at distances up to 35 ft. When the heater was in close proximity (15 ft) to the sensors the minimum time period to produce alarms on the IRIS sensor dropped to 3 seconds. There were a few locations where the IRIS false alarmed when the heater was turned on.

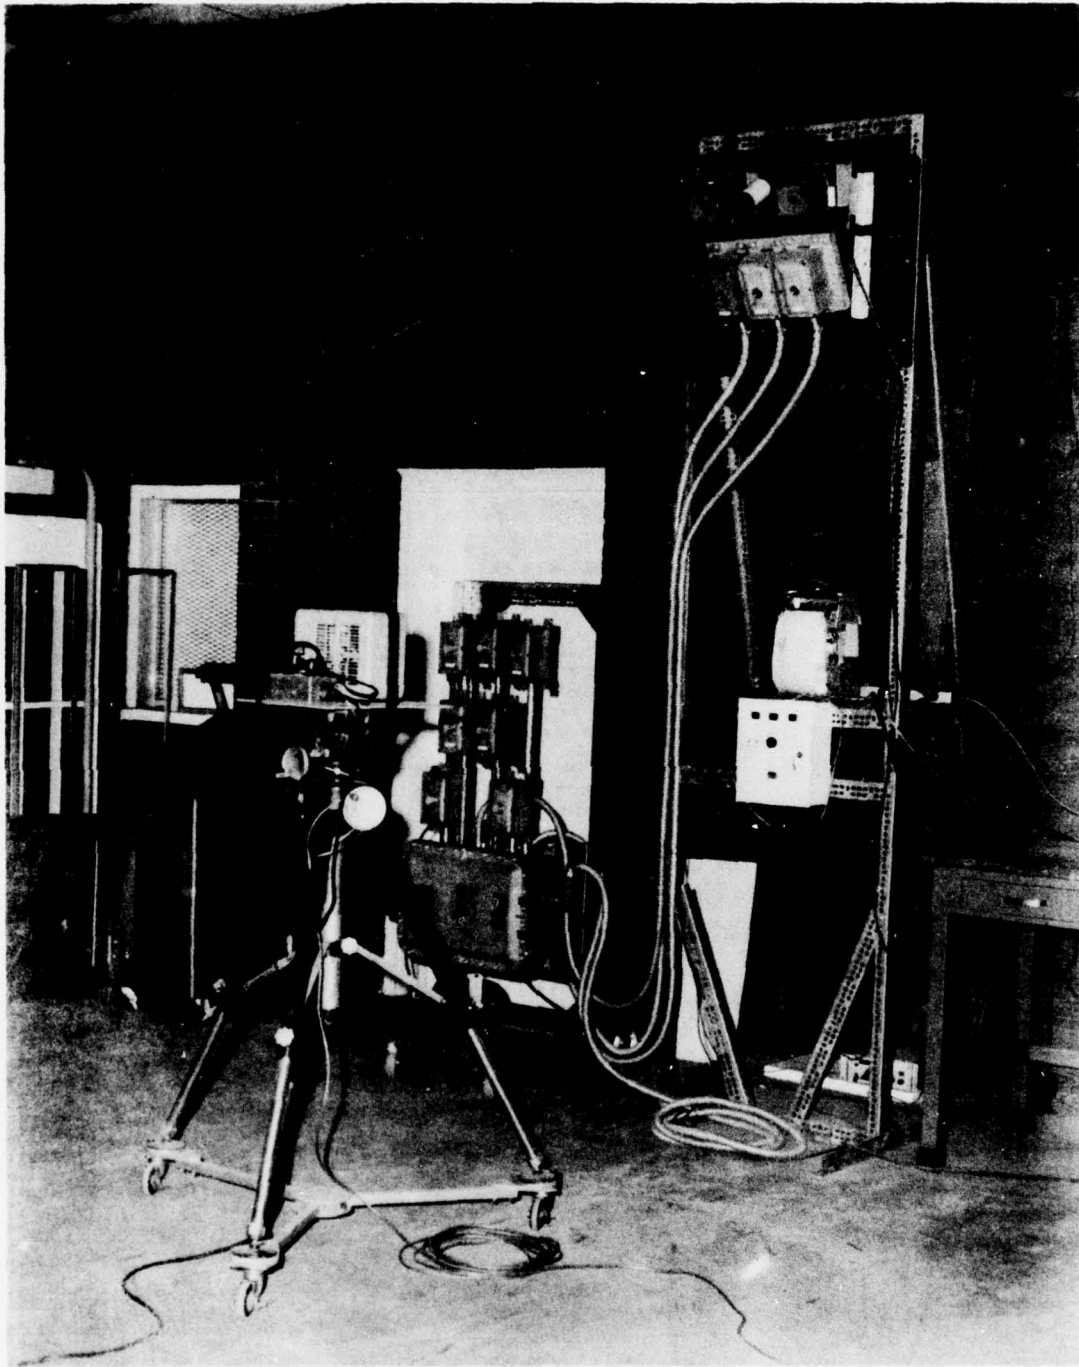
Figure 17. Testing sensors using a portable space heater.

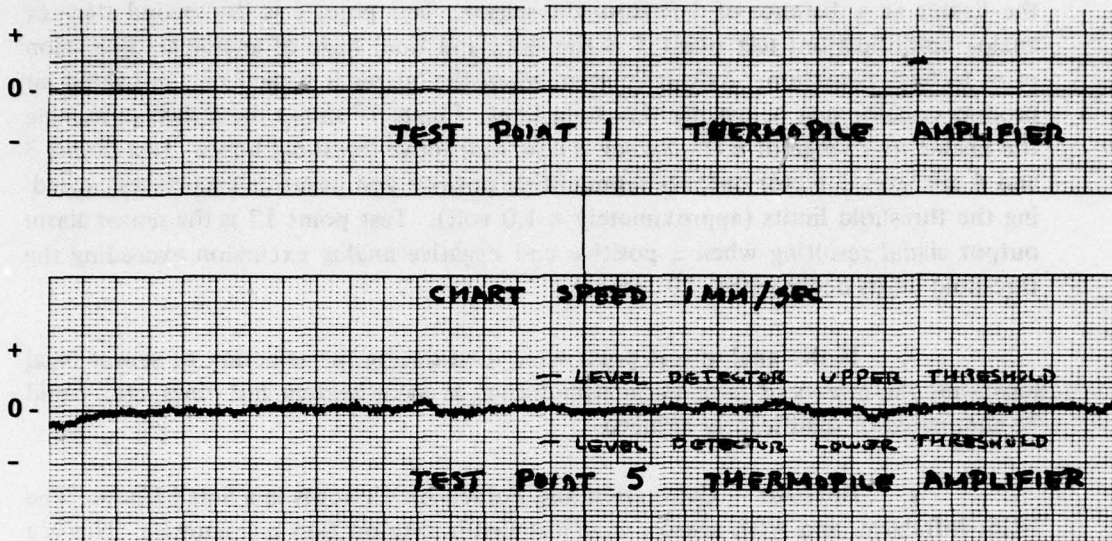
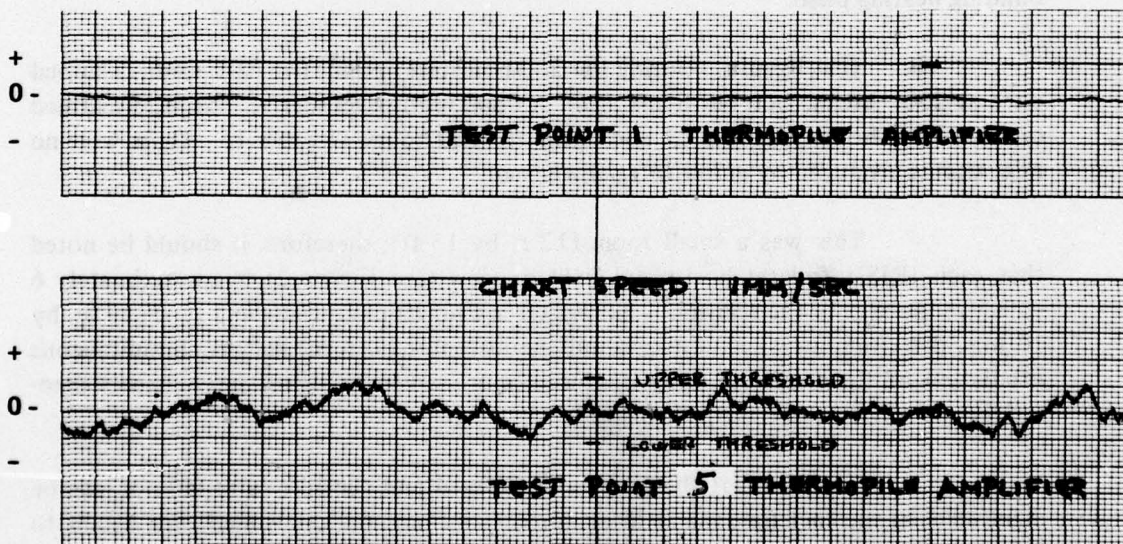
2. Heater turned off.

3. Heater turned on.

Figure 18. IRIS analog response to space heater at 4 ft.

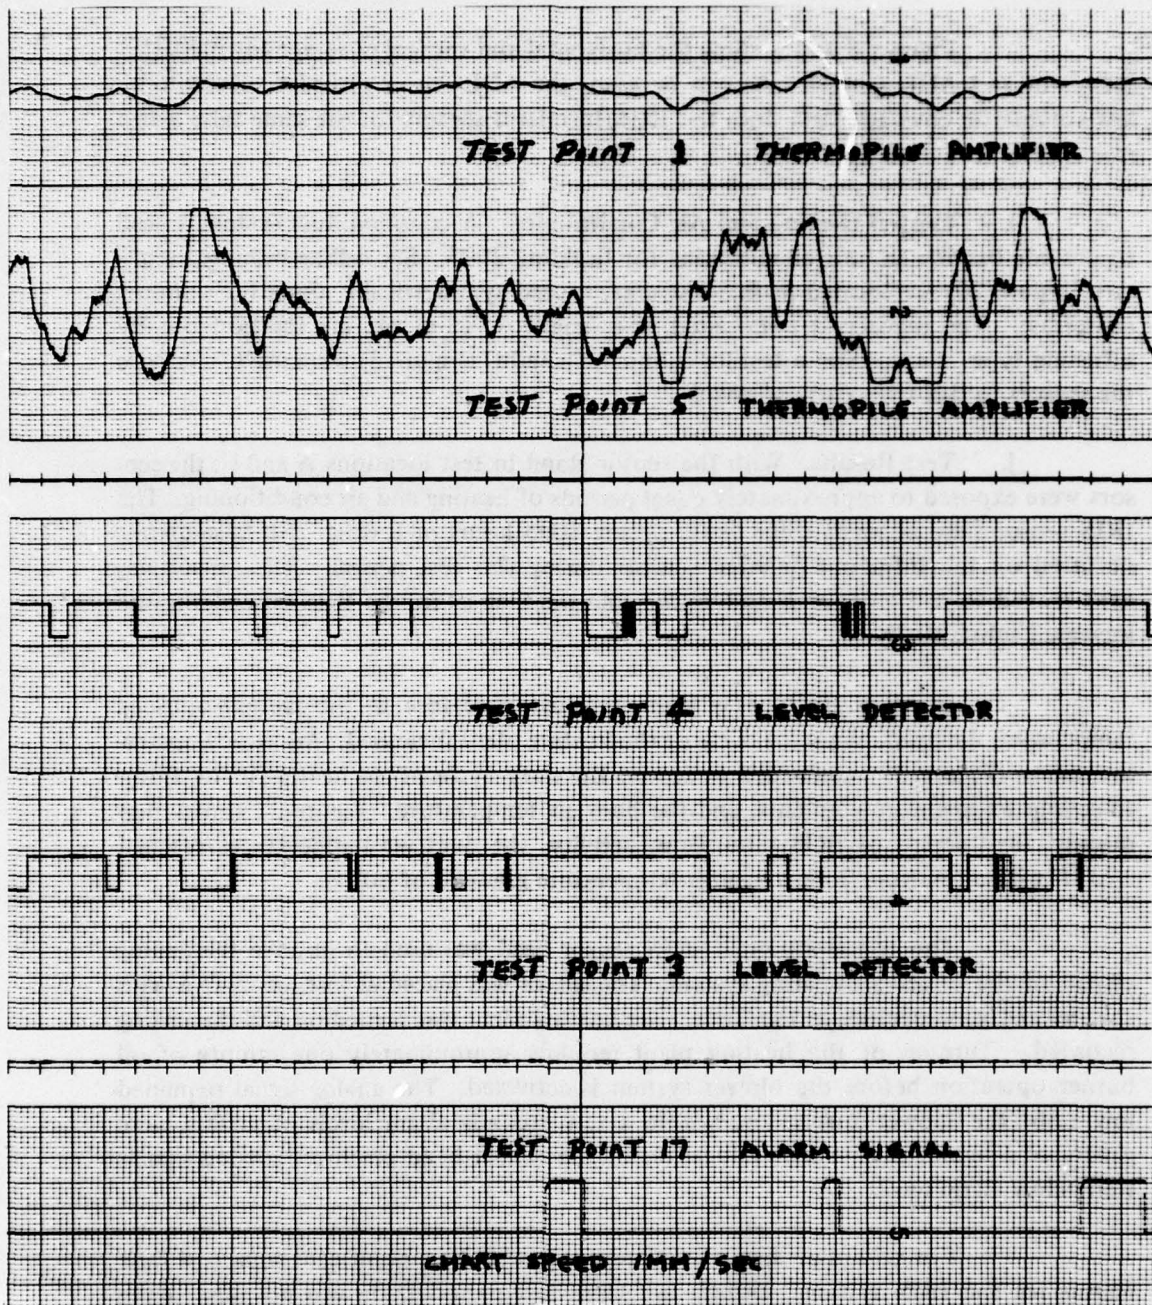
1. Portable heater (1650 watt) located 6 feet from sensor head. Air movement across sensor field of view.

Figure 19. IRIS analog response to space heater at 6 ft.
