14 MERADCOM -  
Report 2237

6 INFRARED MOTION SENSOR EVALUATION

U.S. ARMY MOBILITY EQUIPMENT  
RESEARCH AND DEVELOPMENT COMMAND  
FORT BELVOIR, VIRGINIA

20. ABSTRACT (Continue on reverse side if necessary and identify by block number) This report describes the test program performed by MERADCOM to determine the performance and reliability of model 19-115 Infrared Intrusion Sensor (IRIS). Three commercial infrared sensors were included in the test program to establish a base for comparing the test data. Each sensor was subjected to detection, nuisance alarms, electromagnetic interference (EMI), and temperature to determine each sensor's operating effectiveness when exposed to these conditions. The report describes each test performed and gives detailed performance data for each sensor.

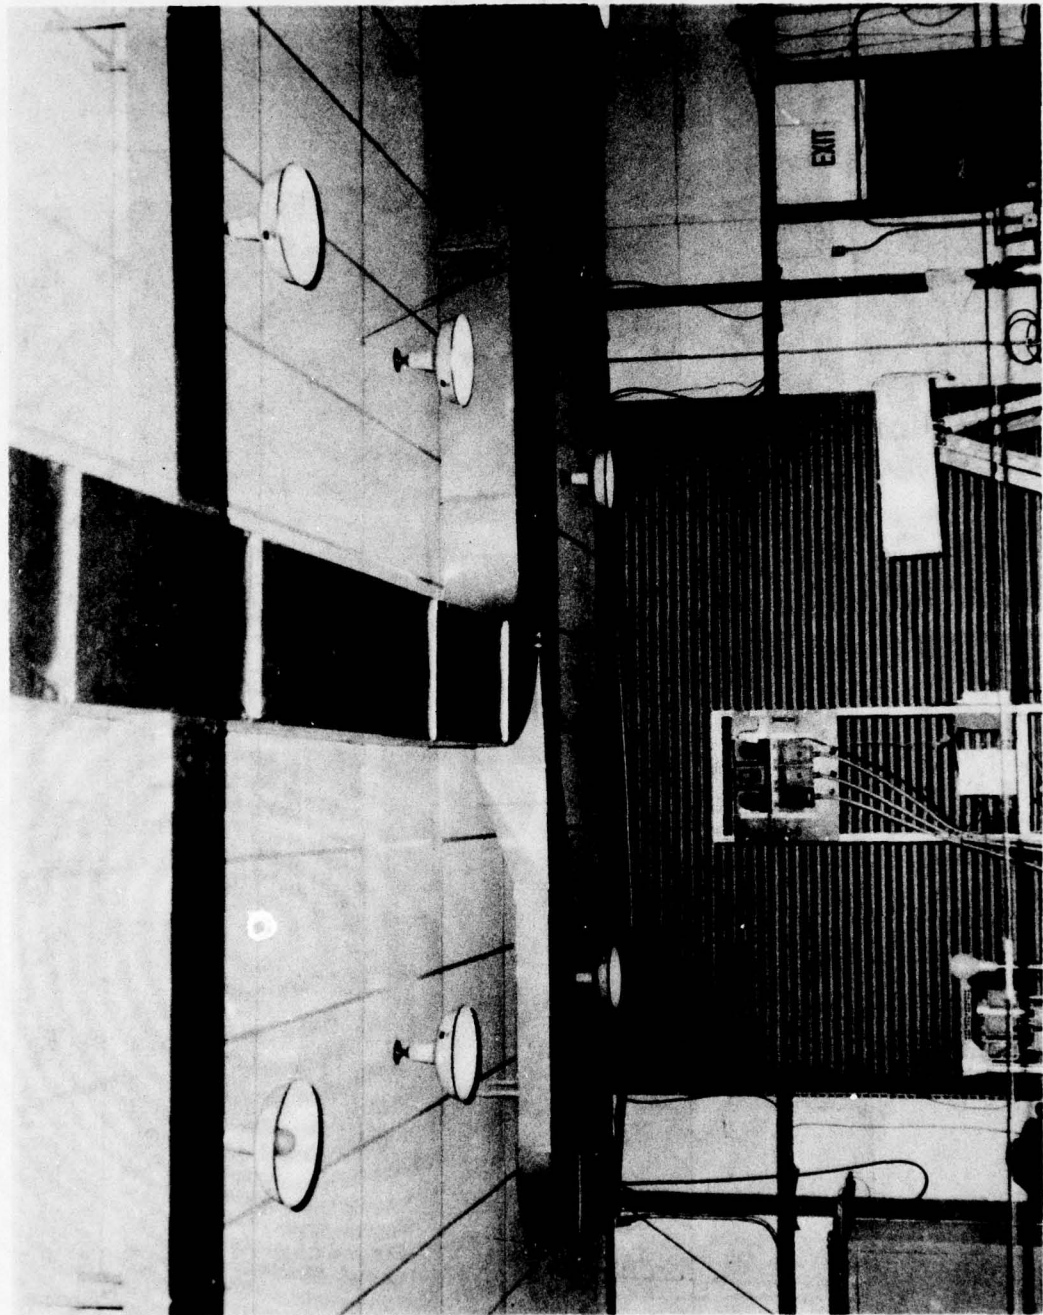
Figure 20. Building 2093 duct system.

i. **Central Heating and Air Conditioning.** A common duct system is used to provide heating and air conditioning for Building 2093. Six ceiling-mounted registers (Figure 20) are located in this test area, spaced symmetrically along the building centerline. The registers are mounted at a height of 12 ft and are the horizontally diffusing type. Sensor stand test locations A, C, and D (Figure 3) were used to expose the sensors to this false alarm stimulus.

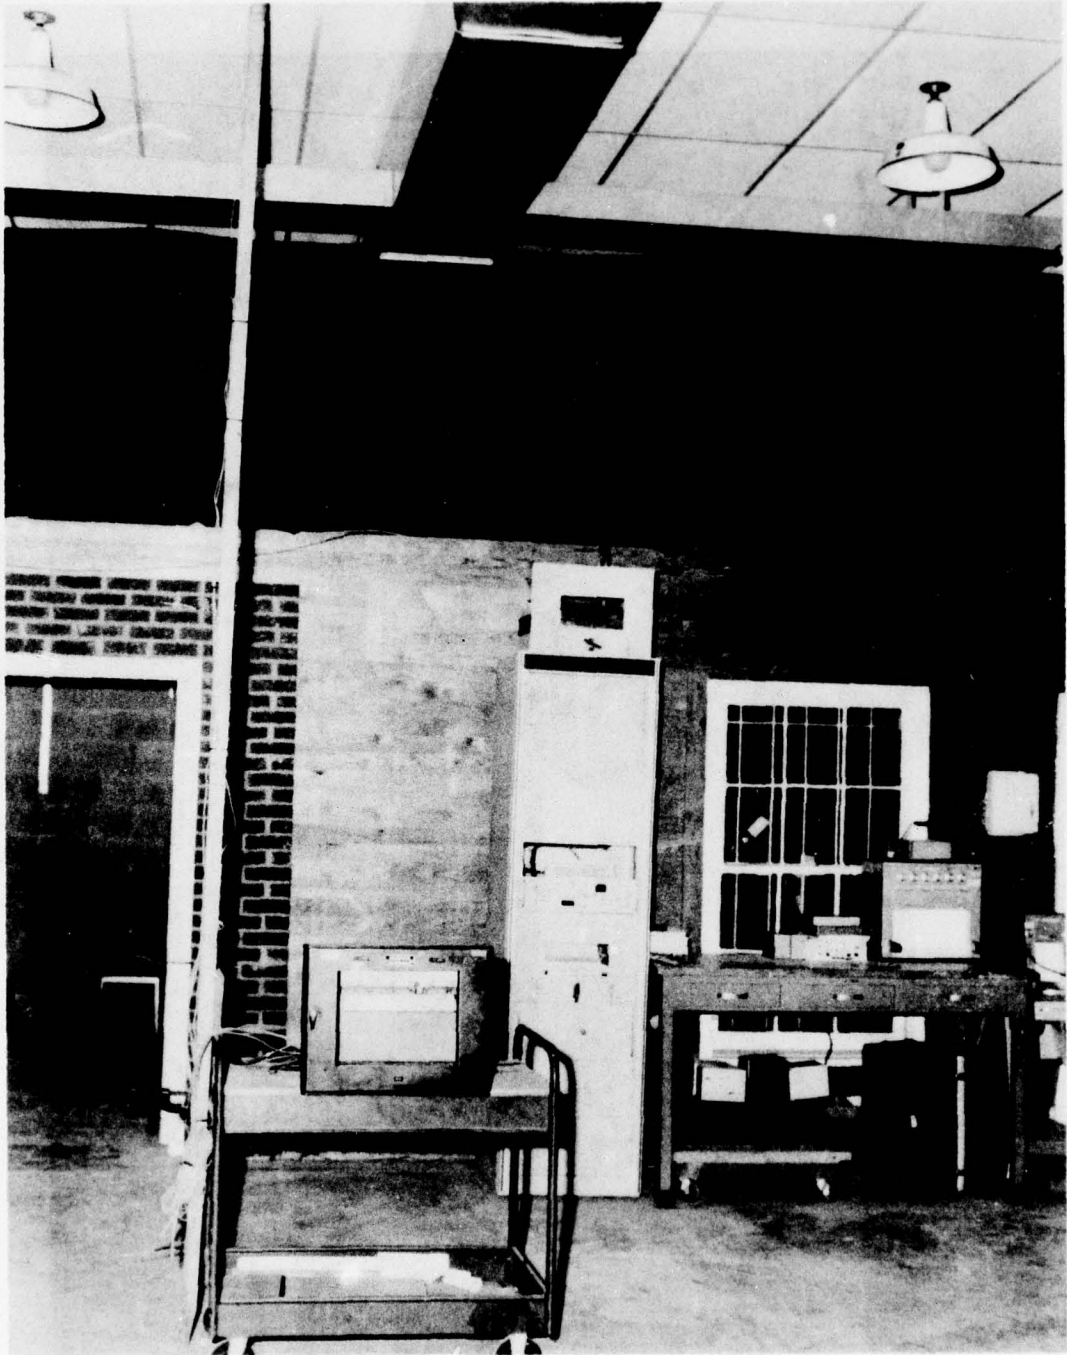
Figure 21. Temperature gradient test equipment.

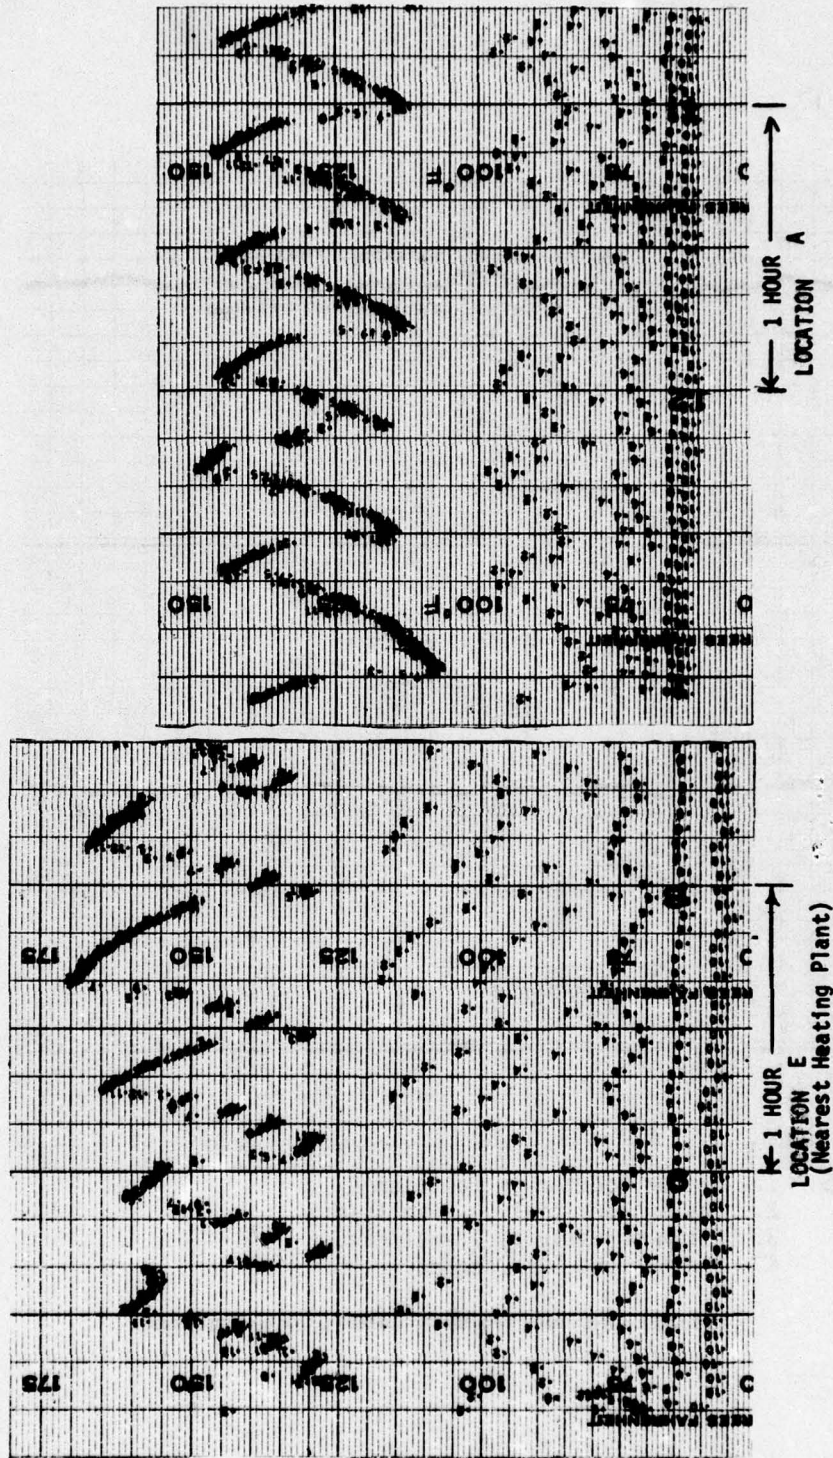
- NOTES:
1. Thermocouples 2,4,6,8 & 10 are uniformly spaced between ceiling and floor.
  2. All odd number channels represent a single thermocouple installed in the duct register nearest the test position.

Figure 22. Chart recording of temperature gradients for Building 2093.

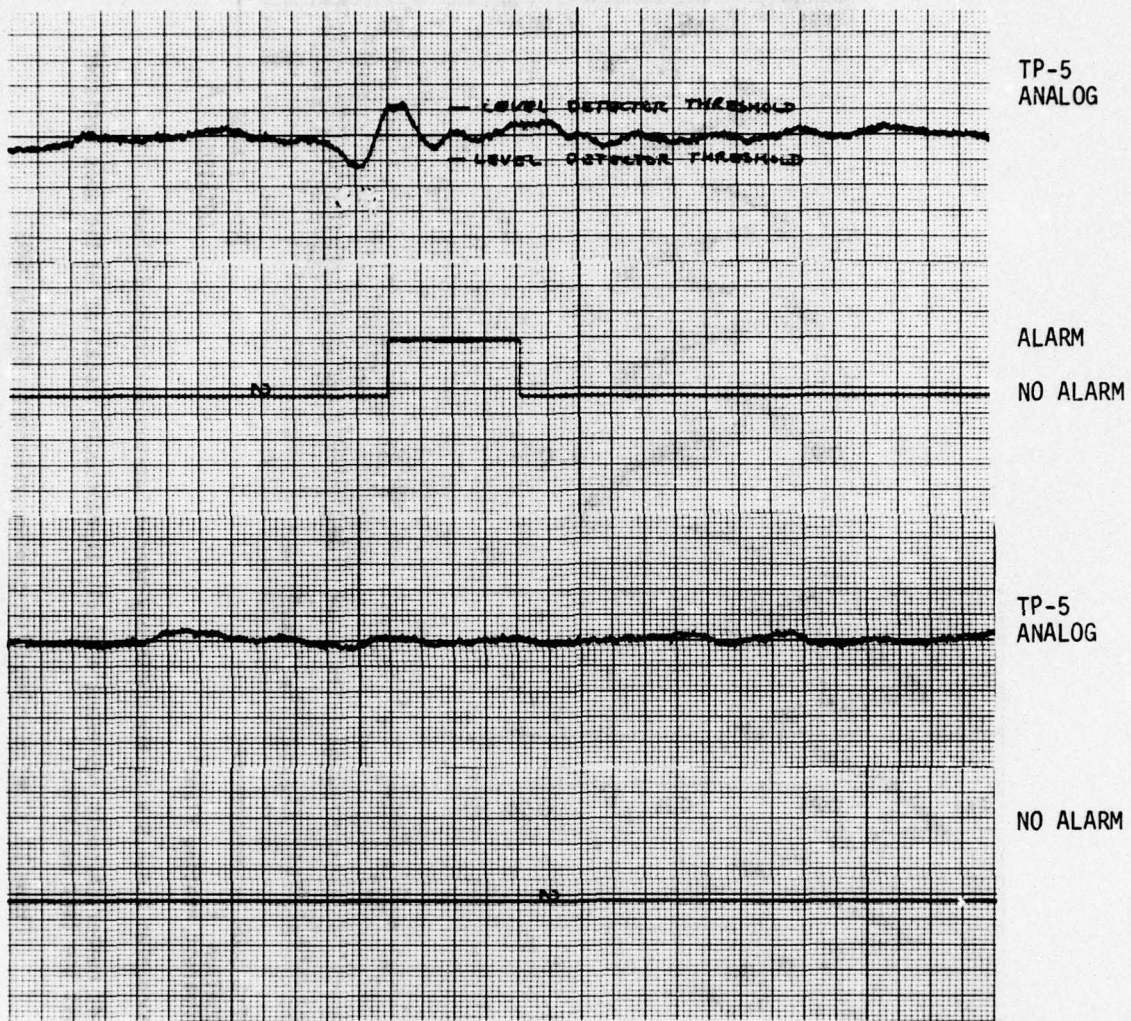
- NOTES: 1. Sensor located in Position A  
 2. Analog sensitivity .2 volts/div.  
 3. Alarm sensitivity 1 volt/div.  
 4. Chart speed 1 mm/second.

Figure 23. IRIS analog response to forced hot air heating system.

The tripod-mounted IRIS sensor head was used to observe the analog effects of the forced-air heating system. The sensor was placed at test location A with the field of view parallel to the floor. The heating plant was turned on and the analog recorded. Turn-on of the heating plant requires approximately one minute of oil burner operation before the blower system is activated. The analog signal remained low until the blower turned on; within a few seconds alarm levels of analog were generated (Figure 23). Slight relocation of the sensor head produced analog signals well below alarm level.

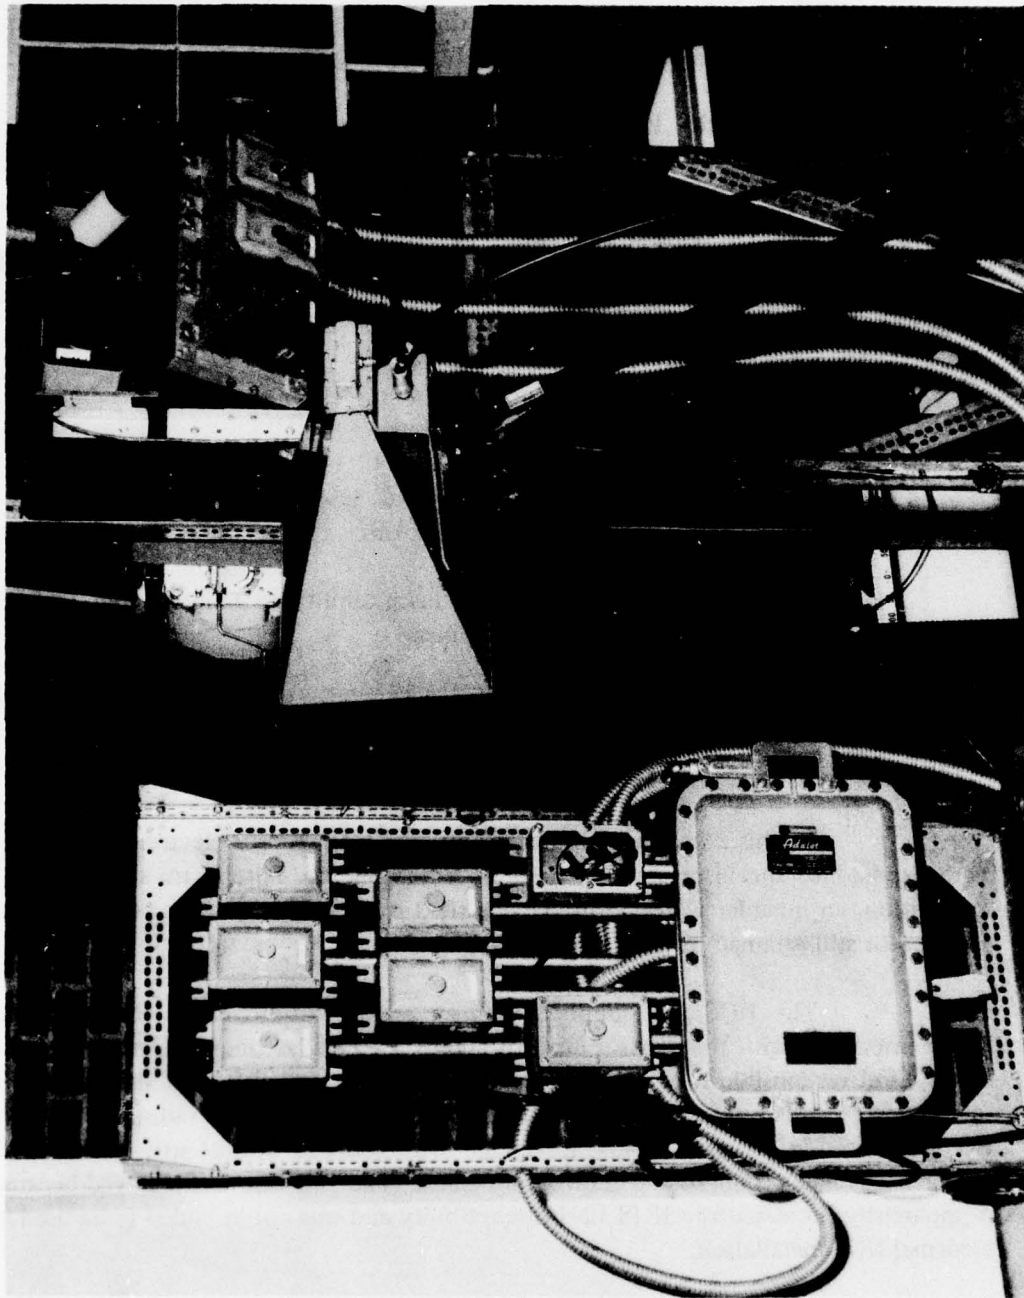
Figure 24. Sensor orientation during high-frequency EMI testing.

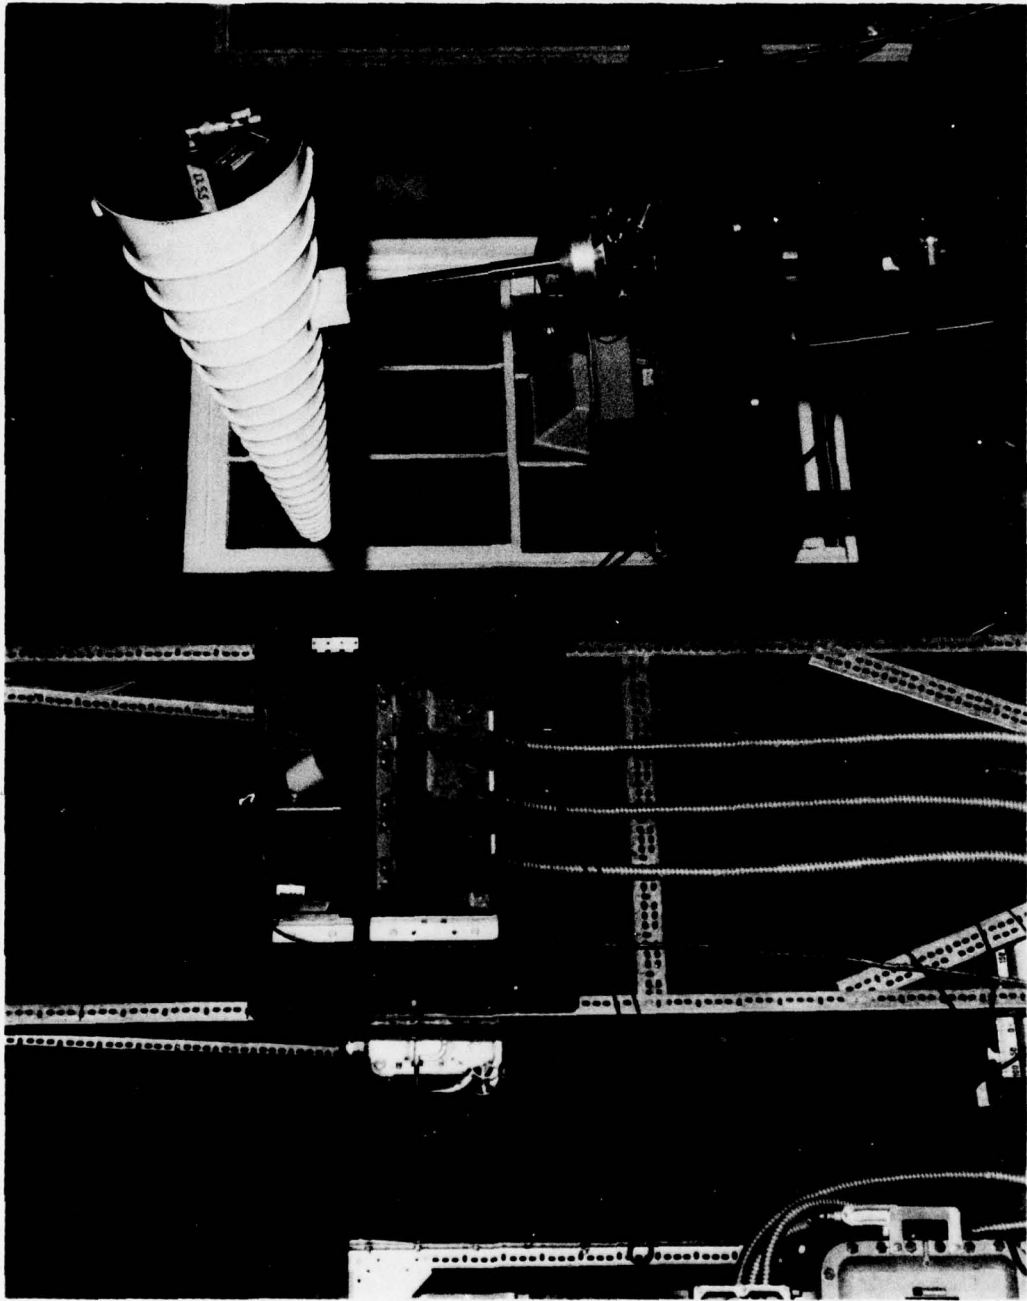
Figure 25. Sensor orientation during medium-frequency EMI testing.

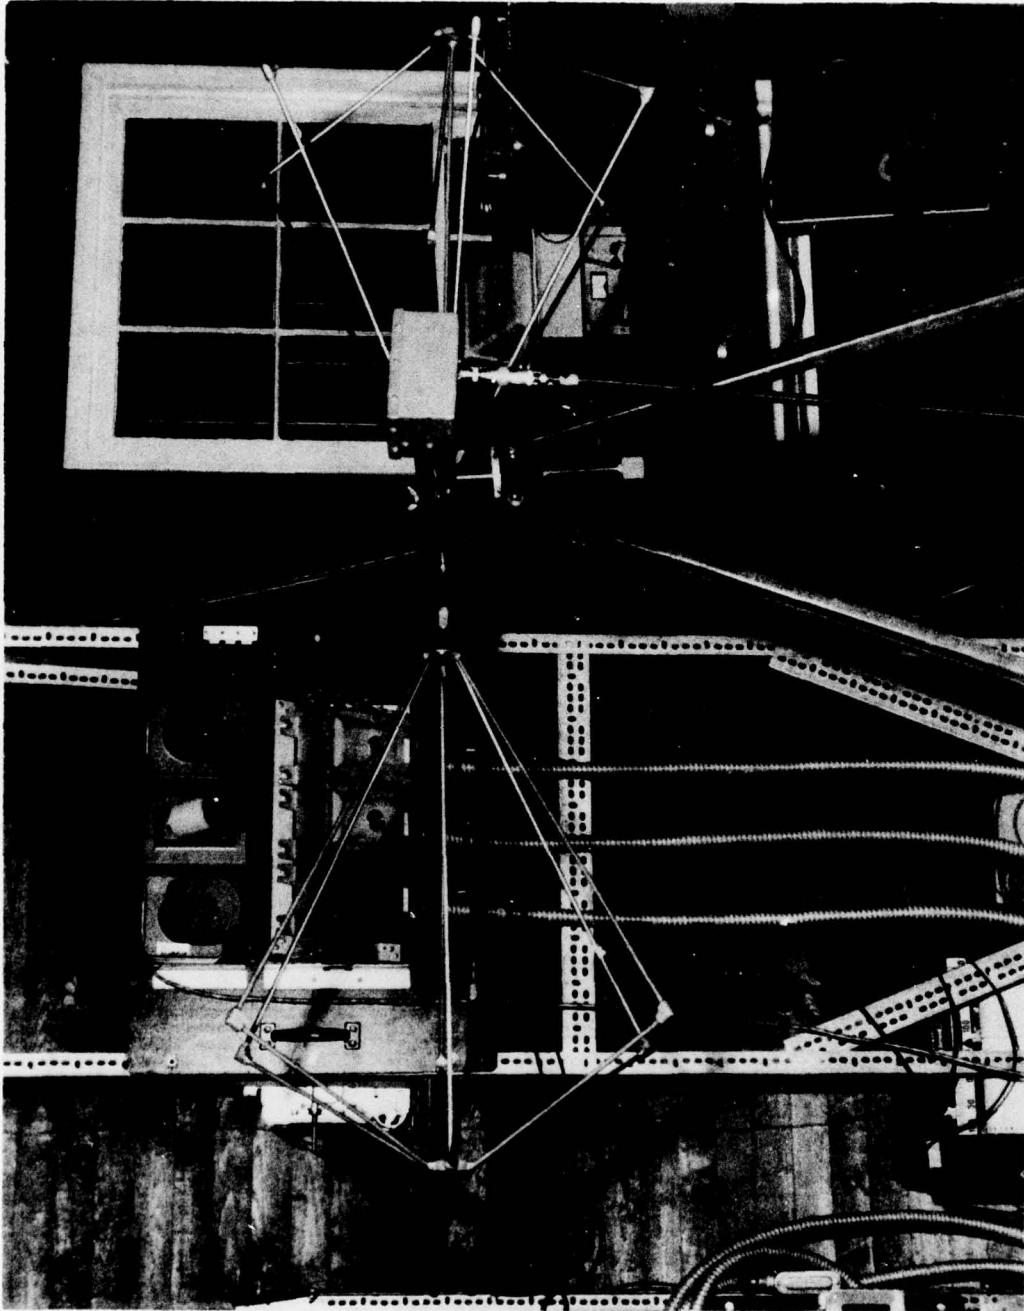
Figure 26. Sensor orientation during low-frequency EMI testing.

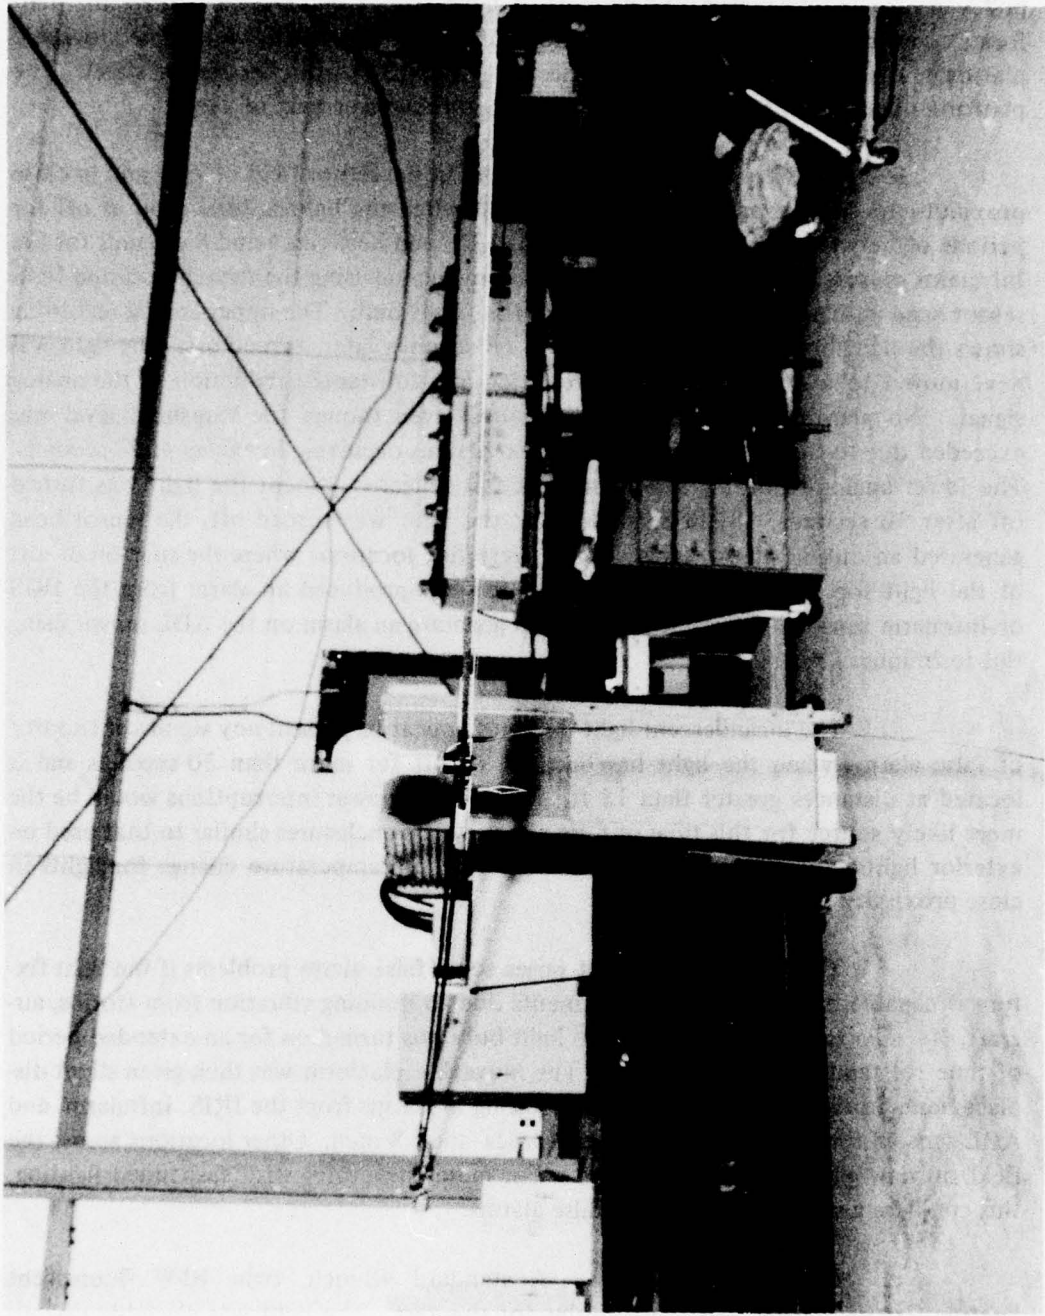
Figure 28. Moveable platform test fixture.

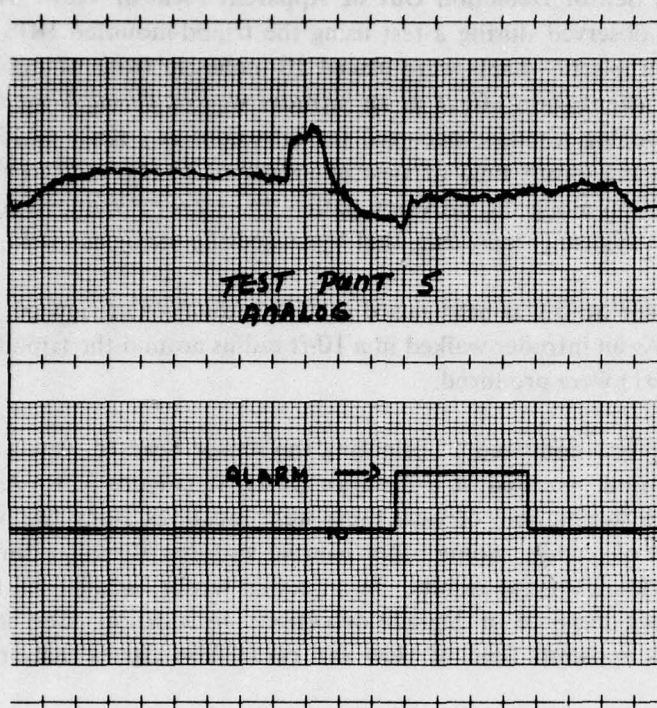
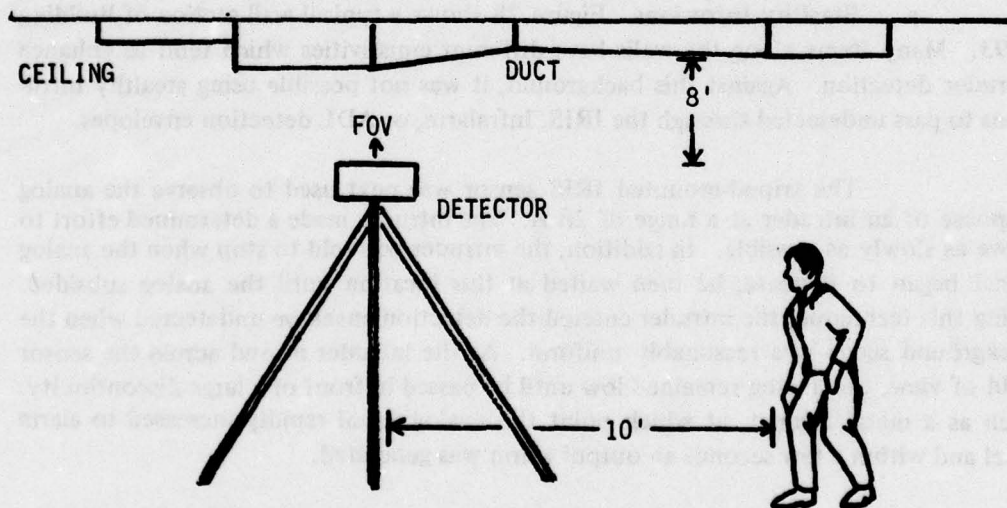
1. Detector field of view facing ceiling mounted duct constructed of galvanized sheet steel.
2. Detector mounted 6' high and intruder moving on 10' radius around detector.

**Figure 31. IRIS analog response (duct reflection) for intrusions out of the apparent field of view.**

**12. Infrared Sensor Detection Out of Apparent Field of View.** An interesting phenomenon was observed during a test using the tripod-mounted IRIS sensor head. Plexiglas and other plastic sheets were placed 18 inches in front of the sensor optics to determine the attenuation effect as an intruder walked through the field of view. For plexiglas, no analog response occurred for intrusions at a range of 15 ft. Another individual crossing the sensor field of view at a range of 28 ft produced alarm levels of analog at one location along the intrusion path – the sensor responded to a reflection, off the ceiling duct system (Figure 20), that by-passed the plexiglas shield.

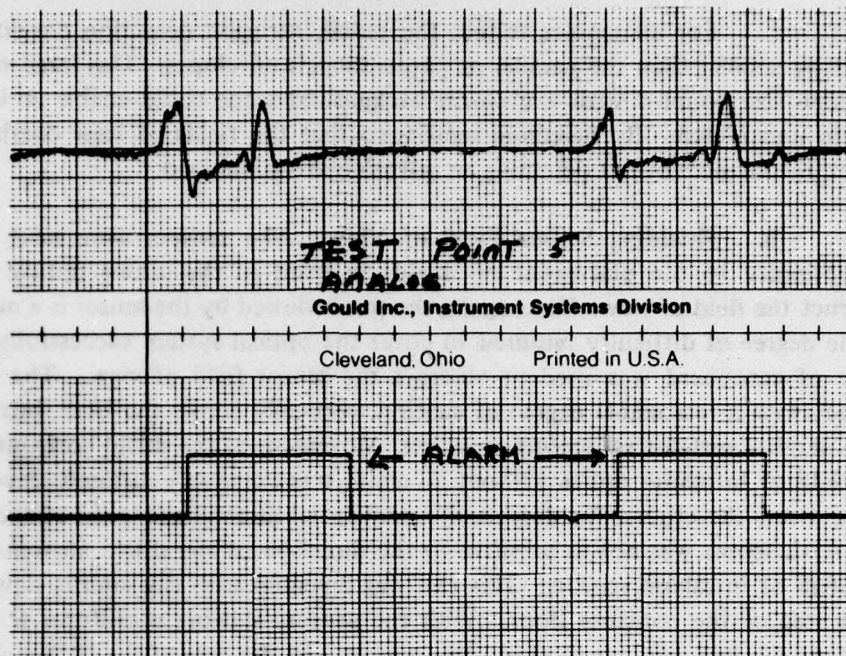
1. Detector facing flat painted metal surface.
2. Human target passes behind detector assembly.

**Figure 32. IRIS analog-response (office partition reflection) for intrusions out of the apparent field of view.**

Another test consisted of orienting the sensor head to view a row of sheet metal office partitions located at a distance of 12 ft (Figure 32). As an intruder walked behind the sensor field of view there were locations along the path that produced alarm levels of analog. Some other painted surfaces of similar dimensions were also tested with widely varying results. In an actual sensor installation, the reflection pattern could either improve or degrade detection. In addition, false alarm stimulus not in the sensors apparent field of view can cause false alarms that are difficult to resolve.

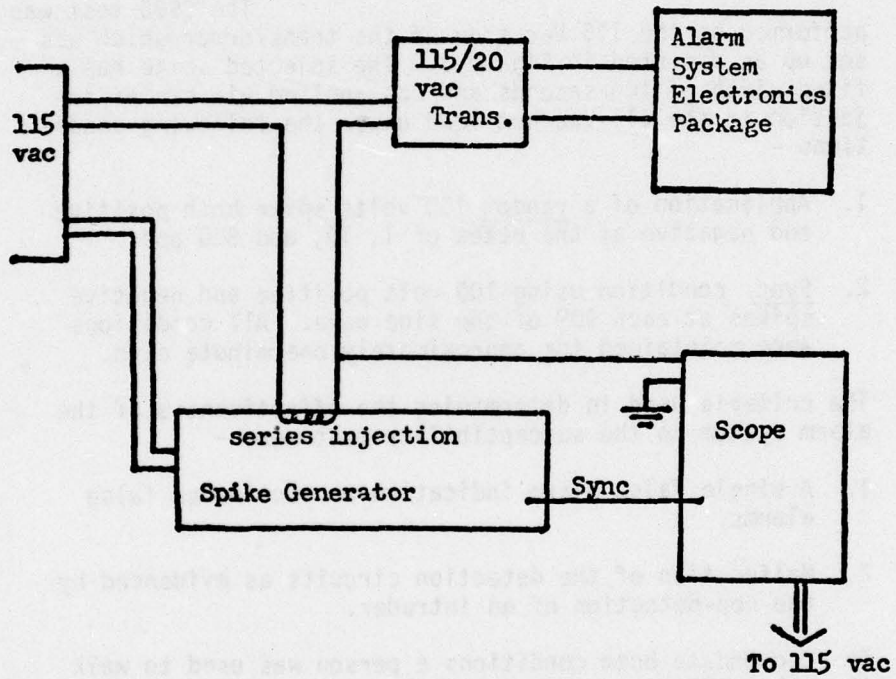
Typical Setup for Method CS06, Spike Susc.- Power Leads

If a response was observed, the amplitude of the spike and/or the repetition rate was decreased until the system returned to normal operation. The threshold of susceptibility was recorded on the data sheets.
