AFML-TR-78-7

ANODIZE OPTIMIZATION AND  
ADHESIVE EVALUATION FOR  
REPAIR APPLICATIONS

Seattle, Washington 98124  
Boeing Commercial Airplane Company

Interim report for period December 1976-September 1977

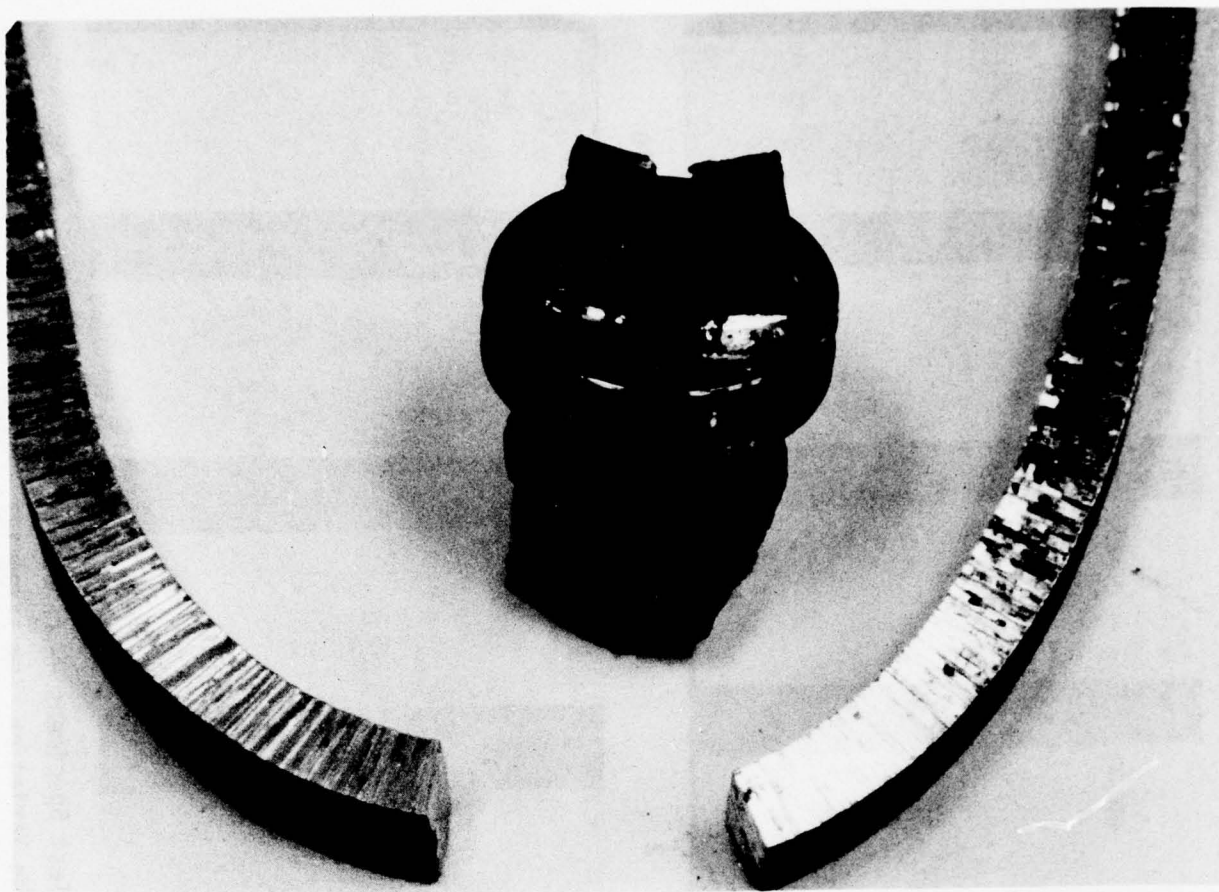
Figure 7 Typical SEM Specimen Mounted on Viewing Stub

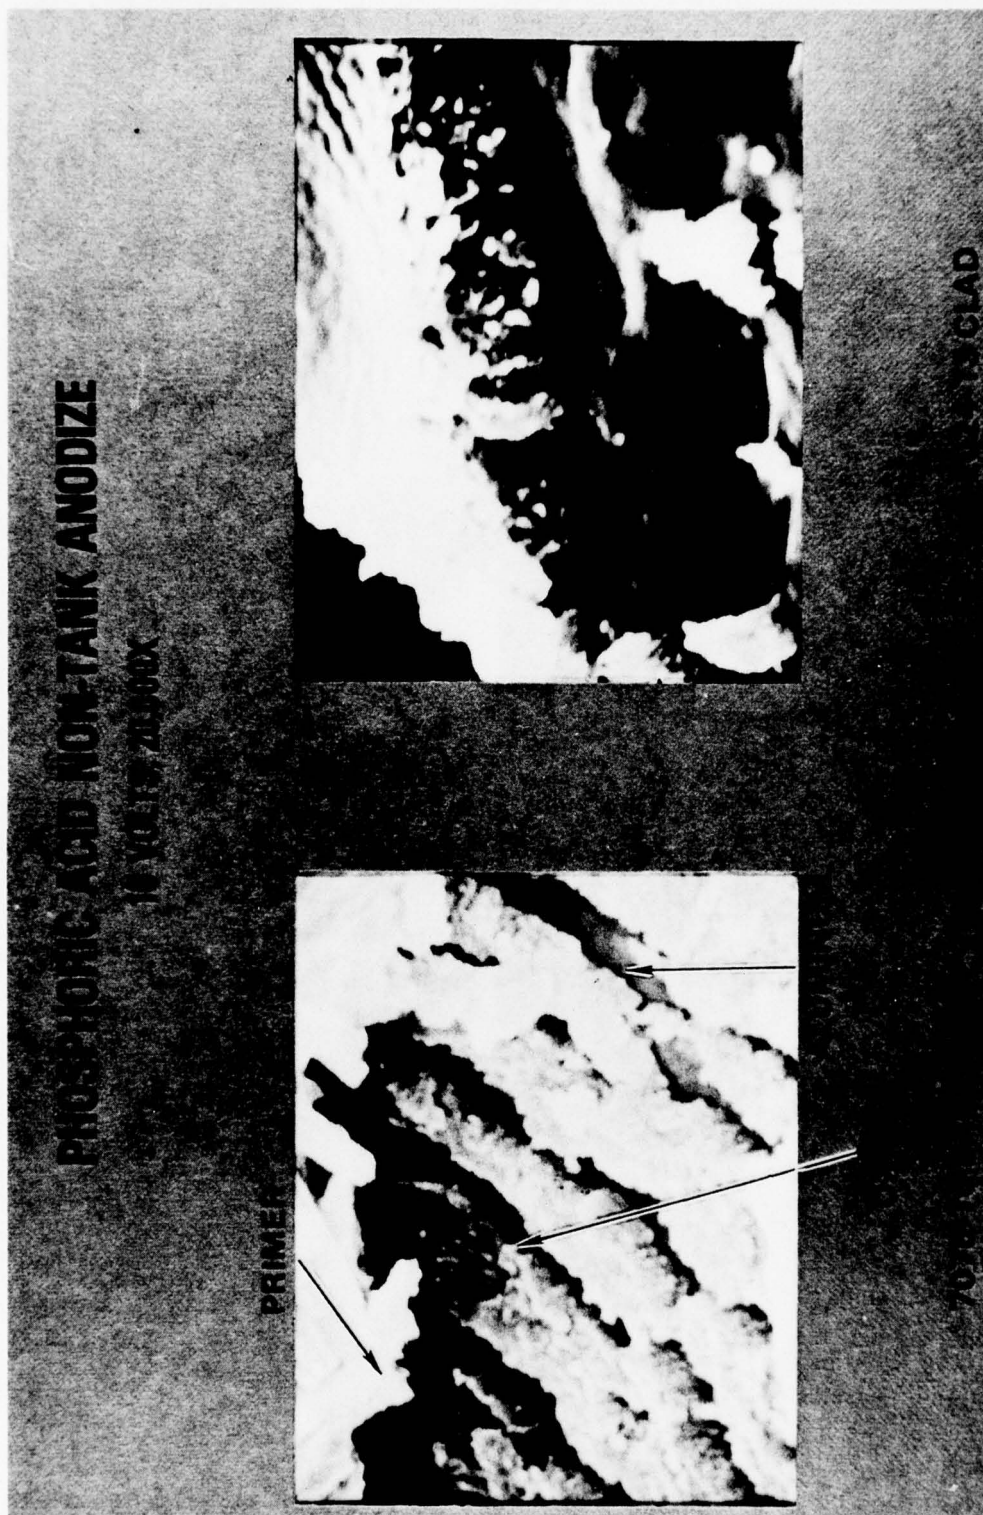
Figure 9 SEM Photomicrograph of Oxide

Oxide thickness measurements were taken from the 20,000X photomicrographs. Figure 9 shows typical views of the 7075-T6 bare and 2024-T3 clad anodized at 10 volts. The CIAP primer coating, oxide, and base metal can be observed rather easily. Figures 10 and 11 show the effects of anodizing under different voltages (from 1 to 10) on the oxide thickness and appearance on 7075-T6 bare and 2024-T3 clad. Little oxide formation is noted at 1 volt. Oxide buildup is increased at 2 volts, but is still quite nonuniform until 4 volts. From 4 to 10 volts, oxide thickness is increased and rather uniform. Figure 12 is a plot of the measured oxide thickness from the photomicrographs, and plotted versus voltage variation. The values for the 1- and 2-volt conditions were from measurements on the 2024-T3 clad surfaces. Inadequate resolutions were obtained on the 7075-T6 bare surface at these voltage levels, and oxide appearance suggests nonuniform or thin oxide formation.

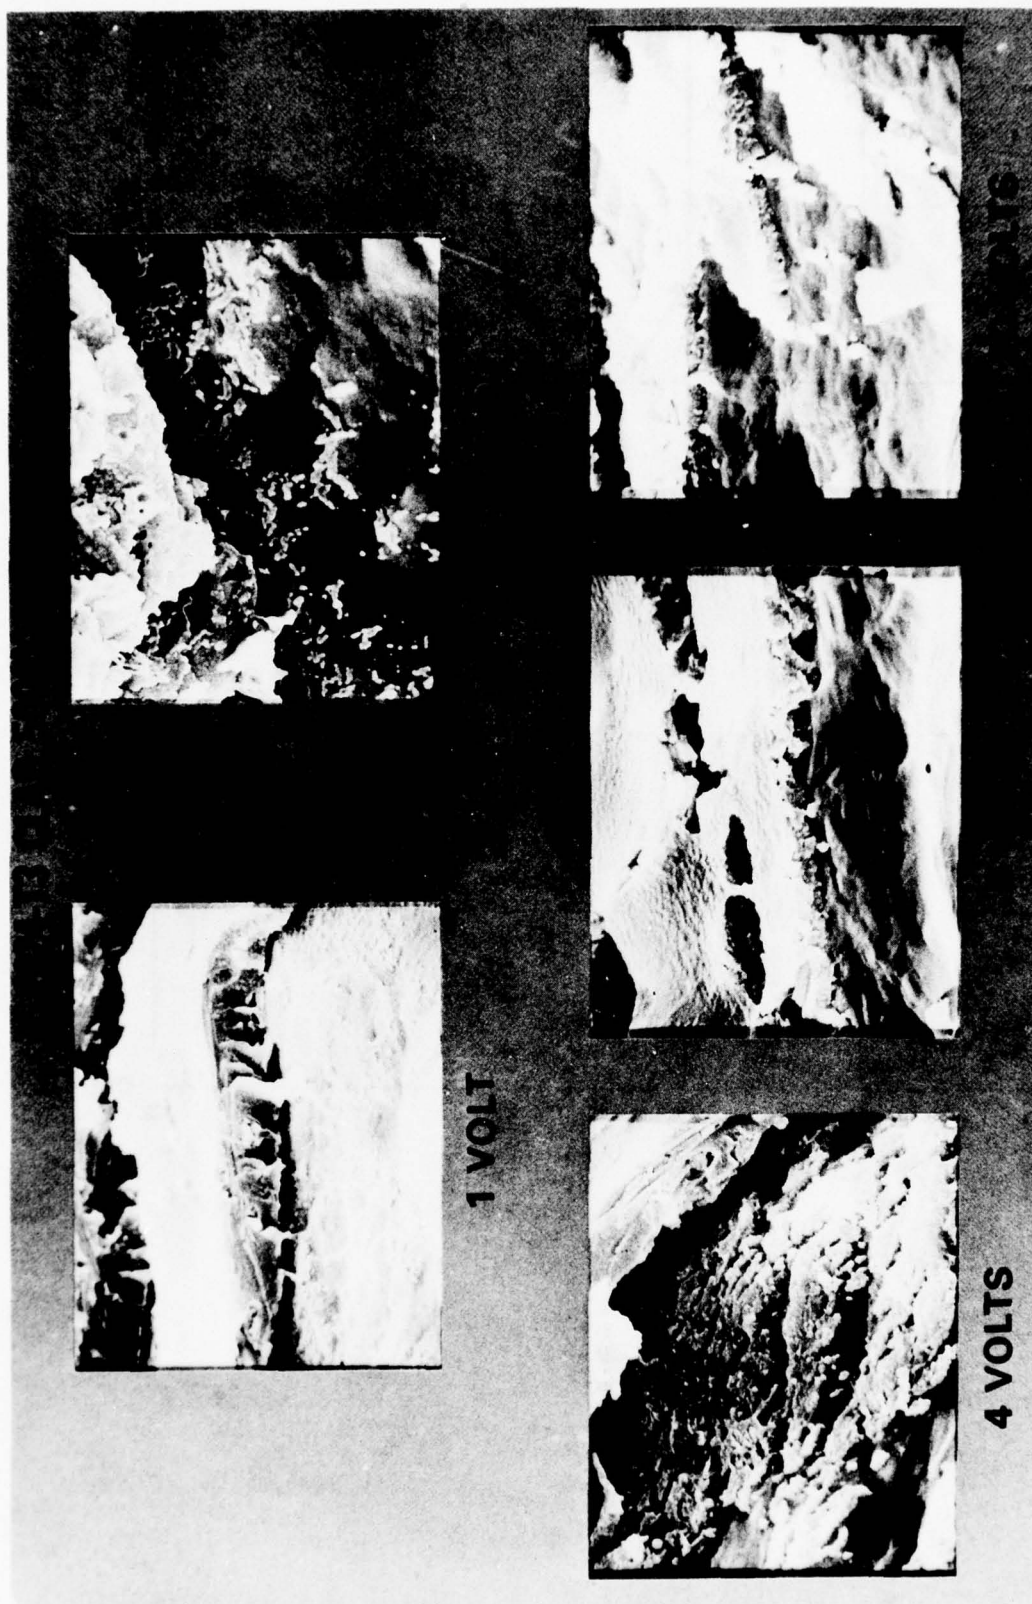
Figure 11 SEM Photomicrograph of Oxide as a Function of Voltage -- 2024-T3 Clad

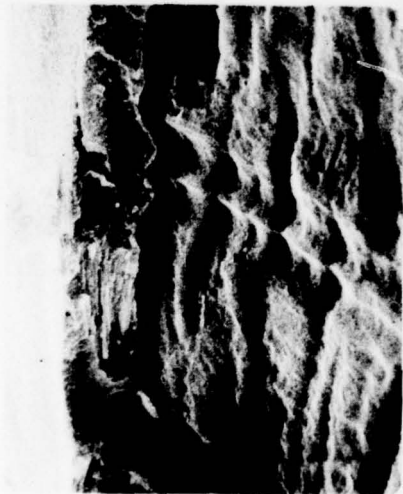
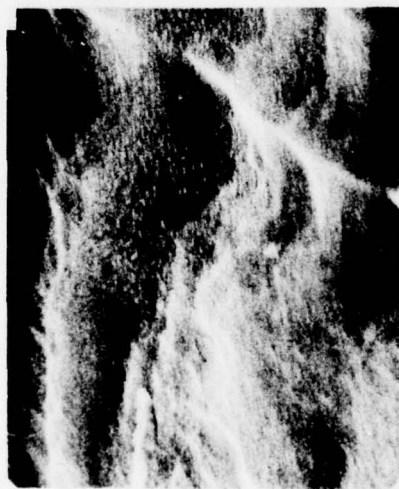
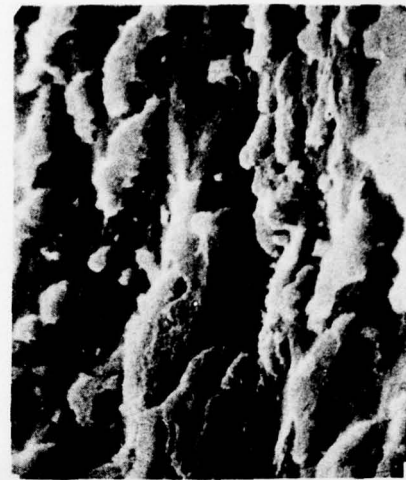
Figure 16 SEM Photomicrograph -- Anodized at 100°F -- 2024-T3 Clad

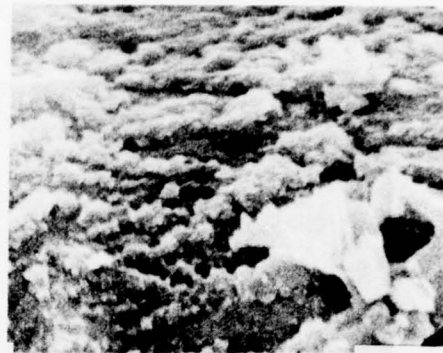
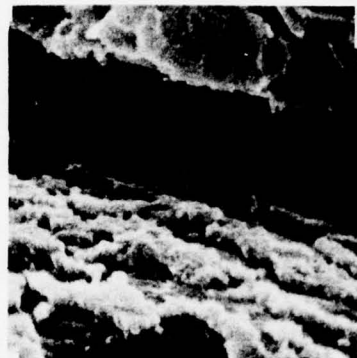
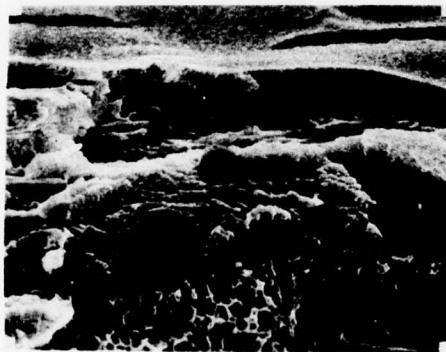
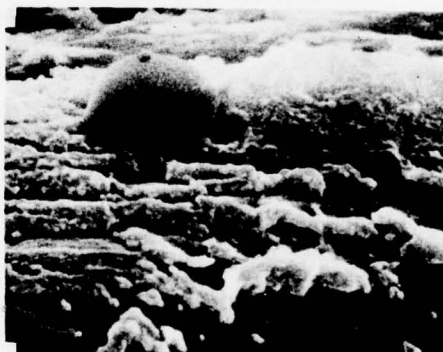
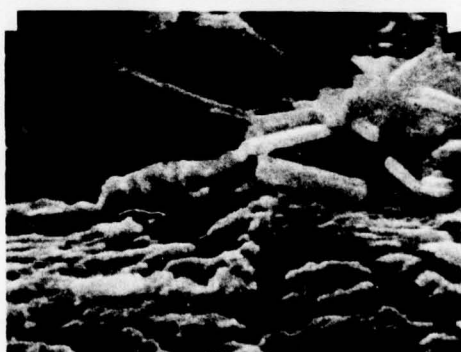
Figure 20 SEM Photomicrograph -- Anodize Time Variation -- 7075-T6 Bare

PRIMER

OXIDE

ALUMINUM

Figures 20 and 21 show the SEM photomicrographs of oxide cross-sections on the bare and clad alloys anodized at 4 volts for 1, 5, 15, and 20 minutes. These times represent low and high durations as compared to the baseline (10 minutes) condition. Oxide buildup as anodizing time is increased is quite apparent. It can be seen that specimens anodized for 1 minute showed comparatively thin, sparsely formed oxide layers as compared to those formed at 15 or 20 minutes, or the baseline 10-minute case (see figs. 10 and 11). These surfaces resulted in wedge test bond failures within 4 hours during exposure to 120°F/100% RH. Except for sporadic failures occurring in three 2024-T3 clad specimens anodized for 5 minutes, no other wedge test failures were encountered.

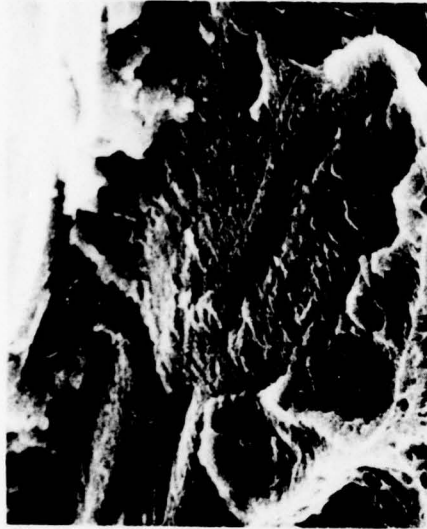
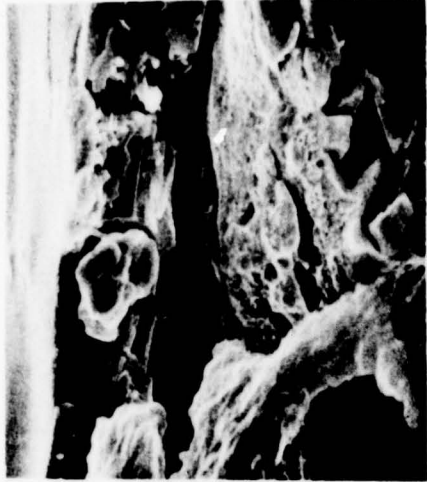
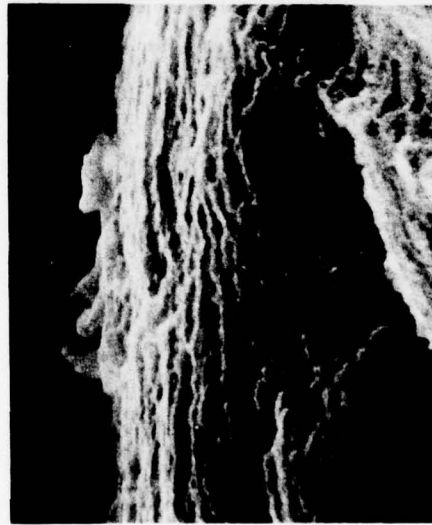
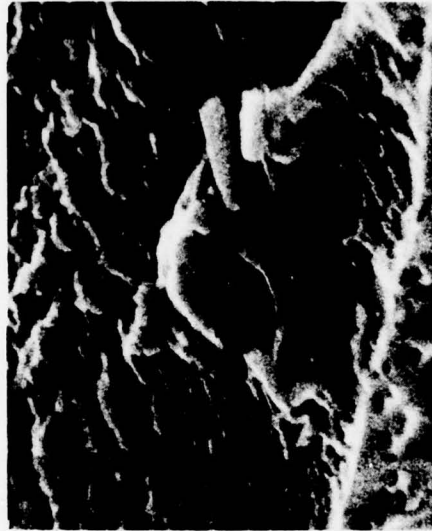
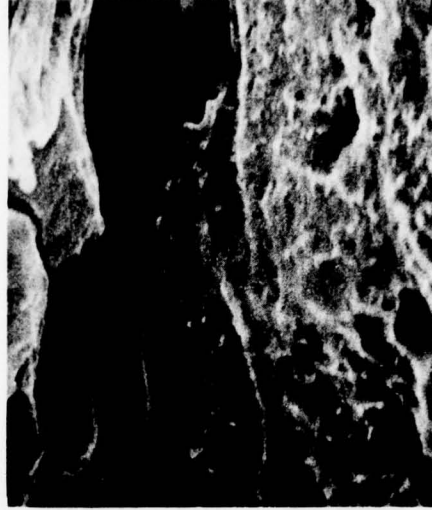
Figure 23 SEM Photomicrograph of Rinse Delay Time -- 7075-T6 Bare

As in earlier tasks, the SEM examination was made on fractured cross-sections of primed, anodized surfaces with rinse delay times of 2, 5, and 10 minutes. As shown in figures 23 and 24 for 7075-T6 bare and 2024-T3 clad, respectively, oxide dissolution is apparent for the 10-minute rinse delay surfaces as compared to the 2-minute delay or no delay cases (see figs. 10 and 11). In fact, for 7075-T6 bare, practically no oxide to sparsely scattered oxide is noted. This condition also resulted in adhesive failure modes and long crack growth in the wedge tests (table 8).

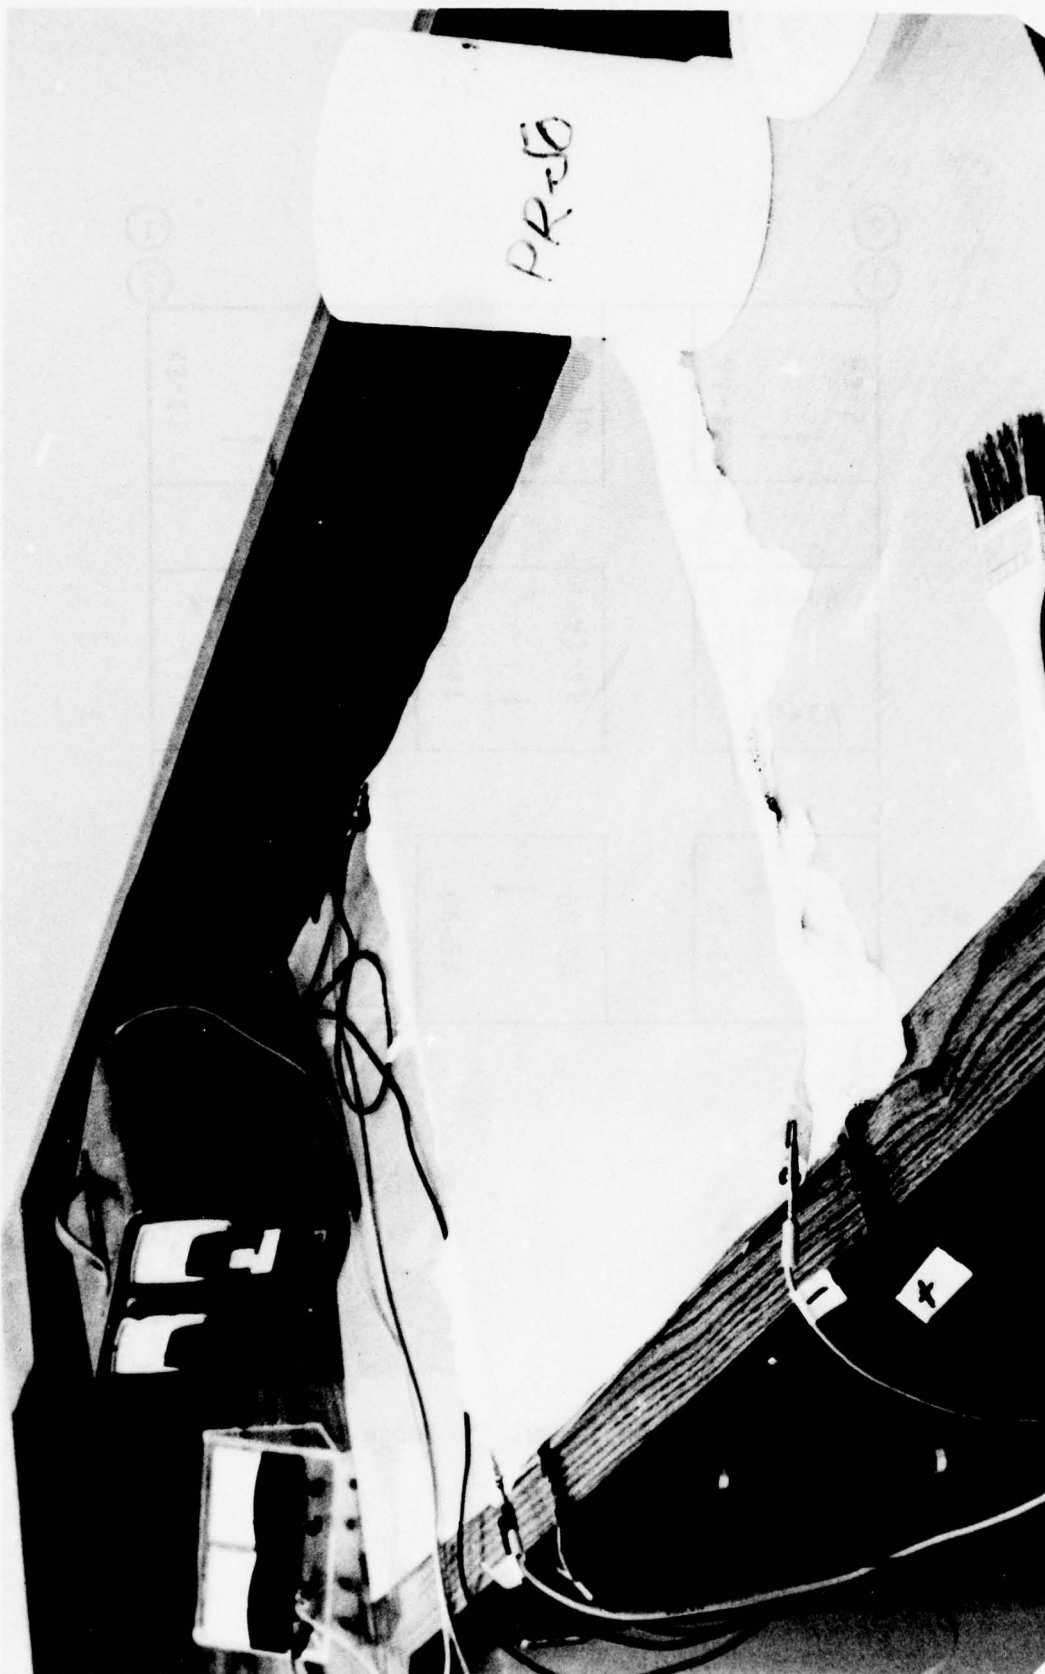
Figure 25 Setup for Anodizing 2- x 2-ft Panel

The objective of this task was to evaluate the effects of anodizing aluminum adherends for large-area repairs. Earlier work had focused on panels ranging from 6- x 6-inch to 14- by 17-inch wedge and metal-metal peel assemblies. In the current effort, two panels, 24 x 24 inches, were anodized. Electrical contacts were arranged on the four corners of the panels and stainless steel screen, as shown in figure 25.

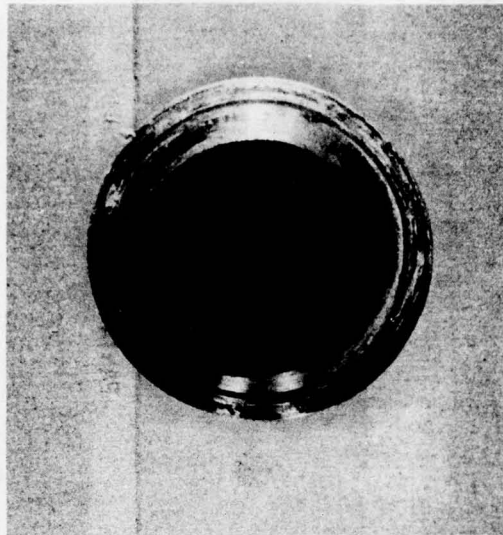
Figure 34 Salt Spray Exposure -- Fasteners Removed

Figure 33 shows the specimens after 14 and 30 days salt spray exposure. No significant changes were observed on the non-tank anodized area versus the untreated, control area. Closer examination of the countersunk area showed no significant difference in the corrosion characteristics, as illustrated in figure 34.

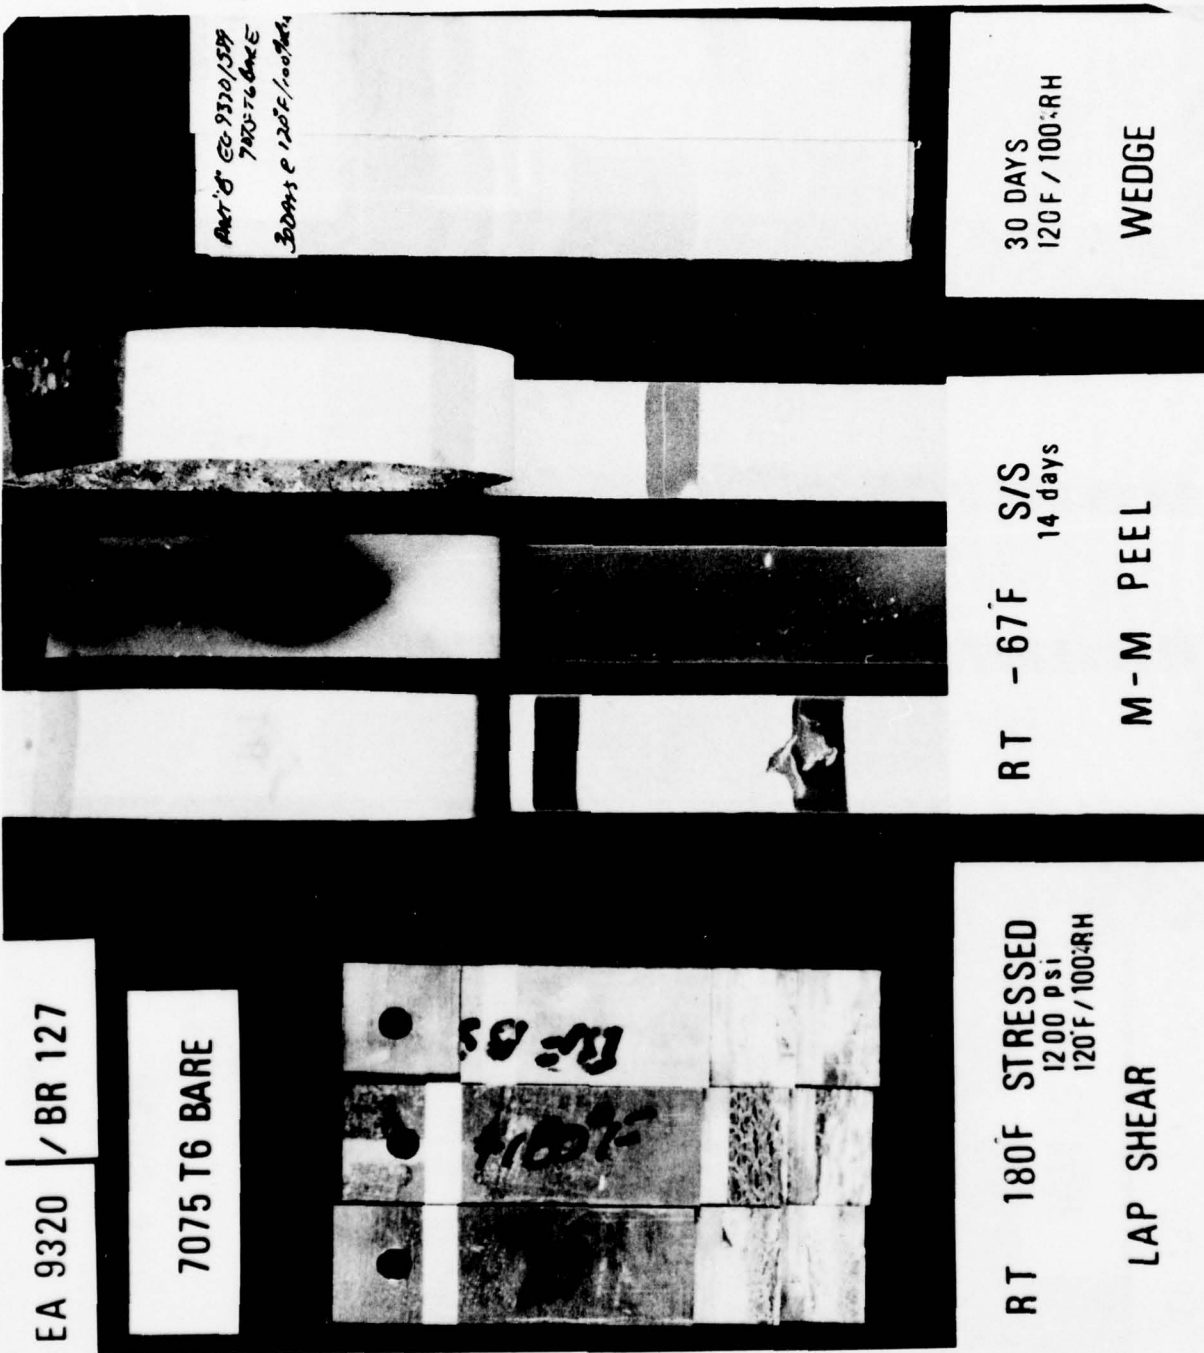
Figure 49 Specimen Bond Surfaces -- EA 9320, 7075-T6 Bare
