**EFFECT OF AN ELEVATED TEMPERATURE  
HIGH HUMIDITY ENVIRONMENT ON  
SCOTCH NO. 425 ALUMINUM TAPE.**

D. ROBERT ASKINS  
UNIVERSITY OF DAYTON RESEARCH INSTITUTE  
DAYTON, OHIO 45469

TECHNICAL REPORT AFML-TR-78-14  
Interim Technical Report November 1976 - October 1977

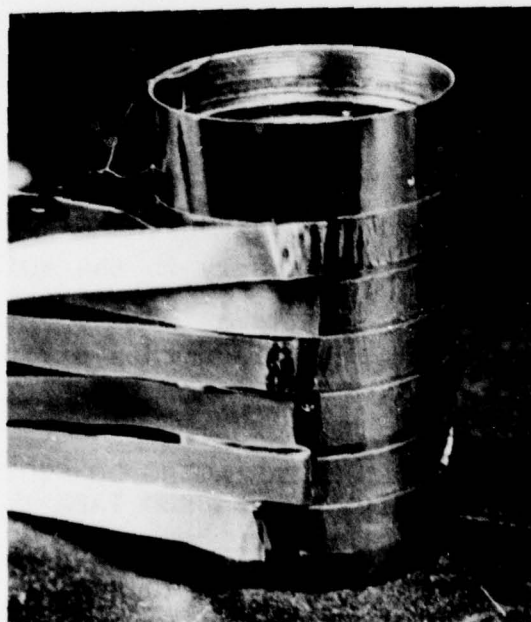
Figure 2. Fuse Body Peel Specimens.

One of these two, for each type surface plate, was used for unaged control peel tests and the other for peel tests after aging for either 60 or 120 days. Adhesive tape strips 1.27 cm (one-half inch) wide by about 50.8 cm (20 inches) long were applied circumferentially around the fuse bodies (three strips on the control and six strips on the body to be aged - see Figure 2). An 8.25 cm (3.25 inch) diameter rubber covered steel roller was used to roll the tape onto the fuse body. The adhered tape extended nearly completely around the fuse body (Figure 2).

(a) Control Specimen - Three Strips of Tape

(b) Specimen For Environmental Exposure - Three Strips to Be Tested After 60 Days and Three After 120 Days Exposure

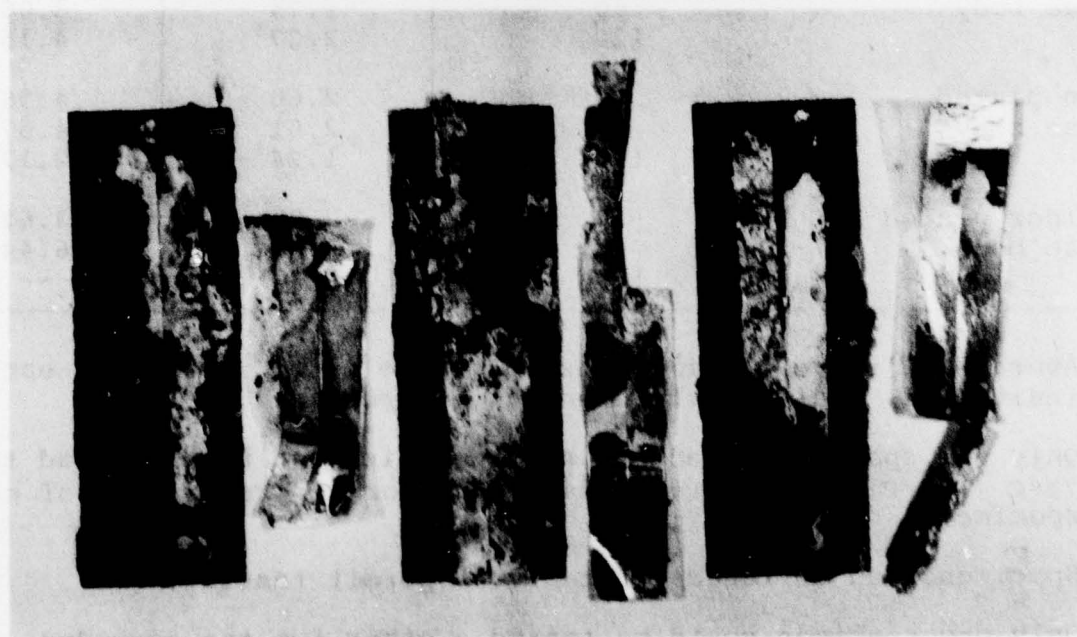
Figure 4. Appearance of Flat 1018 Steel Peel Panels After Aging at  $71^{\circ}\text{C}$  ( $160^{\circ}\text{F}$ ) and 75% R.H.

The environmental aging at 71°C (160°F) and 75 percent R.H. produced severe corrosion on the 1018 steel substrate panels. After 60 days, corrosion was visibly evident and peel strength had fallen 10 percent. After 120 days, corrosion was severe and the specimens could not even be tested.

(a) 60 days aging

(b) 120 days aging

The results obtained for all of the peel tests conducted during this program, including that one just described, are presented in Table 3. Figures 4 and 5 illustrate the appearance of the 1018 steel flat panels and the plated fuse body specimens after the 60 and 120 day aging periods. The 6061T6 aluminum flat panels are not illustrated because no evidence of corrosion damage was present on these specimens after aging. Inspection of Table 3 and Figures 4 and 5 leads to several significant observations.

It is evident in Figures 4 and 5 that salt deposits are present on the test specimens. A sodium chloride solution was used to obtain the 75 percent R.H. environment, and even though the test specimens were never in direct contact with the liquid solution in the aging tanks, it is obvious that some of the electrolyte did deposit upon the samples. The presence of this corrosive media on the samples no doubt contributed to the corrosion which occurred. Since the aluminum foil tape was galvanically dissimilar to all of the substrates to which it was
