Report No. D180-18752-3

FINAL REPORT

Development of Hybrid Thermoplastic Composites

RESEARCH AND ENGINEERING DIVISION  
BOEING AEROSPACE COMPANY  
SEATTLE, WASHINGTON 98124

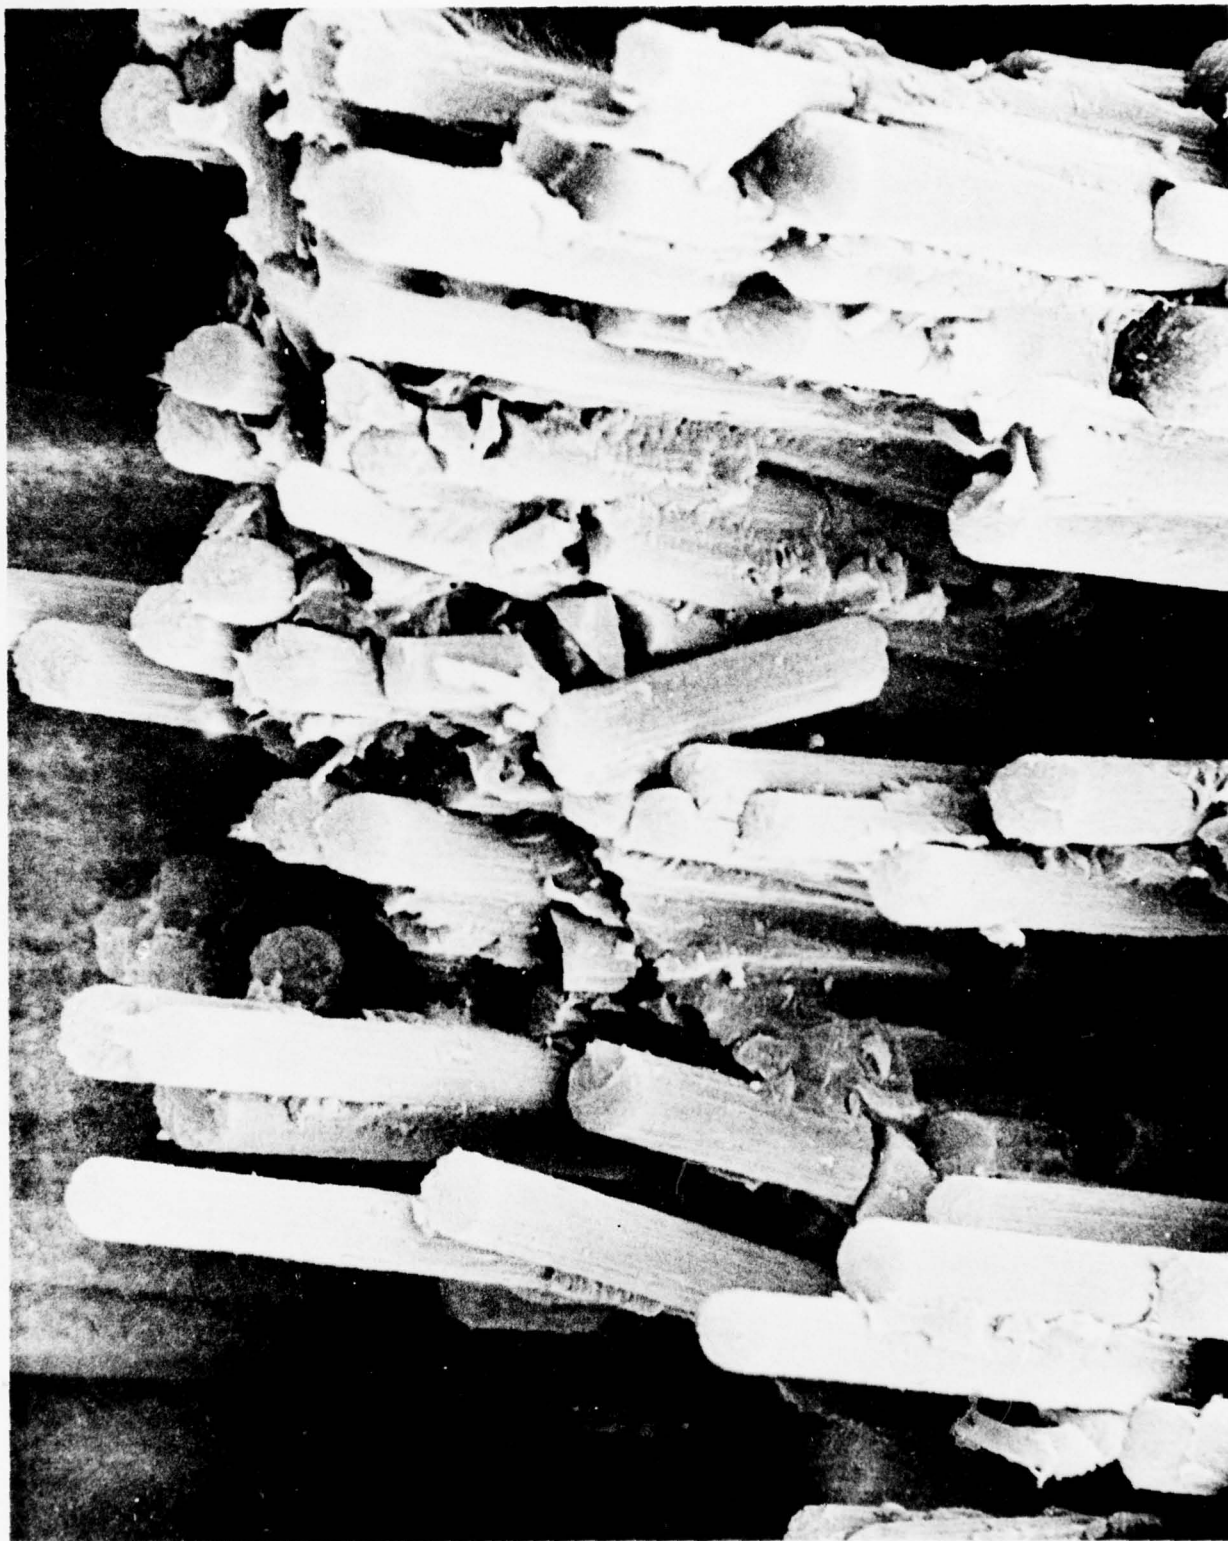
*Figure 2: P-1700/A-S-Epoxy Unidirectional Graphite Composite (600X)*

Scanning electron photomicrographs were taken of a failed flexural specimen from each of the resin systems at a 45° angle to the fracture. Figures 1 and 2 are the scanning electron photomicrographs of the failed PKXA and P-1700 specimens, respectively.

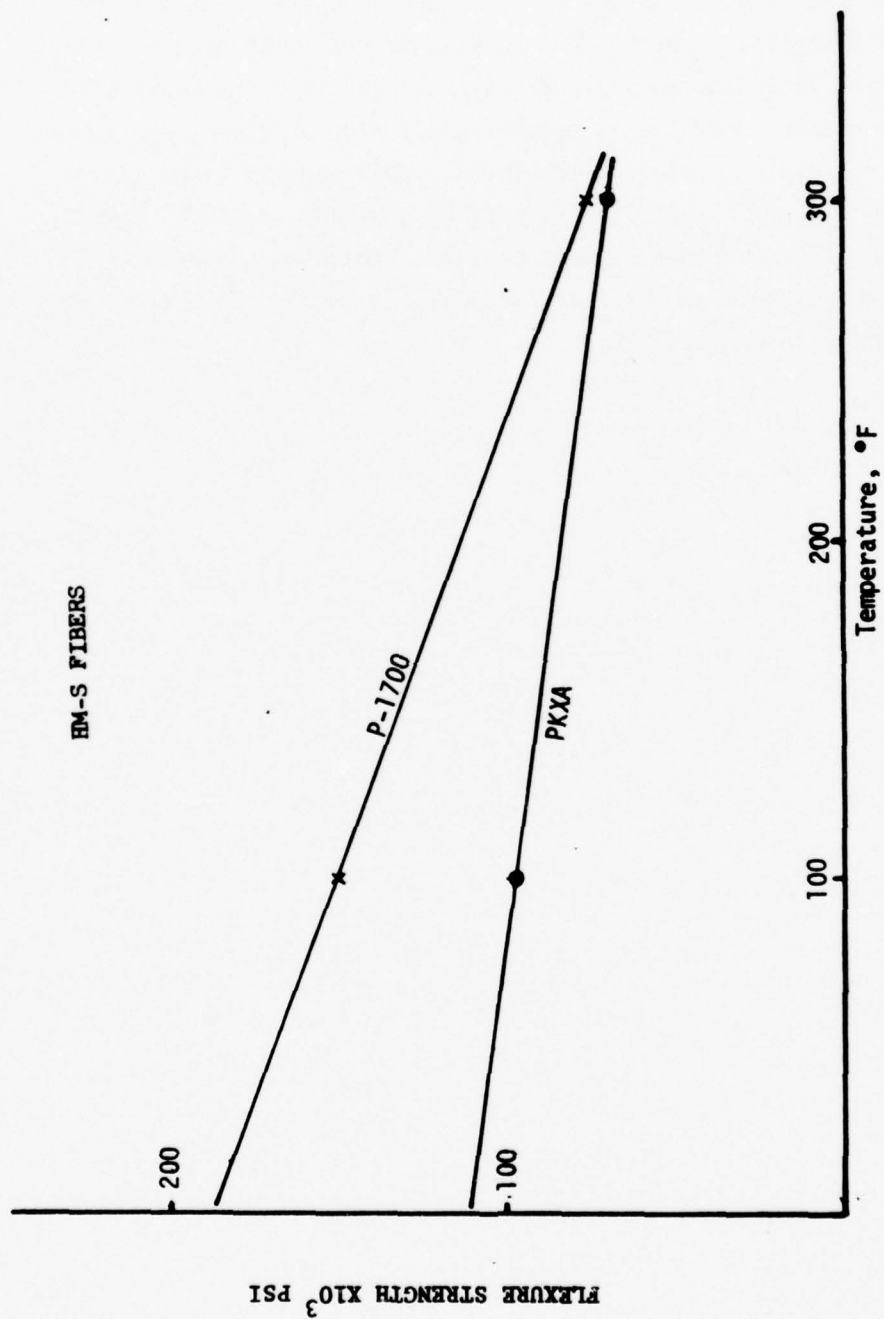
FIGURE 6 FLEXURAL STRESS VS. TEMPERATURE

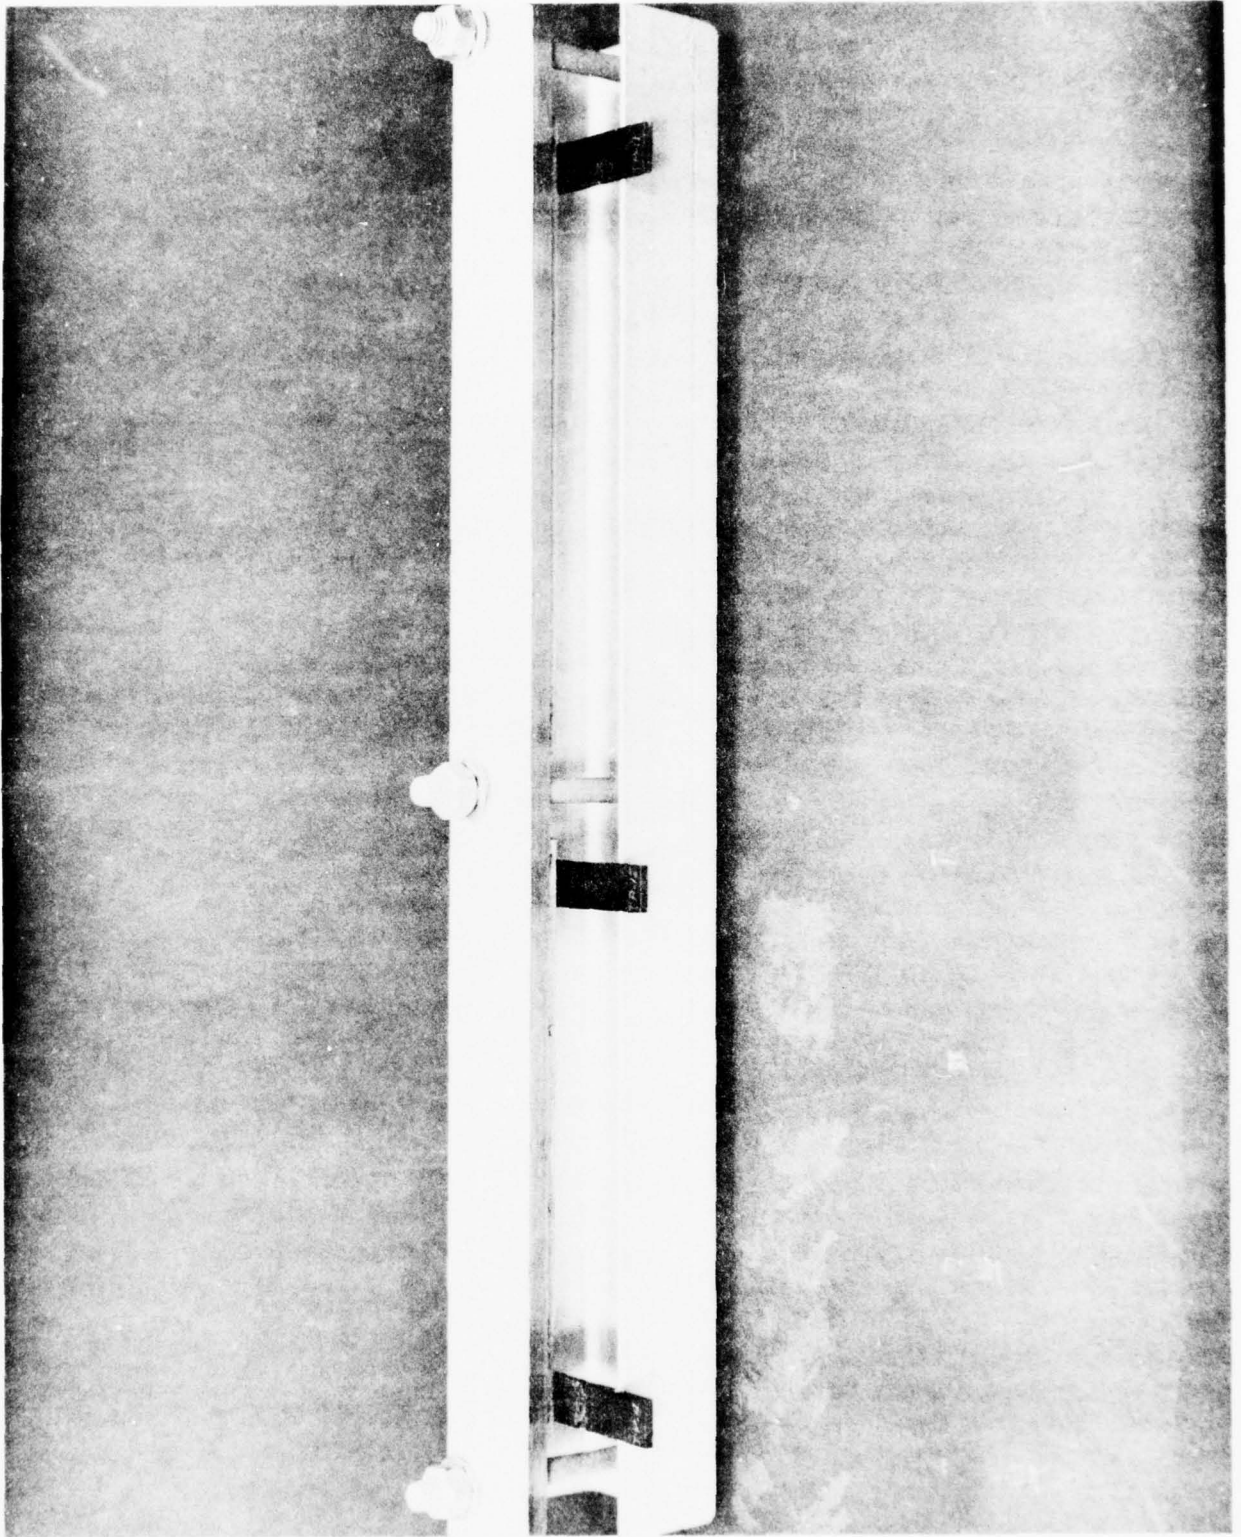
*Figure 7: Fixture For Stressing Flexural Specimens*

Stressed flexural specimens were exposed to accelerated weathering conditions according to ASTM procedure E42-65. Specimens were exposed to 600 20-minute sunlight/rain cycles under stress concentrations of 10, 25, 50, 60, and 75% of their ultimate. These specimens were then tested at room temperature after completing the environmental aging cycle.

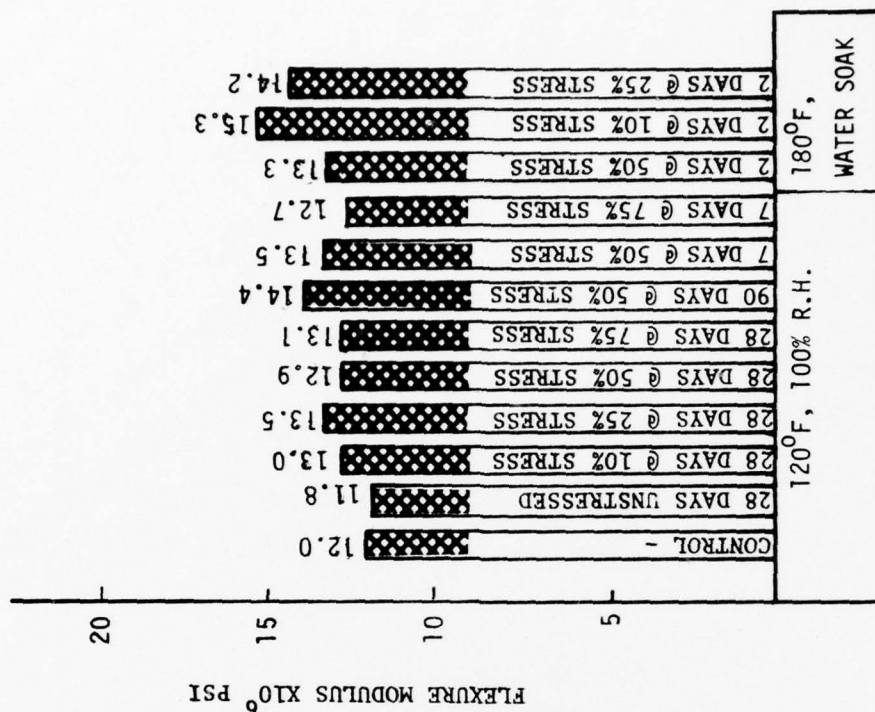
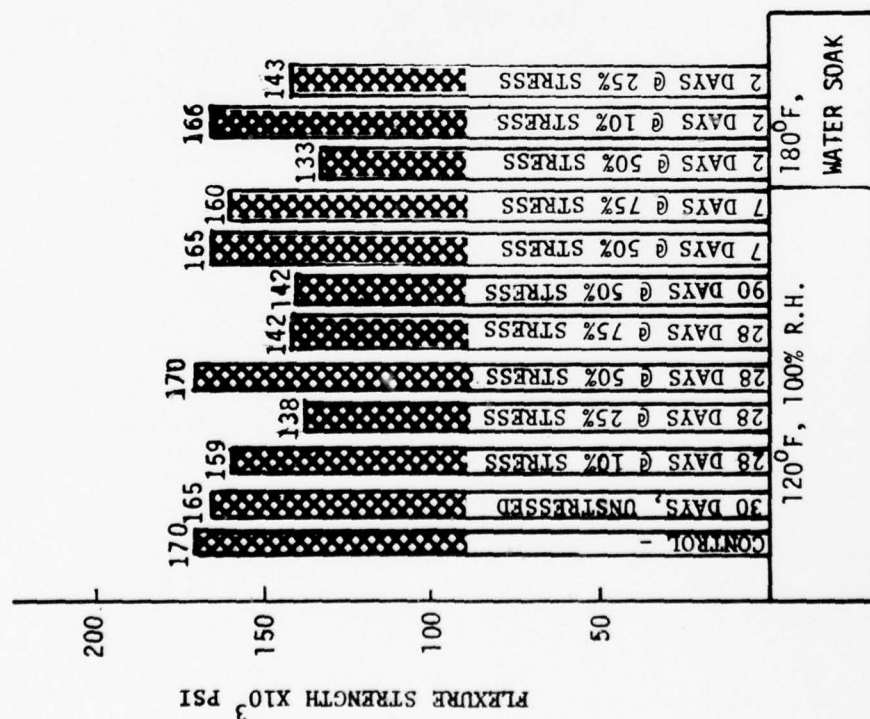
FIGURE 9A P-1700 NONCLAD GRAPHITE LAMINATES IN MOISTURE ENVIRONMENT

Moisture tests were conducted to determine effect on stressed composites as follows: Stressed specimens were placed into a condensing humidity chamber with 100% relative humidity at  $120^{\circ}\text{F} \pm 5^{\circ}\text{F}$  for a period of 7, 30 and 90 days. Specimens were also placed into water at  $180^{\circ}\text{F} \pm 5^{\circ}\text{F}$  and tested after two days of aging. The stress levels, exposure times and data are shown in Figures 9A and 9B.

Flexural specimens stressed under moisture environment displayed very little change in flexural stresses and moduli. The flexural modulus was increased by the environmental aging. These data are reported in Figures 9A and 9B. The increase in moduli was possibly due to the additional heat (120°F) in the environmental chamber which increased the modulus of the polymer.

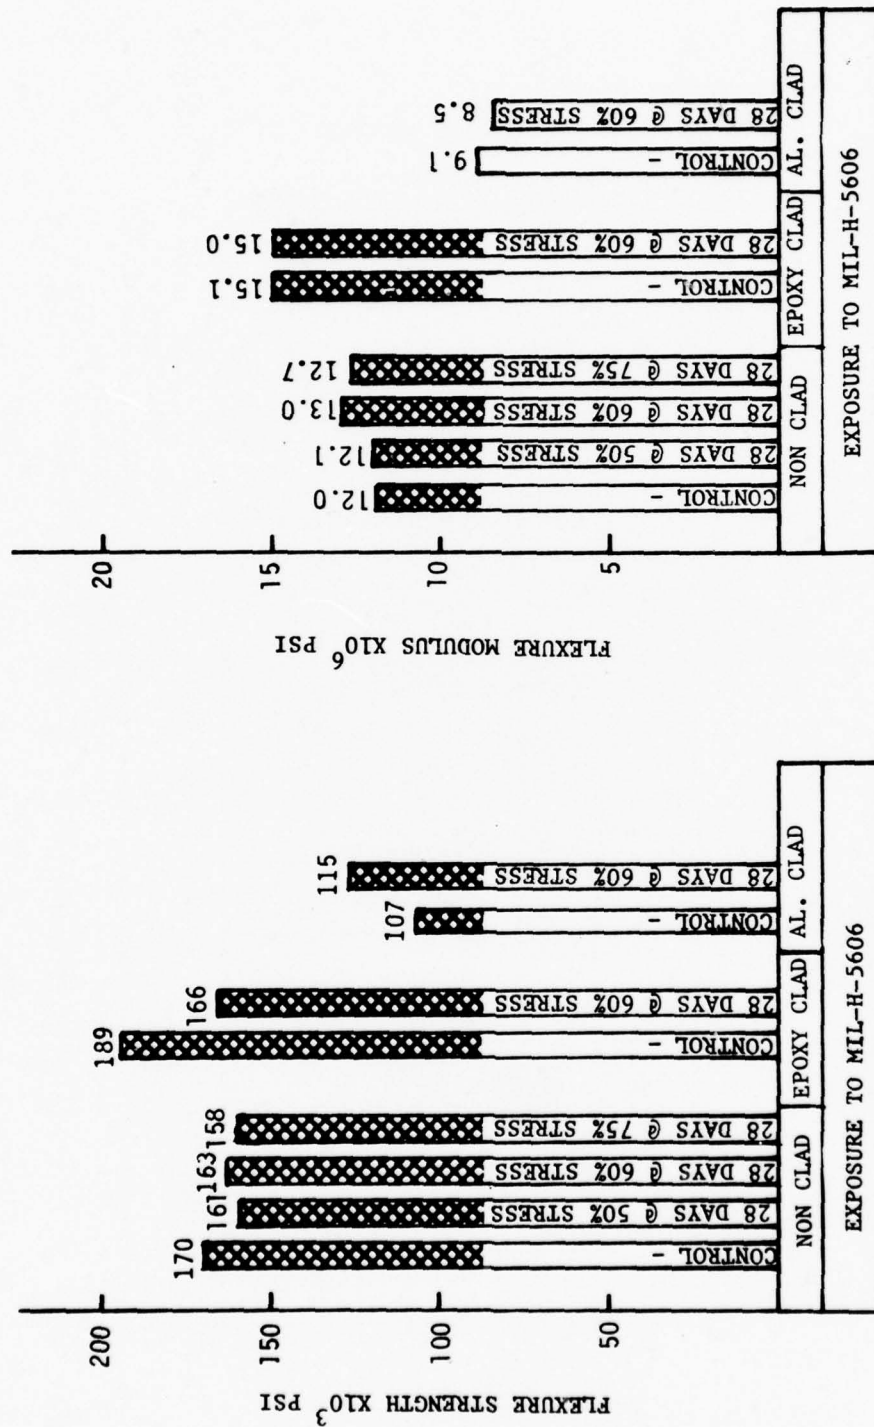
FIGURE 13 FLUID RESISTANCE OF P-1700 CLAD AND NONCLAD GRAPHITE LAMINATES

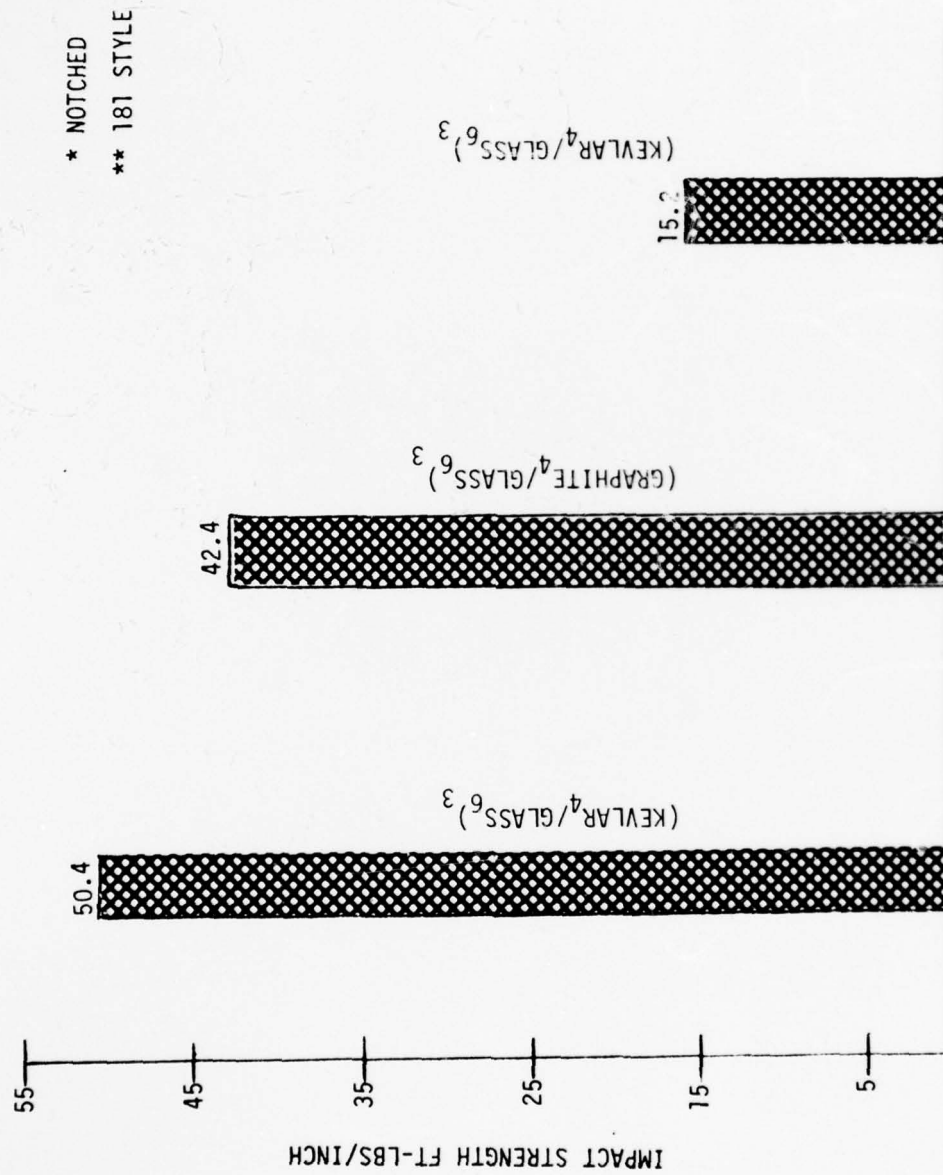
FIGURE 15 IZOD IMPACT STRENGTH\* OF POLYSULFONE/FABRIC\*\* COMPOSITES

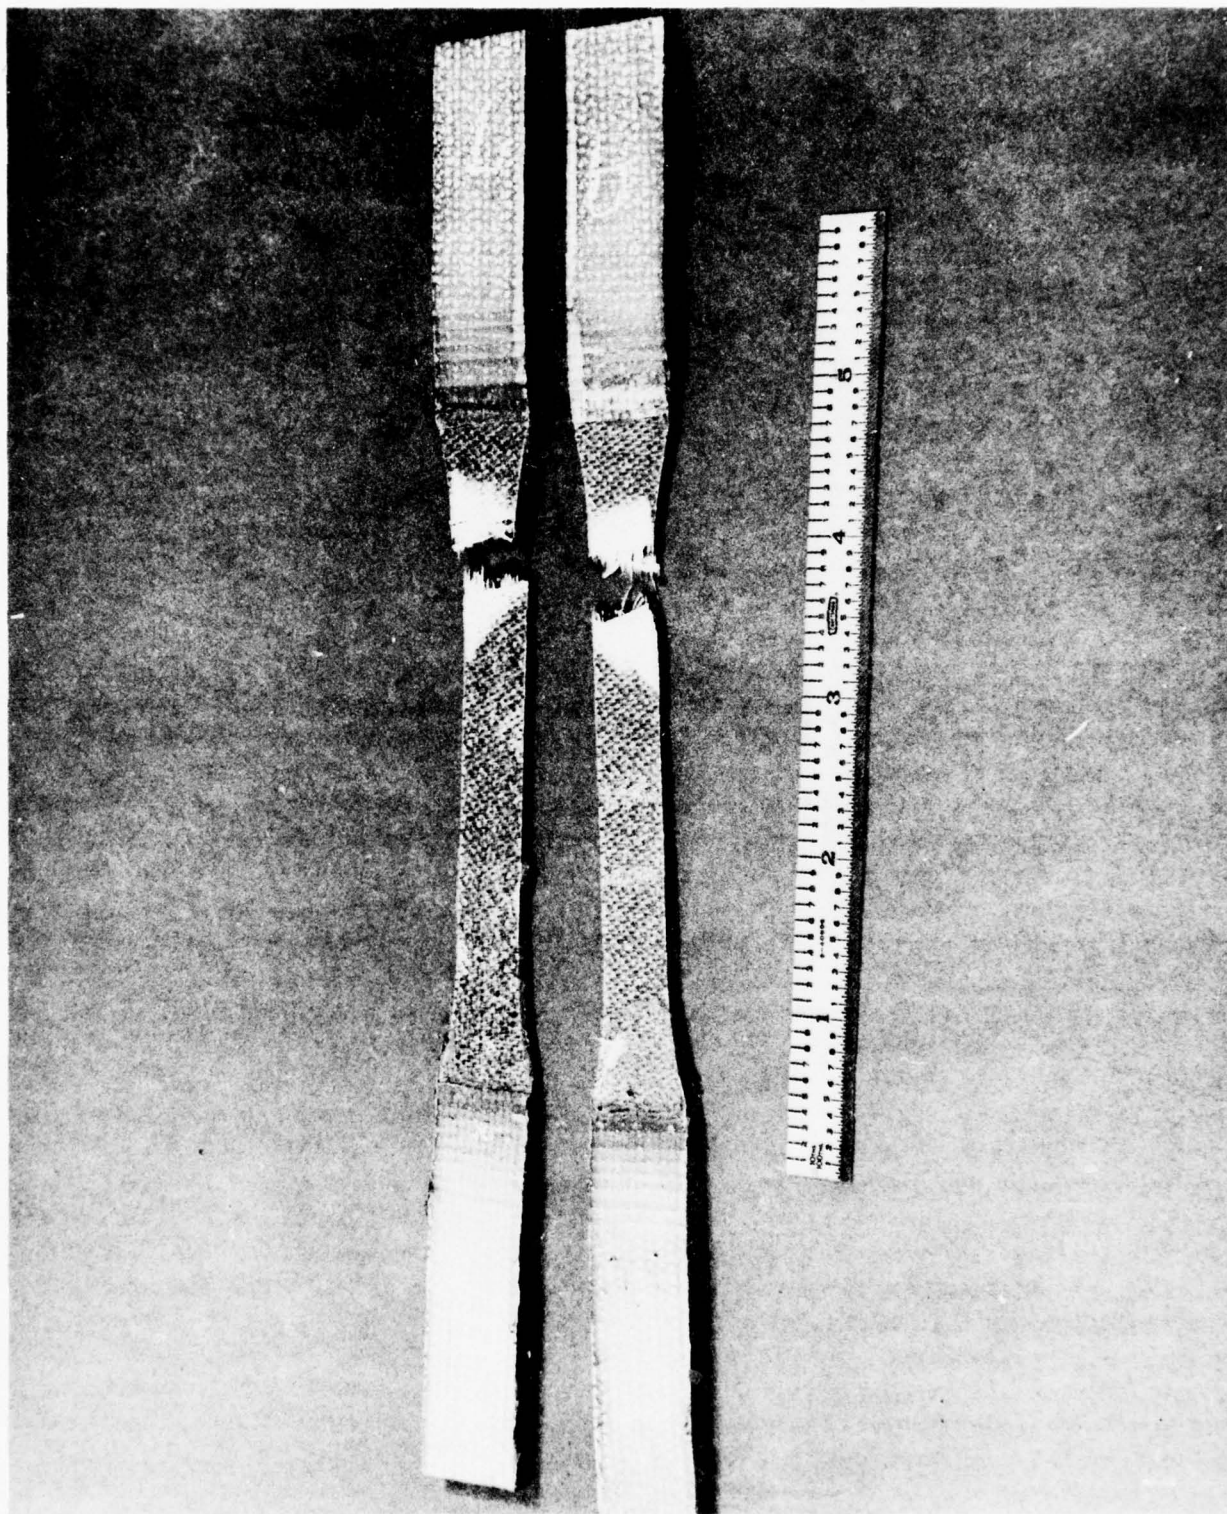
P-1700/KEVLAR/GRAPHITE FABRIC

*Figure 17: Tensile Specimens — Typical Fractures*

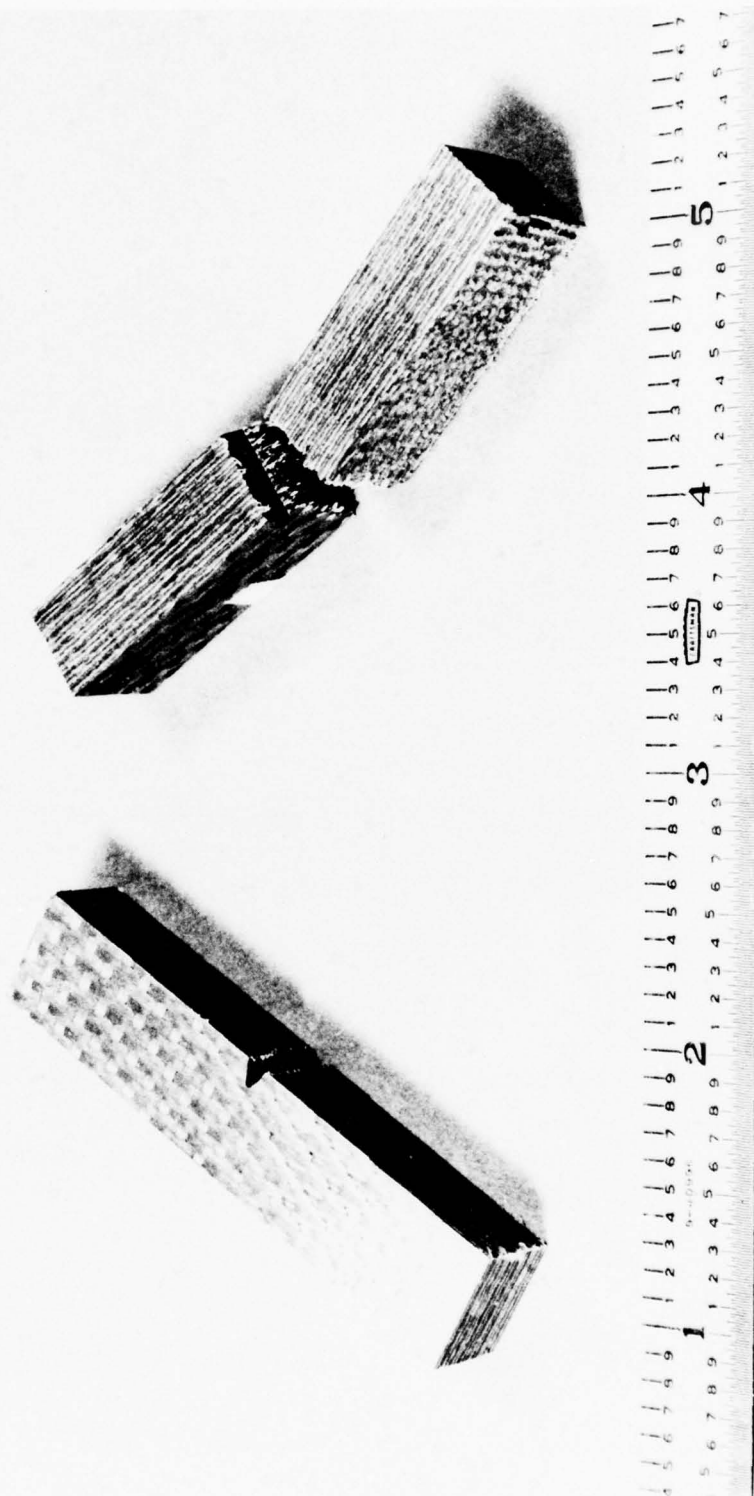
P-1700/KEVLAR/GRAPHITE FABRIC

Figure 26: Izod Impact Specimens – Typical Fractures

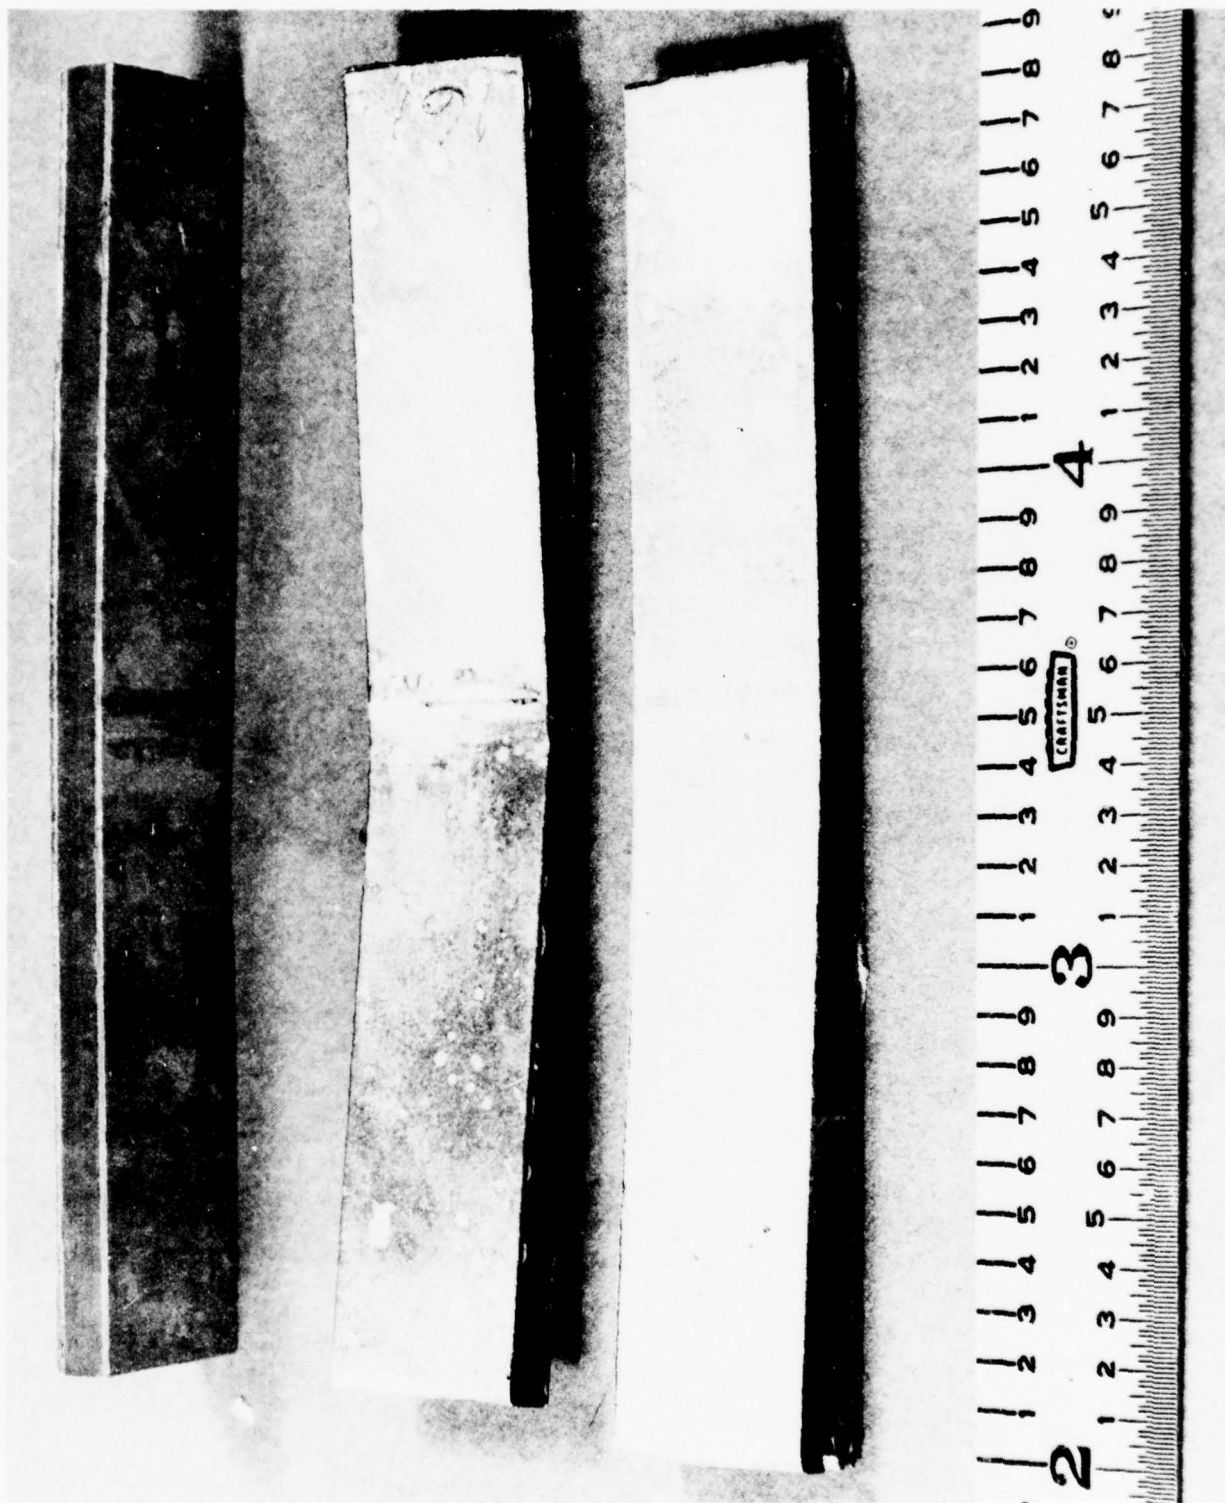
ALUMINUM-CLAD P-1700/A-S

Figure 32: Flexure Specimens – Typical Fractures

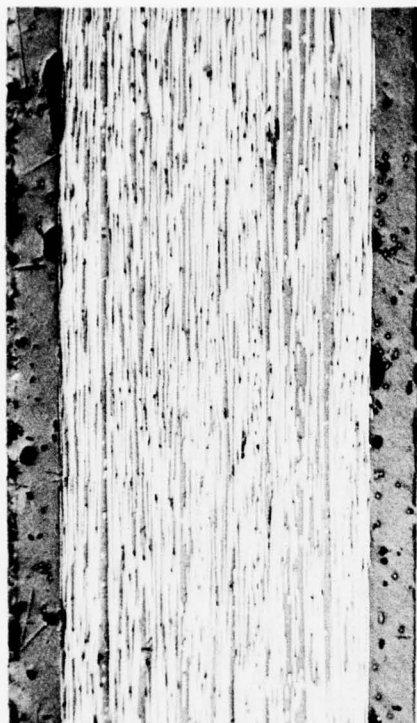
*Figure 34: Aluminum Clad Laminate  
Before Thermal Shock (50X)*

Metal-clad laminates were exposed to 200 cycles of thermal shock (-65°F to +250°F) and thermal aging (500 hours at 250°F), to determine if differences in thermal expansion of the materials would cause delamination. The tests appeared to have no adverse effect on the composites. Figures 34 through 41 are photographs of the laminates before and after exposure.

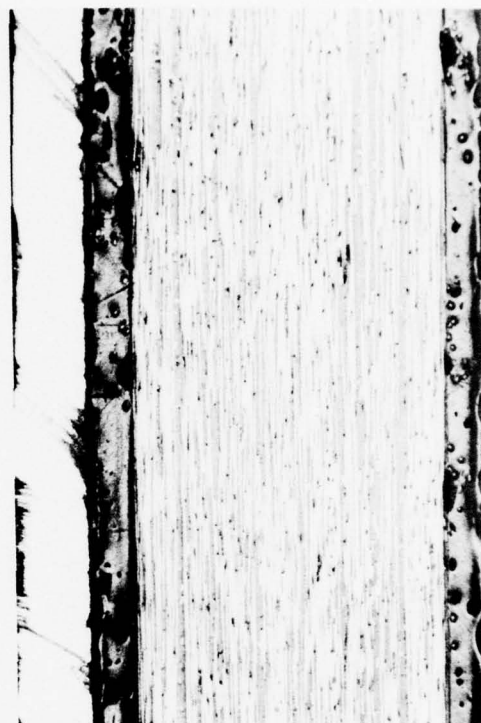
*Figure 35: Aluminum Clad Laminate  
After Thermal Shock (50X)*

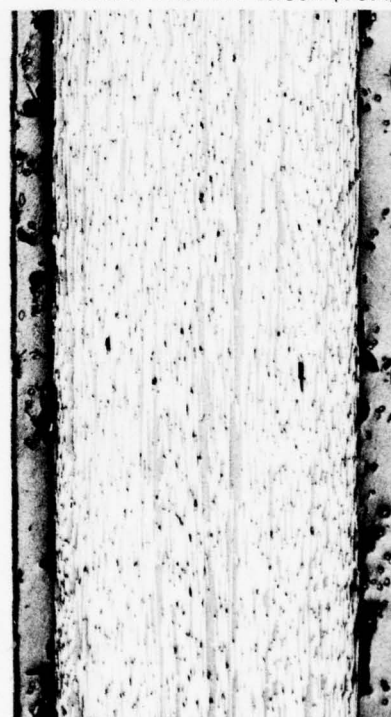
*Figure 37: Aluminum Clad Laminate  
After Heat Aging (50X)*

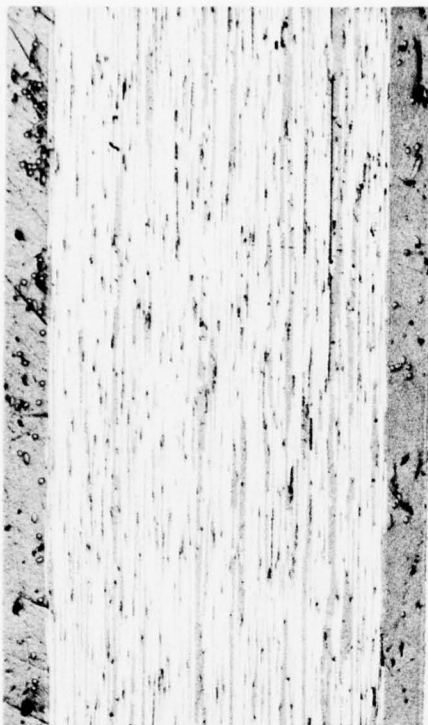
Figure 38: Steel Clad Laminate  
Before Heat Aging (50X)

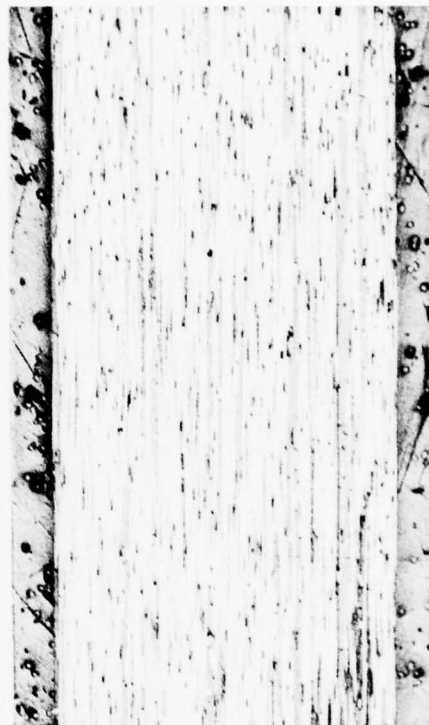
Figure 39: Steel Clad Laminate  
After Heat Aging (50X)

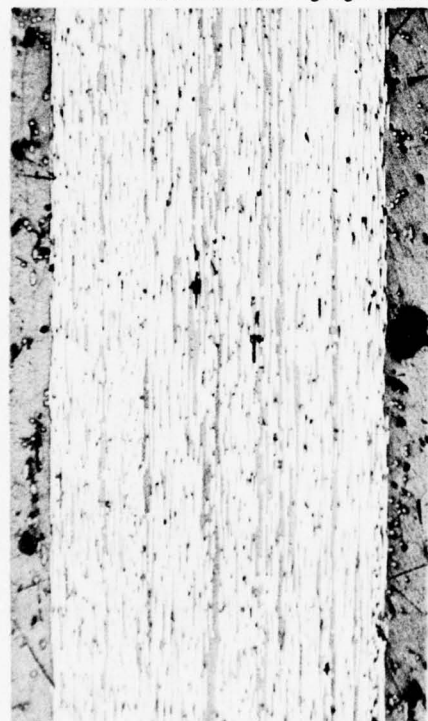
Figure 40: Steel Clad Laminate  
Before Thermal Shock (50X)

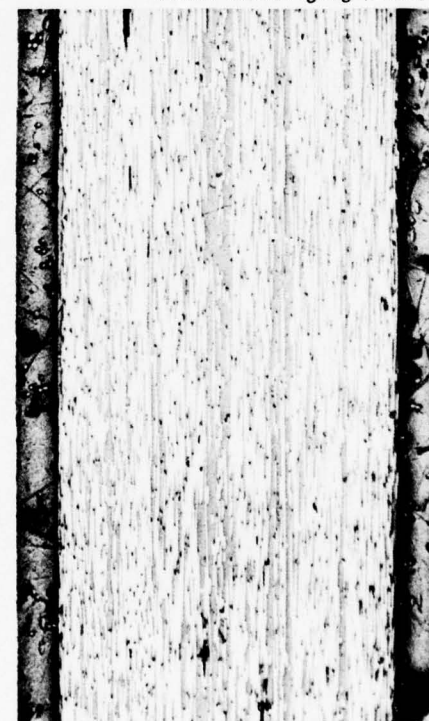
Figure 41: Steel Clad Laminate  
After Thermal Shock (50X)

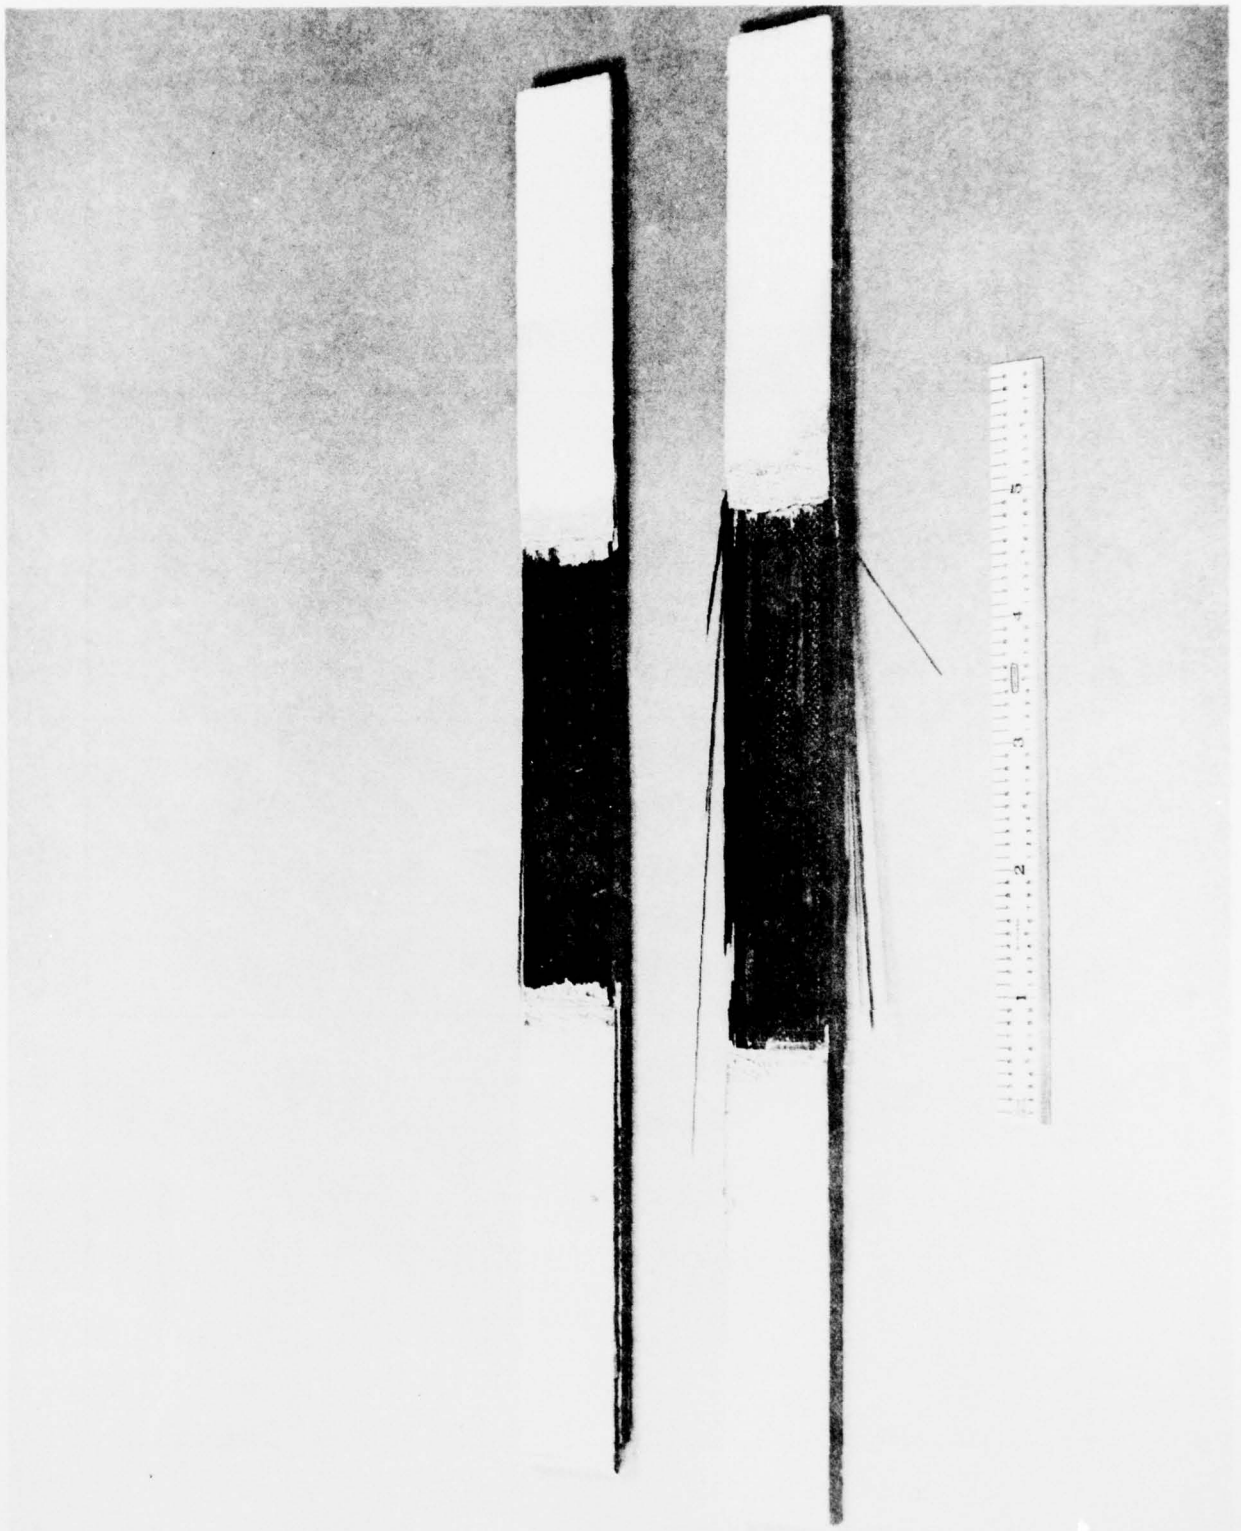
*Figure 43: Epoxy-Clad Tensile Specimen — Typical Fractures*

tabs. Tests were run at room temperature and 300°F. Test data are presented in Table 8. The specimens failed with a sort of brooming effect, with the fibers breaking throughout the laminate. Figure 43 is a typical failed epoxy clad tensile specimen.
