TECHNICAL REPORT D-78-33

HABITAT DEVELOPMENT FIELD INVESTIGATIONS, PORT ST. JOE SEAGRASS DEMONSTRATION SITE PORT ST. JOE, FLORIDA SUMMARY REPORT

HABITAT DEVELOPMENT FIELD INVESTIGATIONS, PORT ST. JOE
SEAGRASS DEMONSTRATION SITE, PORT ST. JOE, FLORIDA

Summary Report

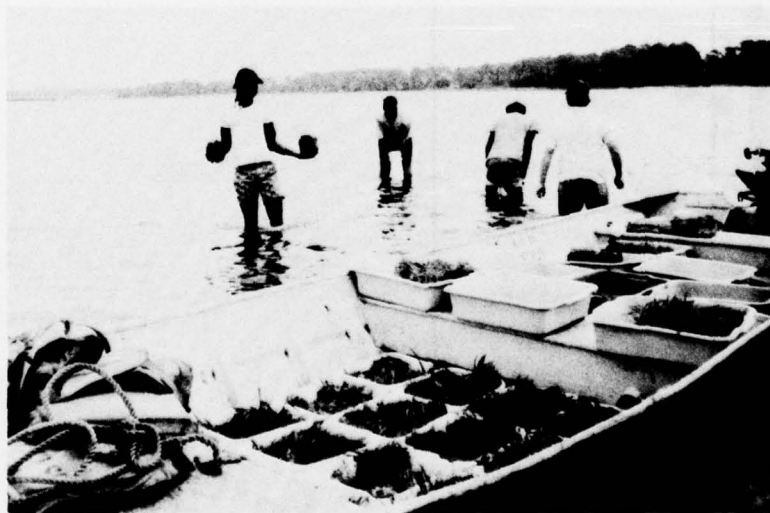
Figure 4. Plugs of shoal grass being removed and placed on boat for transfer to the planting site

24. Following removal, the plants and original substrate were placed intact in plastic containers and transported by boat to the study plots. At the planting site, holes were dug in the dredged material to accommodate the two sizes of plugs. Figures 4 and 5 show photographs of the planting procedure. It took six men about 53 hours (318 man-hours) to obtain and plant the 1488 plugs. At this rate it is estimated that to plant one hectare with plugs at 0.9-, 1.8-, and 2.7-m spacings would require 2180, 555, and 250 man-hours, respectively.

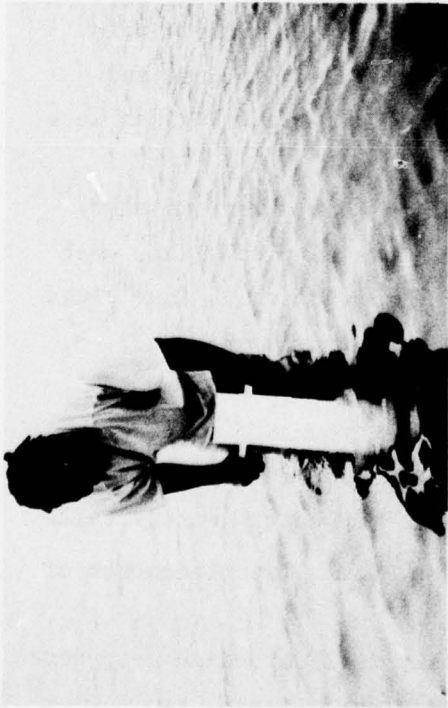
a. PVC coring device being used to remove plugs of shoal grass

Figure 5. Steps in the planting procedure

23. Two different sizes and shapes of coring devices were used to obtain the 1488 plugs. For the 1242 smaller plugs (177 cm^2), a cylindrical 15-cm polyvinyl pipe, constructed at WES, was used. The 246 larger plugs (375 cm^2) were removed with a 15- by 25-cm iron frame rectangular corer. The rectangular corer was constructed by the senior author; the design was based on a similar device described by Ranwell et al. (1974). During coring, a shovel was used to carefully slice the plug and surrounding sediment free from the bottom sediment under the corer. The depth of coring by each device was about 15 cm and was sufficient to obtain the entire shoal grass rhizome, which generally grows to only about 7 to 10 cm.

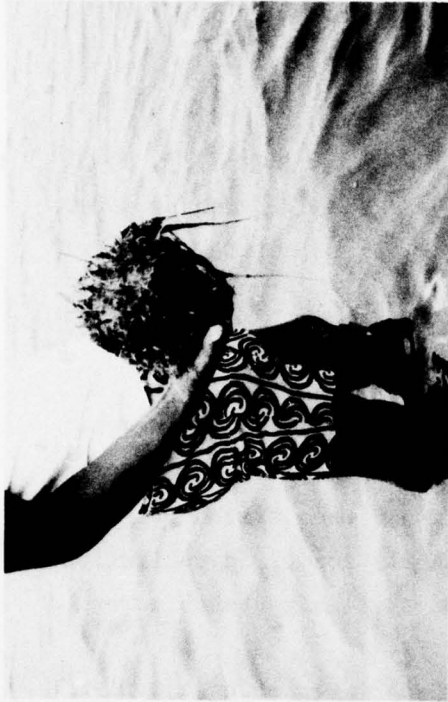
b. Plugs of shoal grass for transplanting onto dredged material substrate

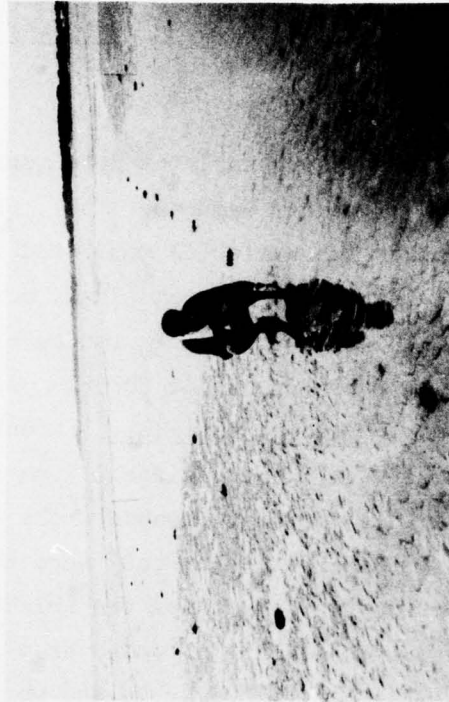
d. Inspection of plants planted on 3-ft centers

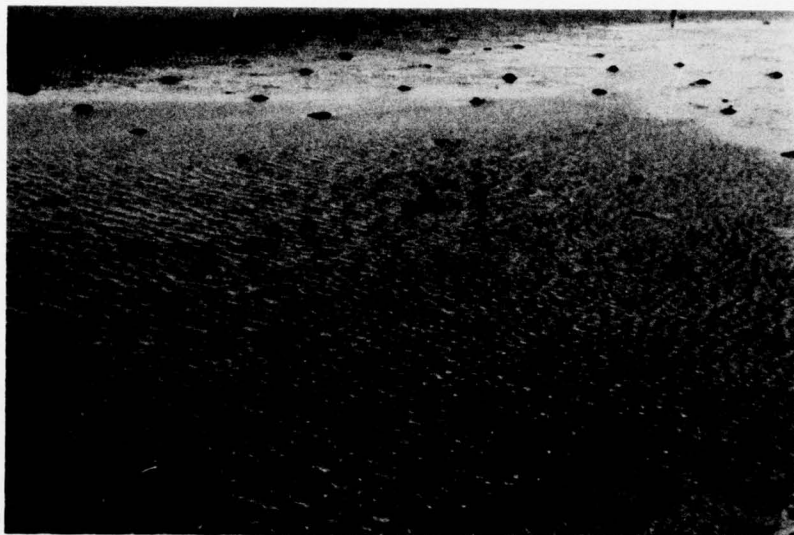
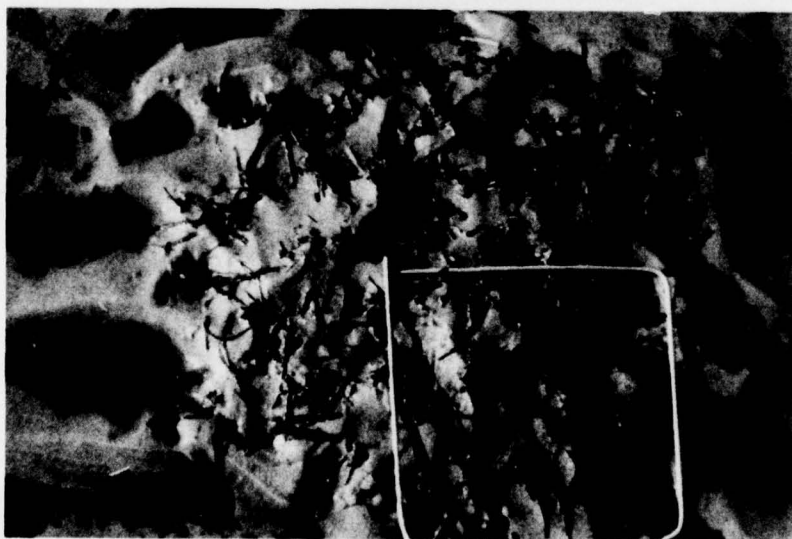
Photo 2. 20 January 1977, plot 1, subplot B
(1.8-m centers) (sheet 1 of 2)

c. Large plug (375 cm²). Note rhizome and plant extensions at upper left and upper right

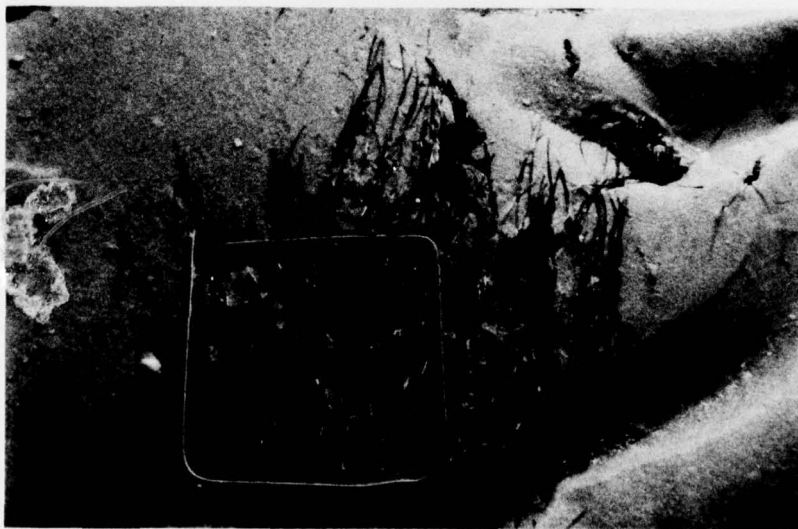
Photo 6. 21 January 1977, plot 2, subplot B
(1.8-m centers) (sheet 1 of 2)

c. Large plug (375 cm²). Note rhizome extension
at lower right

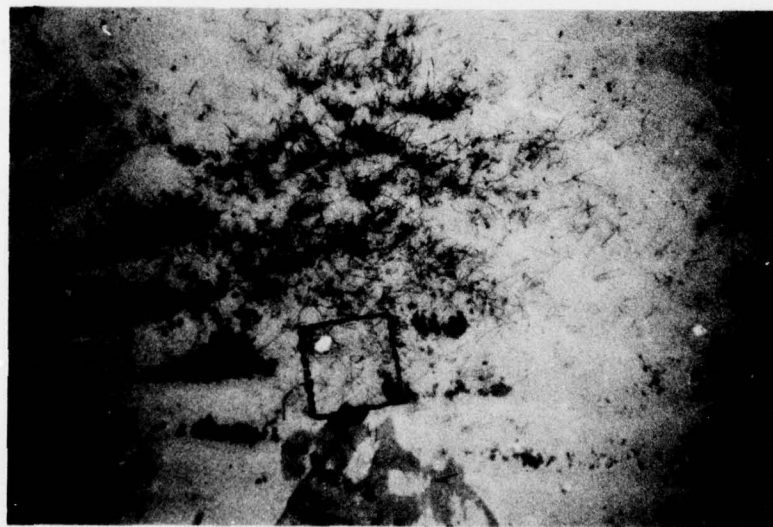
Photo 8. 30 May 1977, plot 2, subplot A
(0.9-m centers)

a. Small plug (177 cm²)

b. Large plug (375 cm²)
