Technical Report 78031 ✓

THE FATIGUE BEHAVIOUR OF A CARBON FIBRE COMPOSITE WITH LAMINATE  
CONSTRUCTIONS OF  $0^\circ$ ,  $0 \pm 45^\circ$  AND  $90 \pm 45^\circ$

J. B. Sturgeon

SUMMARY

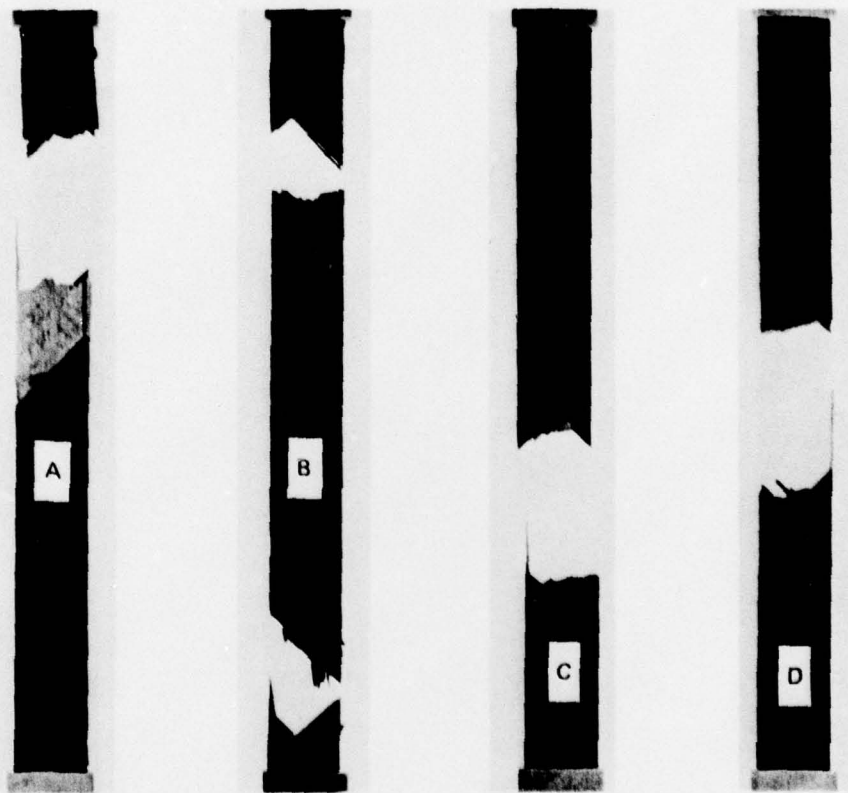
Fig 14 Fatigue failures of multi-ply  $0 \pm 45^\circ$  CFC. The endurance to failure were; specimen (A) 2959300, (B) 342560, (C) 93400, (D) 21100 cycles

Figs 14 to 17 show specimens which failed in fatigue. Common to all groups was the fact that high cycle specimens (that is specimens which survived for long lifetimes) were all more extensively damaged than high stress, hence low cycle specimens. In fact for short lifetimes the failure was almost indistinguishable from monotonic breaks. Sometimes there was a little more cracking in fatigue specimens to identify them from monotonic test-pieces but separation of a mixture of broken specimens into fatigue and monotonic failures cannot be achieved with confidence. High cycle specimens can easily be distinguished and in plain material the outer  $45^\circ$  layers often delaminated and fell away. Specimens containing holes were not so extensively damaged as the plain material but were more damaged than low cycle test-pieces. The run-up failures in Figs 15 and 17 are examples of specimens that failed either on the first load cycle or almost immediately after testing commenced and at the most did not experience 100 cycles.

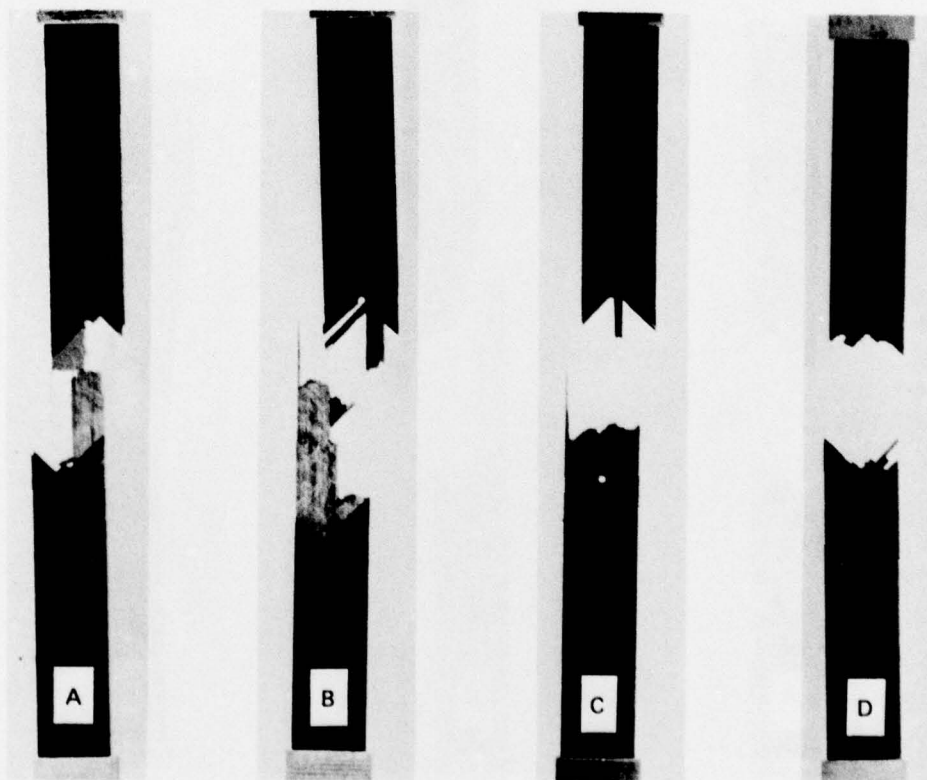
Fig 17 Fatigue failures of multi-directional  $0 \pm 45^\circ$  CFC containing a 2mm diameter hole. Specimens were preconditioned for 3000 hours at  $40^\circ\text{C}$  and 95% RH and their endurance to failure were; specimen (A) 2644100, (B) 1234500, (C) 810100 cycles, (D) failed on run-up to full load

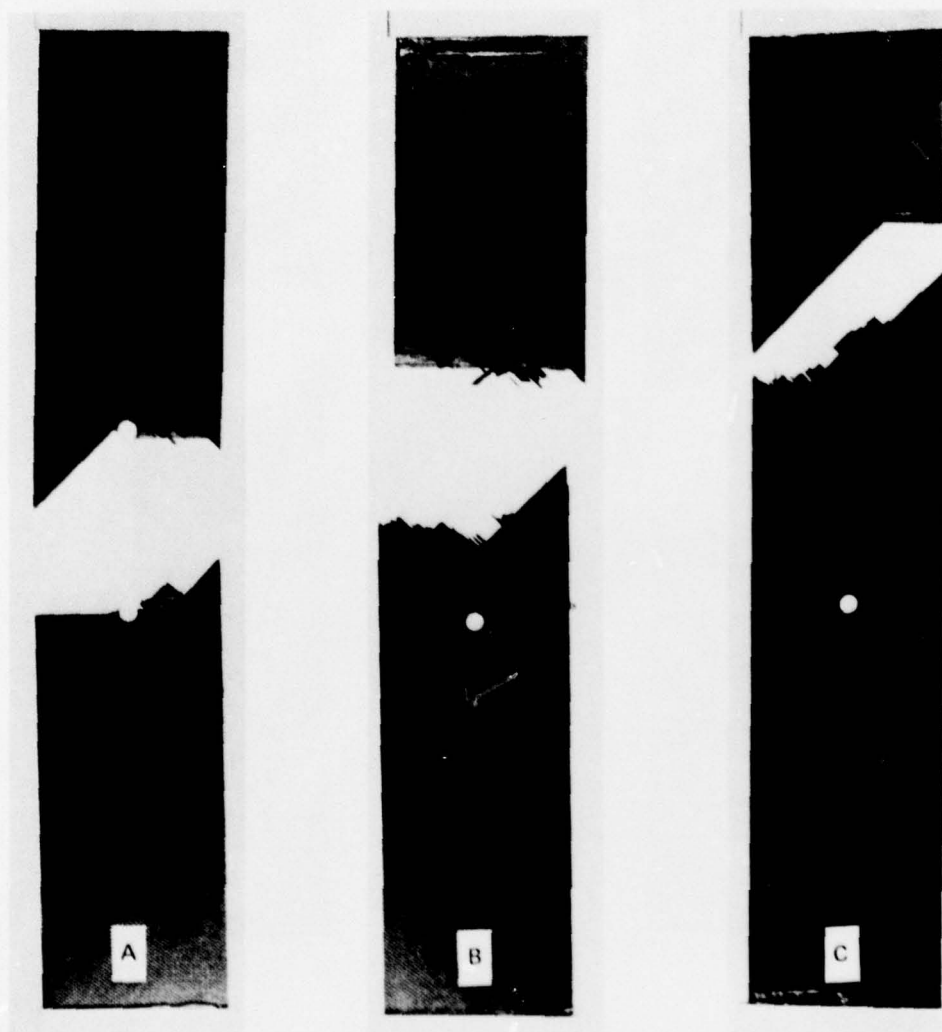
Fig 20 Monotonic failures of multi-ply  $90 \pm 45^\circ$  CFC containing a 4mm diameter hole. Tested after preageing for 3000 hours at  $40^\circ\text{C}$

Monotonic failures of  $90 \pm 45^\circ$  CFC are illustrated in Figs 18 to 21. Fig 18 shows failed plain specimens which indicate the combined failure of splitting or shearing of the  $45^\circ$  layers with some interply delamination coupled with a simple break across to  $90^\circ$  fibres. As illustrated in Figs 19 to 21 specimens containing holes did not always break at the stress concentration. In all cases the damage associated with failure was not extensive being confined around one small region. When failure was directly through the hole a straight tensile break sometimes occurred, see Figs 20 and 21. In plain specimens and in holed specimens where failure was remote from the hole the failure surface appears to contain more contributions from the  $45^\circ$  plies giving a sloping or jagged fracture.

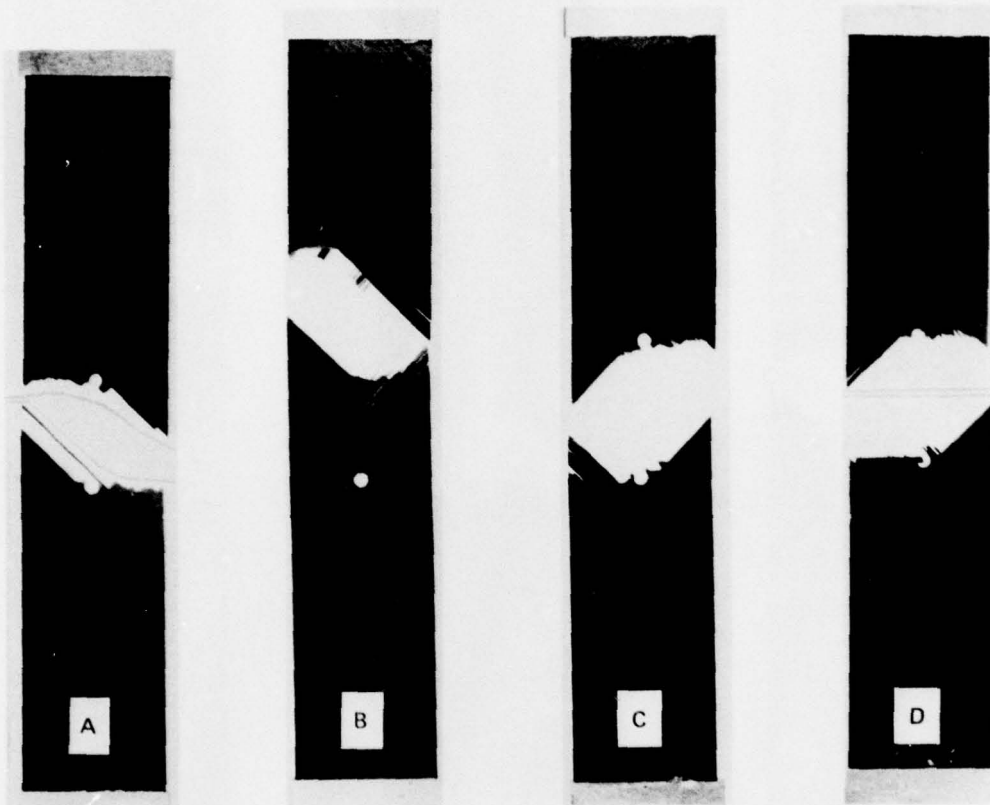
Fig 24 Fatigue failures of multi-ply  $90 \pm 45^\circ$  CFC containing a 4mm diameter hole. Specimens were preaged for 3000 hours at  $40^\circ\text{C}$  and their endurance to failure were; specimen (A) 455000, (B) 348000, (C) 33100, (D) 1440 cycles

Figs 22 to 25 show typical fatigue failed specimens. A superficial examination would reveal almost no obvious differences between the fatigue and monotonic failures. However fatigue specimens usually contain interply delaminations caused by the zig-zag ladder cracking of the  $45^\circ$  layers<sup>3</sup> and splitting of the  $90^\circ$  layer in some cases. The general form of the cracking and damage progression was similar to other work reported elsewhere<sup>3</sup>. Preconditioning and preageing had no obvious effect on the failure mechanisms or appearance.
