CABLE, ELECTRO-MECHANICAL TOW TYPE AN/SQA-13
from
USS SAUFLEY (DE 465)
for
VARIABLE DEPTH SONAR APPLICATIONS

LAB PROJECT 9400-53, TECHNICAL MEMORANDUM 4

1- Photo No. L-19659-5 - Damaged Area of AN/SQA-13 Cable

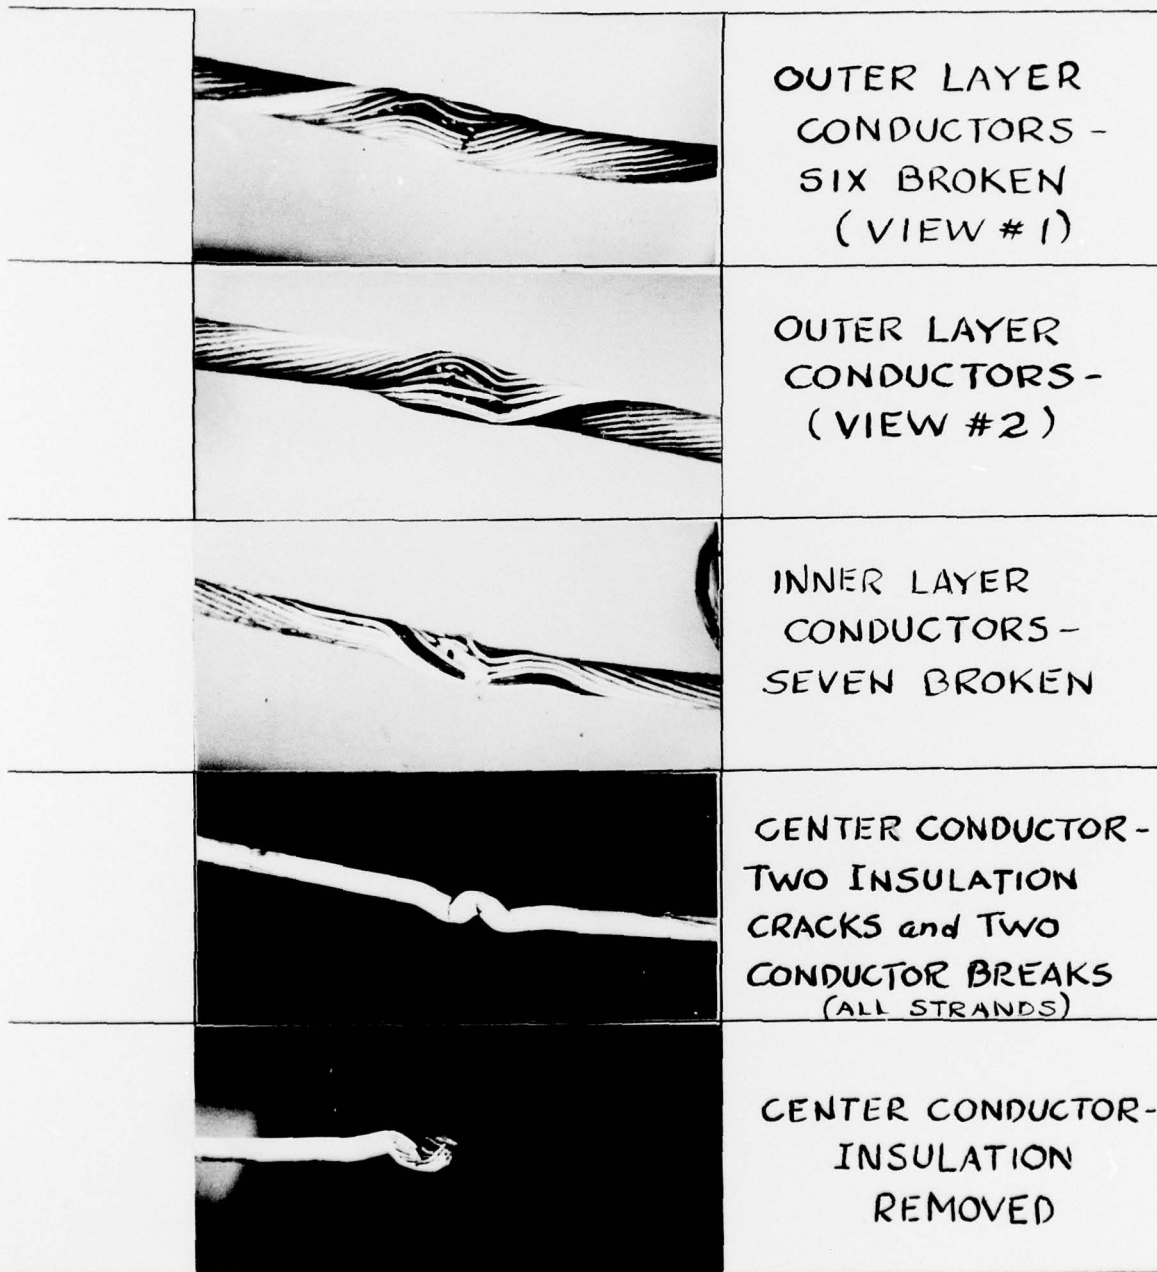
FIGURE 1
AN/5QA-13 CABLE

- a. Six feet from cone location- (See Fig. 1)
6 Outer layer conductors broken
7 Inner layer conductors broken
Center conductor- Insulation cracked in two places at kink (knuckle). All strands broken under insulation and fatigue type rupture indicated.

- b. There were three other kinks in the center conductor in the 25-foot length. The three kinks as measured from the rupture in the conductor were four to five feet apart. The two layers of small conductors were displaced at the kink locations but were not damaged or broken.

7. A firm conclusion as to the cause for center conductor damage in the AN/SQA-13 cable removed from the USS SAUFLEY cannot be made based on the work done by this Laboratory. Investigations to simulate shipboard towing operations and duplicate kinks in the center conductor were limited by available apparatus which provided a maximum tensile force of approximately 10000 pounds, a maximum cable travel of three feet and a sheave diameter of 30 inches (Shipboard sheave is 26 inches in diameter). Furthermore, tow cables may be subjected to many stresses including transient surge loads, twist and extreme flexing unknown to the operator under towing conditions.

8. To form a conductor kink (knuckle), three primary conditions are required; a. The conductor must be located within a closely confined area. b. The conductor must be movable longitudinally and restricted at more than one place along its length. c. The conductor must be subjected to compression in the movable section between restricted areas. The core of electro-mechanical tow cables is designed to run over sheaves. Relative motion between conductors in a confined area must occur when the cable bends over the sheave because of the increase in circumferential distances from the sheave surface to the outer cable surface. During the latter part of vehicle retrieval the cable passes over approximately 90 degrees of the sheave surface. The center conductor is being subjected to maximum tensile

forces in the sheave area at this time. The compressive force between the cable and the sheave surface applies a gripping action on the center conductor which is transmitted by the surrounding members of the cable. This restriction of center conductor movement apparently produces a cumulative lengthening effect of the center conductor in the region between the sheave and the vehicle that can only be relieved by the knuckling action previously described. The question arises as to what conditions restricted the center conductor movement in this particular cable to a degree that it would not move in or beyond the sheave area. Any source of force which applies a strong circumferential squeeze on the cable core appears to be an obvious answer. Of the many possible conditions that could cause external pressure on the cable core and compact it, the following appear most likely:

- a. Armor wires applied excessively tight during the manufacturing process.
- b. Reduction in helix diameter of the formed armor wires by excessive tension in the cable during towing operations.
- c. Excessive compression (flattening of cable) when running over the outboard sheave or drum while the cable is subjected to high tension.

In an attempt to verify the existence of some of these conditions, the armor wires of the AN/SQA-13 cable were examined. Although the degree of tightness of armor wire is often difficult to estimate, that of the cable under investigation did not appear to have been applied excessively tight during manufacturing. Conditions b. and c. above concerning excessive cable tension during towing or vehicle handling operations are, of course, unknown. The fact that the cable kinks appeared only in the last 25 feet of cable near the vehicle end indicates that the cable may have experienced excessive tension or crushing forces during initial step of launching or final step of retrieving operations during which time vehicle handling, especially in moderate to high sea states, is most difficult.
