NRL Report 8258

**Fractographic Analysis of Fatigue Specimens of
Annealed Type 304 Stainless Steel**

V. PROVENZANO AND F. A. SMIDT, JR.

**NAVAL RESEARCH LABORATORY
Washington, D.C.**

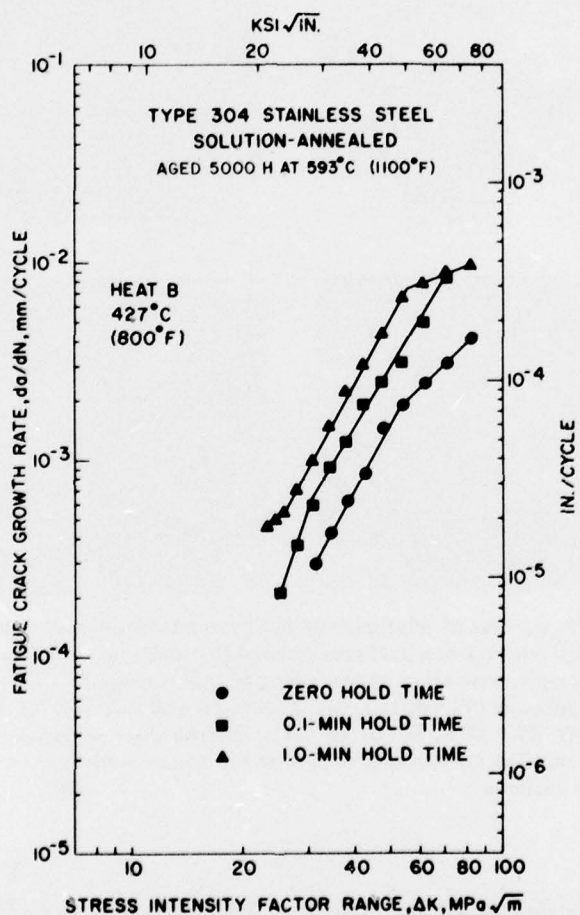
Fig. 7 — Effect of hold time on fatigue crack propagation behavior in air at 427°C for solution-annealed, aged Type 304 stainless steel, Heat B.

Fig. 7 shows fatigue data for aged, solution-annealed, Heat B material tested at 427°C. Except for a slight change in the slope at the upper ends of the curves, the data are linear on a log-log plot. This crack growth rate and the slope of the log da/dN vs log ΔK curve show that the zero-hold-time data are approximately the same as the corresponding values for the SA material tested at the same temperature (refer to Fig. 1). The introduction of 0.1- and 1.0-min hold time during the fatigue cycle progressively increased the growth rate. This effect of hold time in aged Type 304 stainless steel tested at 427°C differs from the observations on aged Type 316 steel tested at the same temperature where no hold time effect was observed (1).

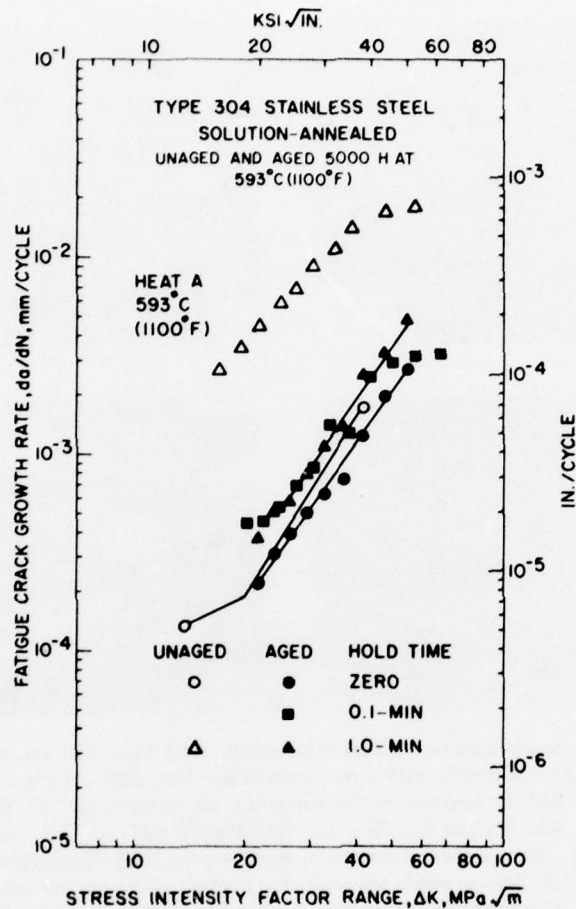
Fig. 13 - Effect of hold time on fatigue propagation rate, da/dN , in air at 593°C for solution-annealed, and solution-annealed and aged, Heat A material.

Crack growth rate data for SA material from Heat A, tested at 593°C, are shown in Fig. 13. The crack growth rate for the test with no hold time increased from 1×10^{-4} mm/cycle (4×10^{-6} in./cycle) at 14.3 $\text{MPa}\sqrt{\text{m}}$ (13 $\text{ksi}\sqrt{\text{in.}}$) to 2.4×10^{-3} mm/cycle (6×10^{-5} in./cycle) at 40 $\text{MPa}\sqrt{\text{m}}$ (36.4 $\text{ksi}\sqrt{\text{in.}}$). The crack growth rate is nearly linear over the above range. The introduction of 1-min hold time during the fatigue cycle increased the crack growth rate by about an order of magnitude as compared to the test with no hold time.

The fatigue data for the aged material, Heat A, tested at 593°C are also presented in Fig. 13. The data are linear in the log-log plot and approximately equal to the crack growth rate of the SA specimen of the same heat tested without hold time. Hold times up to 1 min produced a slight increase in the growth rate. Thus, the hold-time effect, clearly present in the fatigue data of the SA material, became negligibly small or was completely absent in the aged material from Heat A.

The fatigue crack growth rate of 25% cold-worked Type 304 steel, Heat A, tested at 593°C without hold time was comparable to the crack growth rate of SA Type 304 steel without hold time (Figs. 13 and 18). The introduction of a 1-min hold time resulted in an acceleration of the crack growth rate by about two orders of magnitude. The fatigue crack growth behavior of the cold-worked and aged material, also summarized in Fig. 18, showed that the growth rate was slightly higher than the growth rate of the corresponding cold-worked specimen. Imposition of hold times up to 1 min progressively increased the crack growth rate, but not as much as in the cold-worked specimen. The failure mode for the cold-worked specimen tested with 1-min hold time was largely intergranular for the entire crack path (Fig. 19). Slip steps, indicative of local plastic deformation, were present on most grain facets (Fig. 19). The failure mode was mixed for the cold-worked and aged specimens tested at 593°C with 0.1- and 1-min hold times. Slip steps were also present on the fracture surfaces of the aged specimens.
