NRL Memorandum Report 3894

An Investigation into the Causes of Ceramic Cracking in the Mark 11 Source (400 Series).

R.C./POHANKA, P.L./SMITH and P.C. MILLER

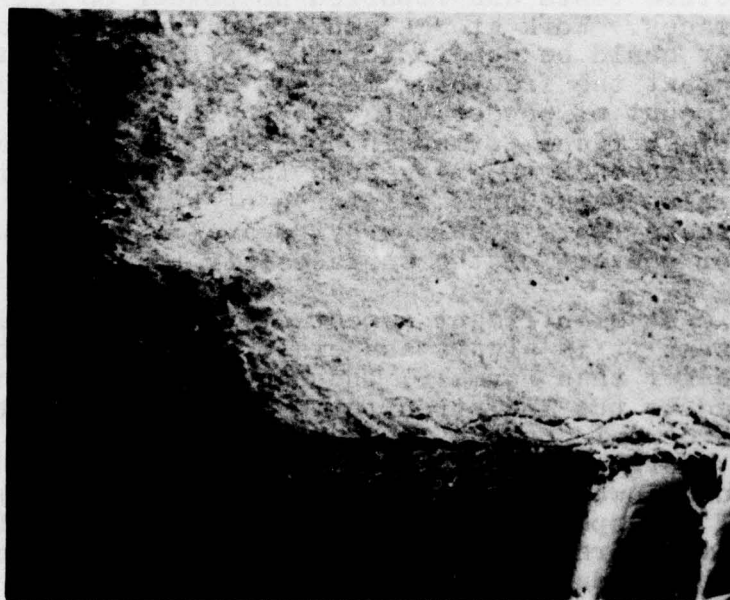
Fig. 1b — Failure from surface flaw x 50

flaw on the non-bonded side of the ceramic.
