AFML-TR-76-81  
Part III

## DEFECT-PROPERTY RELATIONSHIPS IN COMPOSITE MATERIALS

VIRGINIA POLYTECHNIC INSTITUTE & STATE UNIVERSITY  
BLACKSBURG, VIRGINIA 24061

TECHNICAL REPORT AFML-TR-76-81, Part III  
Final Report for Period 3 February 1977 — 3 February 1978

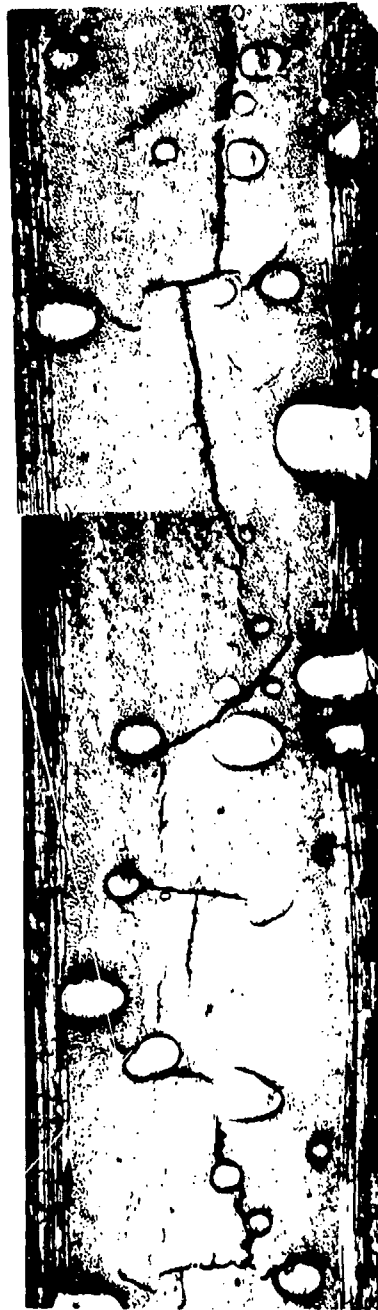
Fig. 2-1 and 2-2 Prefracture replica patterns

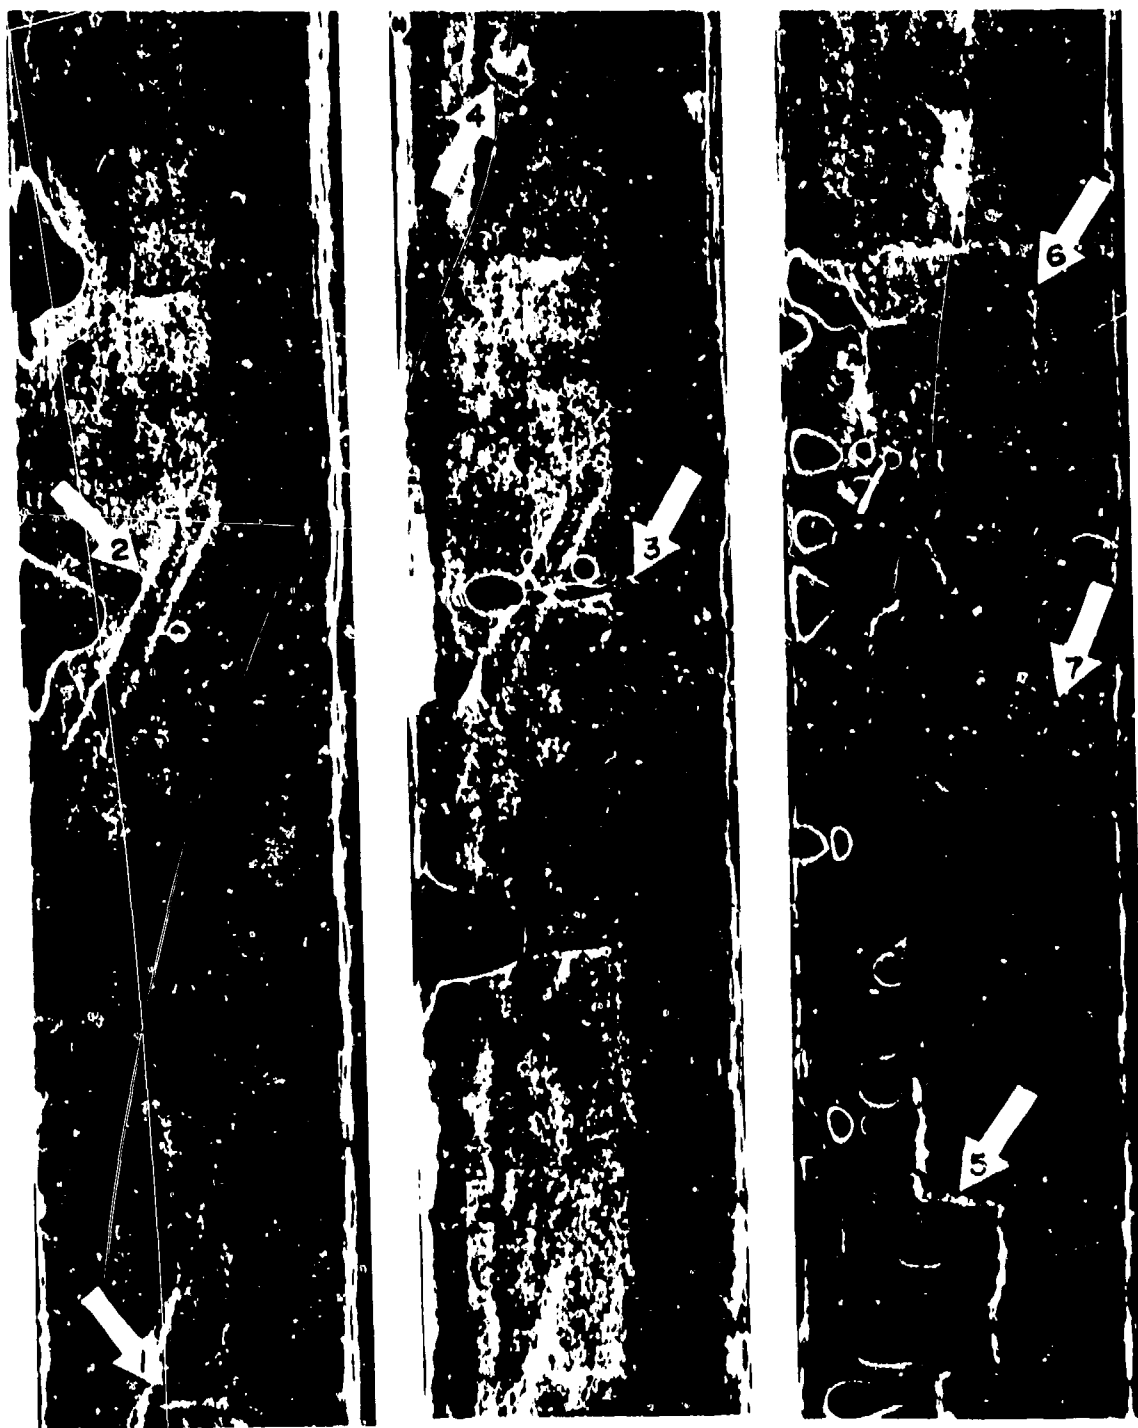
Fig. 3-1 Damage along the edge of a type I specimen at 234 MPa after a) static preload, b) 50 cycles, c) 10,000 cycles

Figure 3.1a represents a 5 mm (0.20 in.) length along the edge of a type I specimen at the 234 MPa static preload (1/2 cycle). Arrow 1 points out one of the four transverse cracks present in this region after the static preload had been applied. These cracks span the two inner 30° layers. The long white lines (arrow 2) are not cracks but are scratches left in the specimen by the cutting process in which the specimens are cut from larger panels. These saw marks are seen in many of the replicas. Figure 3.1b is of the same location as (a) but after 50 cycles. There are no changes except for a small "hooked" crack (arrow 3) that has branched into one of the inner 45° layers. Arrow 4 points out a piece of dust or lint that has stuck to the replica. Some experience is required to properly interpret the information that a replica contains. Confusing areas will be pointed out so that they will not distract from the value of the replication technique itself. As can be seen in Fig. 3.1c, arrow 5, an additional transverse crack has formed after 10,000 cycles. There is also a delamination along the -45°/90° interface at the bottom of the picture. A transverse crack has caused it to jump to the opposite 90°/-45° interface and then the crack at

arrow 5 has caused it to jump back again. From the top of the picture a delamination along the  $90^\circ/90^\circ$  interface appears to have grown downward until it was stopped by another transverse crack. In this case, instead of jumping to another interface, small "branch" delaminations begin to grow from the tips of the transverse crack along the  $+45^\circ/-45^\circ$  interfaces (arrow 6). The transverse crack below this also has branch delaminations originating from its crack tips as well as a small longitudinal crack which has grown into its center. This longitudinal crack may be the beginning of a major delamination. Other points of interest in this picture are the cracks through the outer  $+45^\circ$  layers that stem from the branch delaminations. One of these four cracks is pointed out by arrow 7.

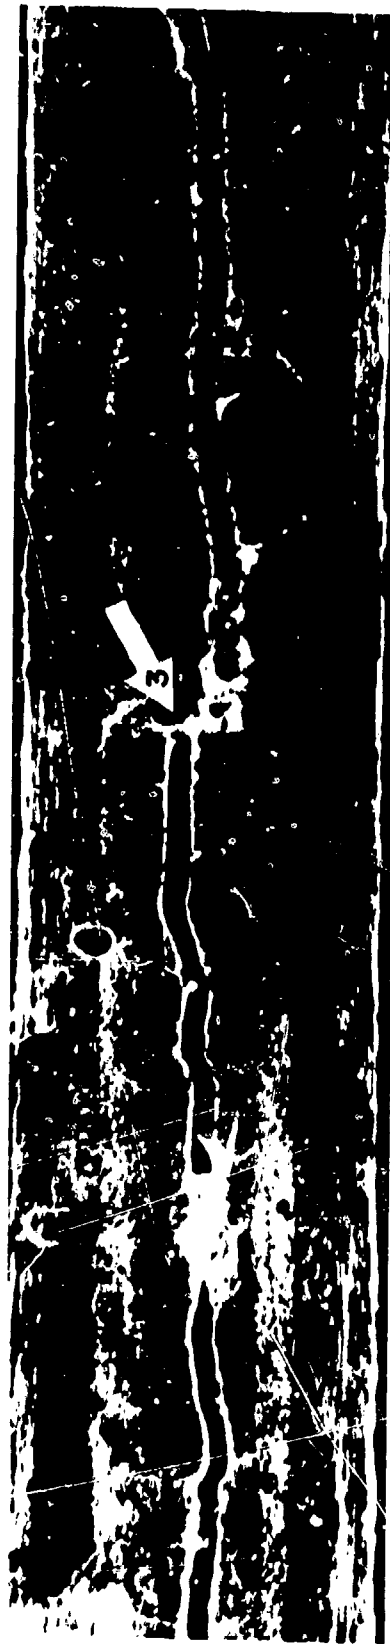
Fig. 3-3 Delamination in a type I specimen at 234 MPa after  
a) 50 cycles, b) 10,000 cycles

A third section of this same 234 MPa specimen is shown in Fig. 3.3. The main purpose of this figure is to illustrate the magnitude of the delamination width at the most severe location. In (a), the delamination growing along the  $90^\circ/90^\circ$  interface from the right hand side has been stopped by a transverse crack and a branch delamination has formed. However, after 10,000 cycles (Fig. 3.3b), it can be seen that the delamination broke through the crack and continued its growth. As observed earlier, there is no jumping between interfaces due to the transverse crack if the delamination is along the midplane. The branch delamination appears to stop growing when the delamination breaks through the parent transverse crack. Arrows 1 and 2 point out longitudinal cracking that has occurred prior to delamination as seen in (b), these cracks determine the path that the delamination will take. The delaminations from the left and right have continued to grow and finally met at the transverse crack pointed out by arrow 3.

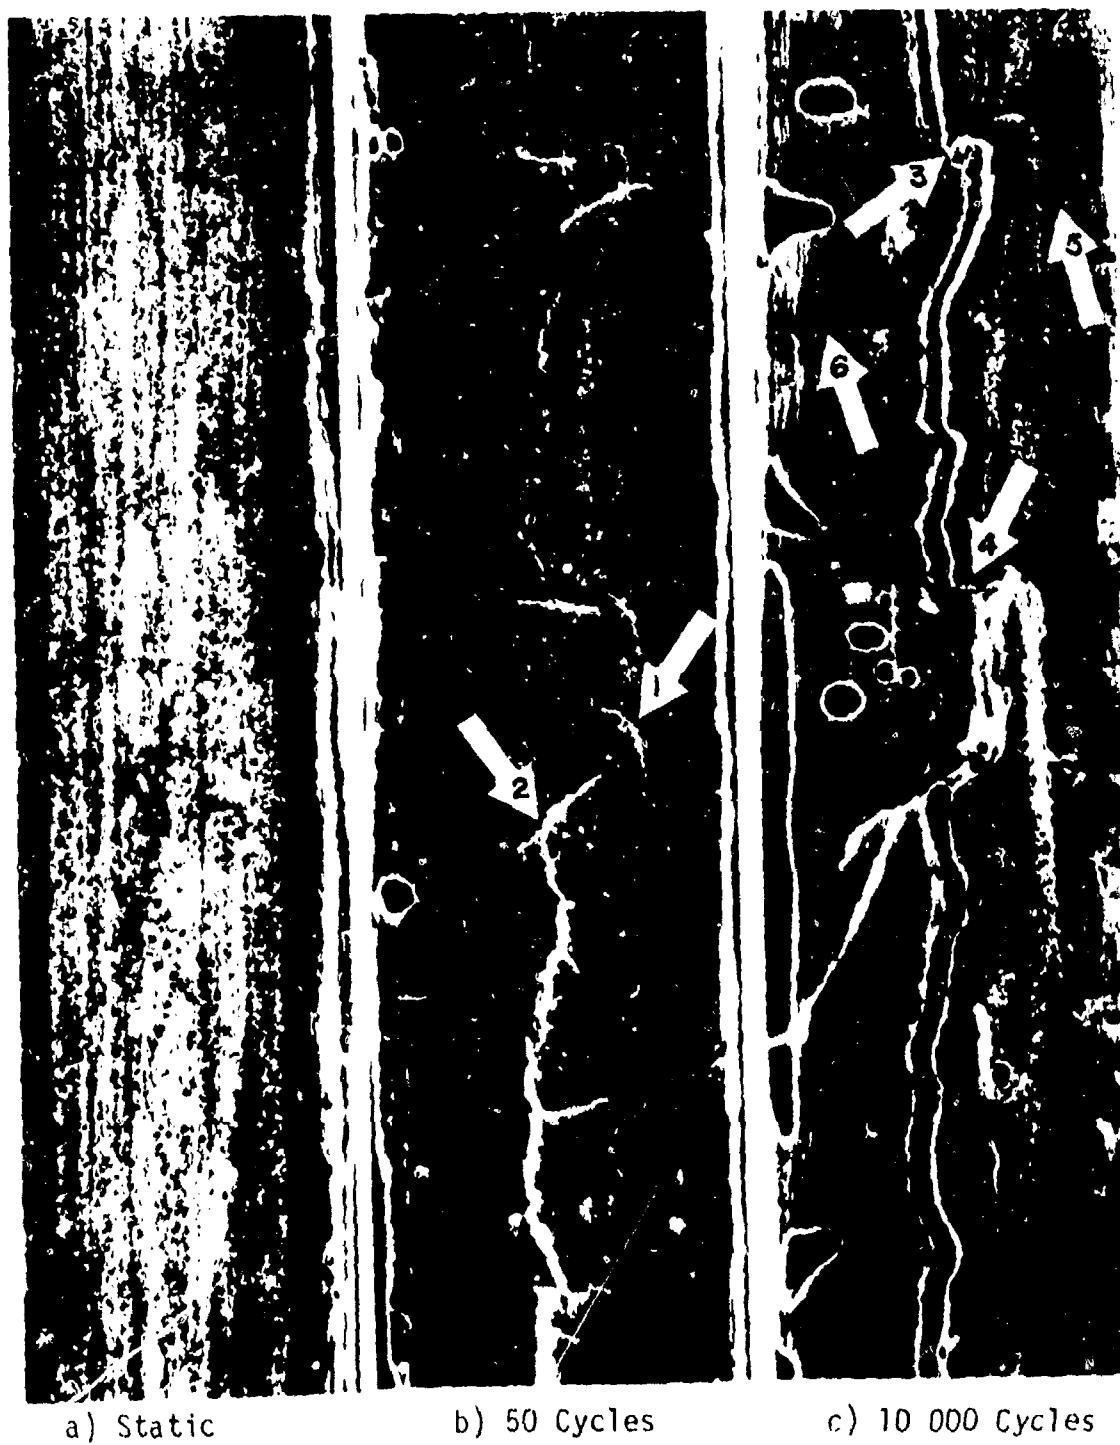
Fig. 3-4 Damage along the edge of a type I specimen at 290 MPa  
after a) static preload, b) 50 cycles c) 10,000 cycles

The characteristics of the damage development observed in the 234 MPa specimen are also observed in the 290 MPa specimen, however, some of the individual phenomena and details, such as branch delamination and longitudinal cracking, appear more pronounced. For example, Fig. 3.4 represents a sequence of events from the 290 MPa specimen. In (a), it can be seen that this particular location on the specimen contained only one transverse crack. After 50 cycles, (b) indicates four, possibly five, transverse cracks, as well as three distinct hooked cracks in the inner  $-45^\circ$  layer. One of these (arrow 1) does not appear to be associated with a parent transverse crack. Arrow 2 points out a turning point in the delamination. This may have been caused by a slanted or angle crack, a portion of which is visible above the turning point.

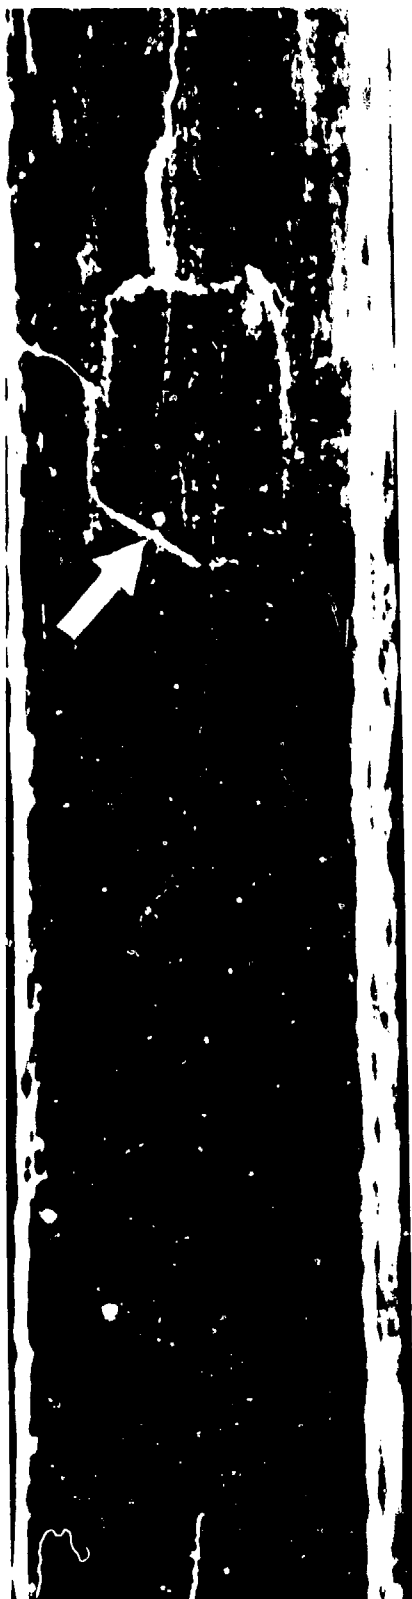
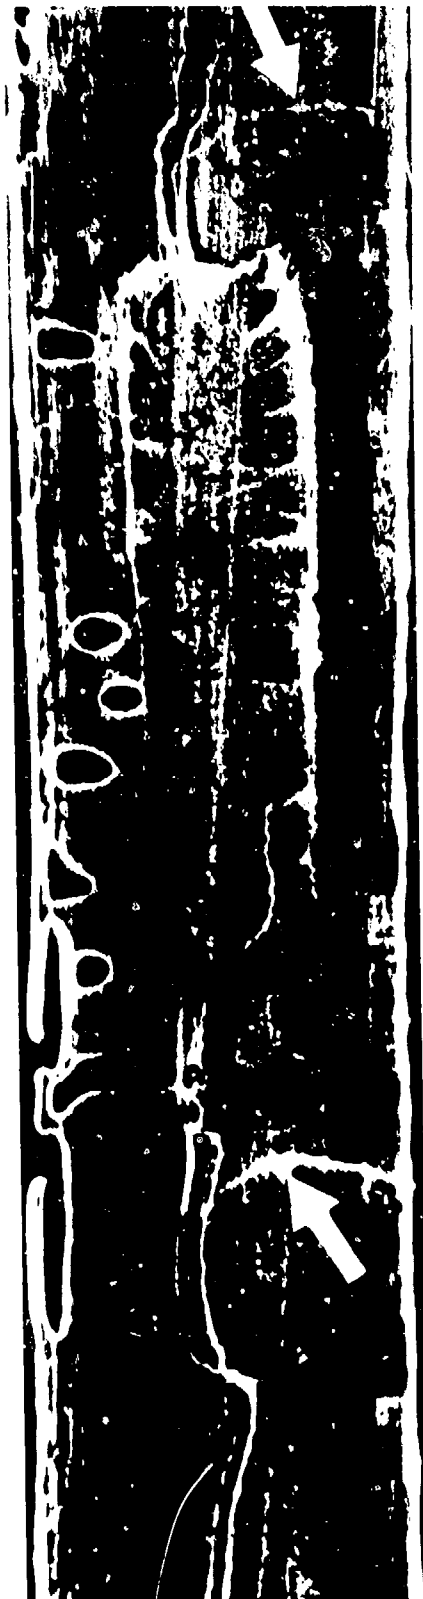
Fig. 3-5 Delamination of  $\pm 45^\circ$  interface at 290 MPa after  
a) 500 cycles, b) 10,000 cycles

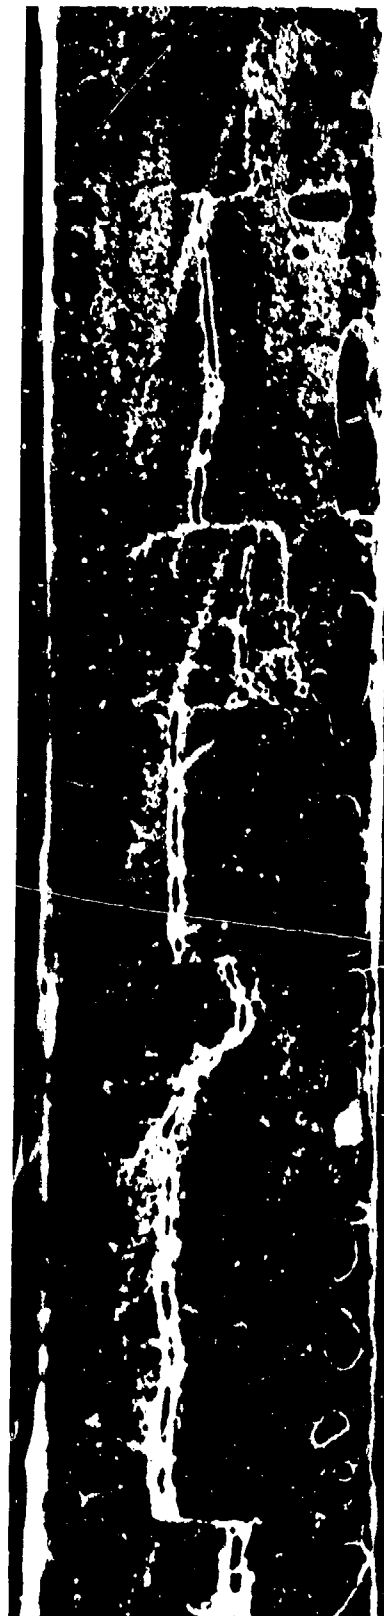
Fig. 3-6 Damage along the edge of a type I specimen at 393 MPa after a) static preload, b) 50 cycles

Figures 3.6 and 3.7 are of the 393 MPa specimen. The characteristics of damage development discussed for the previous specimens are found to be the same for this specimen. Even though it was only fatigued for 500 cycles, the amount of damage is similar to the 290 MPa specimen after 10,000 cycles, except that delaminations are more extensive. There is approximately 97 percent delamination for the 290 MPa specimen and 100 percent for the 393 MPa specimen but its maximum crack width is more than twice as large. As can be seen in Fig. 3.6a, a large number of transverse cracks occur when the specimen is loaded to the static pre-load. The spacing between these cracks is representative of the entire specimen. It tends to vary from about the thickness of the laminate

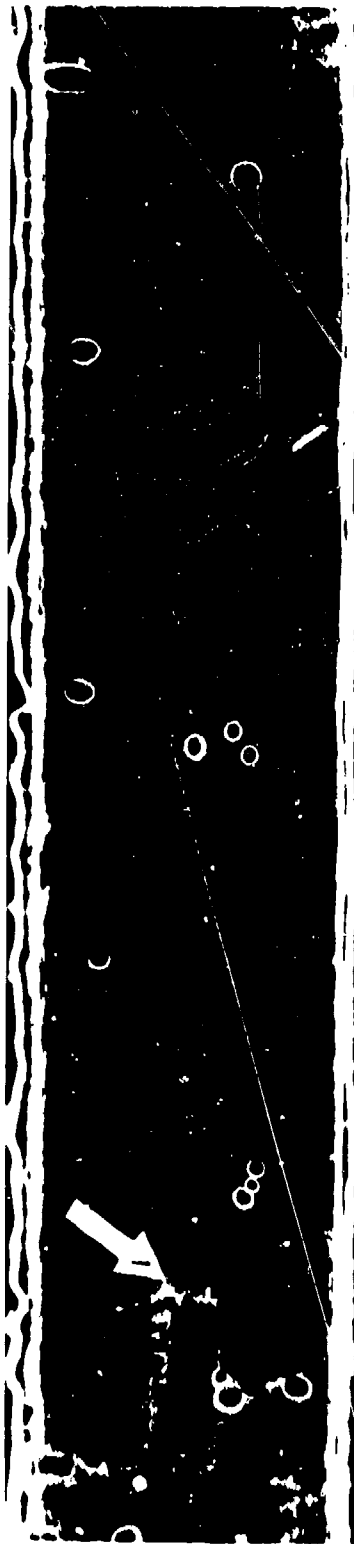
Fig. 3-10 a) Combination of cracks and delaminations through the interior  
six plies of a type II laminate at 290 MPa after 10,000 cycles.  
b) Longitudinal cracking near the end tabs in a type II specimen  
at 290 MPa after 10,000 cycles

Figure 3.10 is of two different areas on this same 290 MPa specimen after 10,000 cycles. The arrow on (a) indicates one of the three transverse cracks through the inner -45° layers. These cracks are connected to cracks through the outer +45° layers by the +45°/-45° interface
