**LIGHTNING TRANSIENT RESEARCH  
ON AN F-111E AIRCRAFT**

*TECHNOLOGY/SCIENTIFIC SERVICES, INC.  
AIR FORCE FLIGHT DYNAMICS LABORATORY (AFFDL)  
ELECTROMAGNETIC HAZARDS GROUP (FES)*

TECHNICAL REPORT AFFDL-TR-78-1  
Final Report for Period June 1976 - December 1976

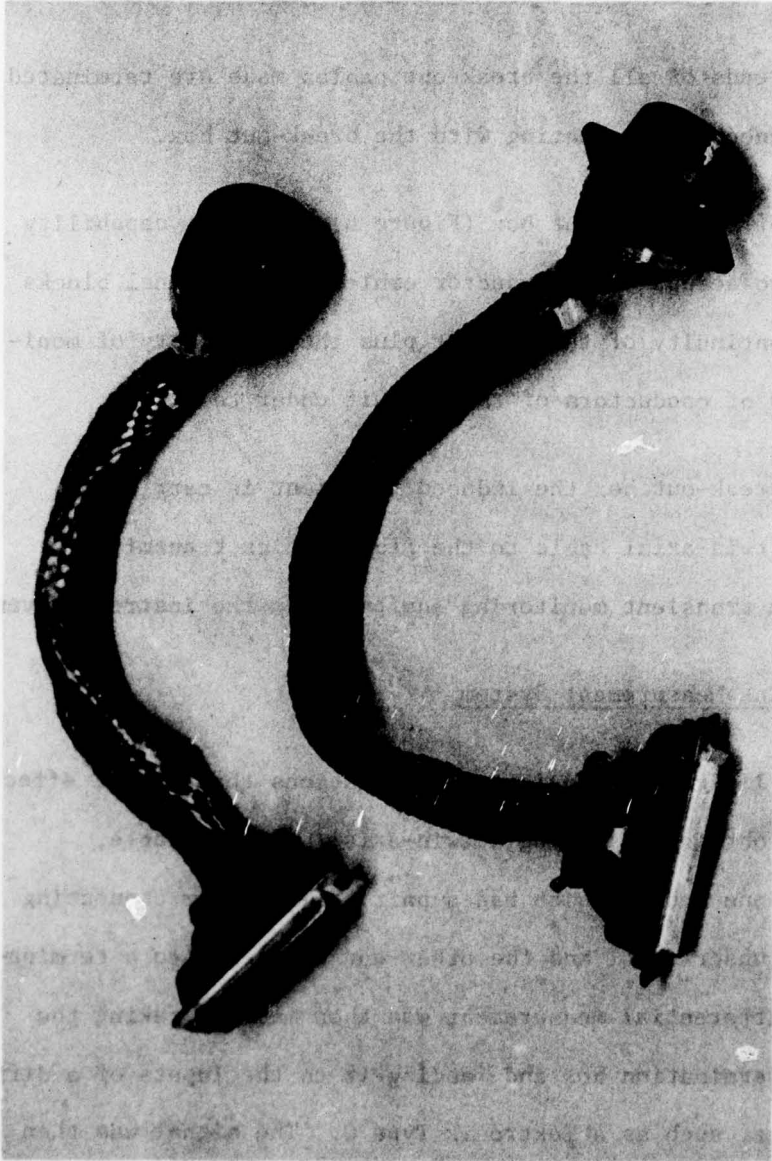
**FIGURE 7**  
**MULTICONDUCTOR CABLES USED**  
**WITH BREAK-OUT BOX**

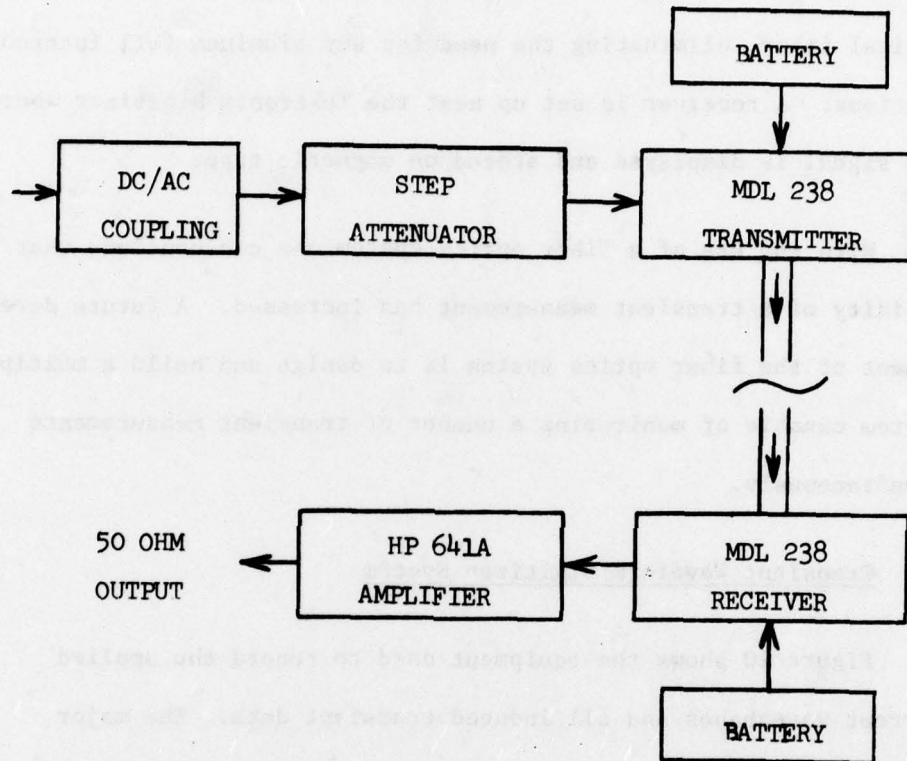
**FIGURE 9**  
**FIBER OPTICS MEASUREMENT SYSTEM**

The fiber optics measurement system was built to be readily adaptable to the break-out box where connections to circuits are made. Maximum input to the fiber optics transmitter is 500 millivolts either positive or negative. Coupled with a variable attenuator of up to 50:1, it is possible to accurately observe a voltage

transient of up to 50 volts. The frequency response of the system has been calibrated from 2 KHz to 22 MHz.
