## Laser Irradiation of Carbon Fibers and Composites

J. STEPHEN EVANGELIDES  
Development Group  
The Aerospace Corporation  
El Segundo, Calif. 90245

25 January 1979

Final Report

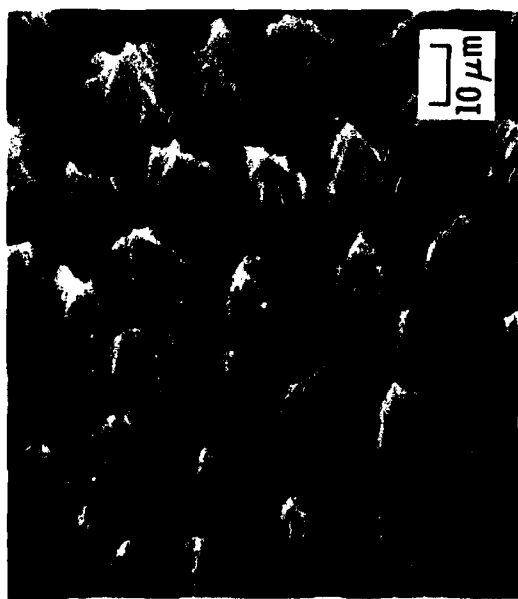
Figure 29. Scanning Electron Micrographs of WYB After Irradiation

The rayon precursor filaments after irradiation are shown in Figures 29 thru 31. The rayon filaments typically eroded to a conical or slightly pointed shape. Internal flaws and microporosity can be found. The internal structure is most apparent in the WYB filament. Groups of oriented planes appear parallel to the surface of the filament, matching the filament crenulations.
