FIELD TESTS OF SIX OFFSHORE
OIL CONTAINMENT BOOMS

P. R. Corpuz and R. A. Griffiths

Environmental Technology Branch
United States Coast Guard
Washington, DC 20590

Final Report
Part 1

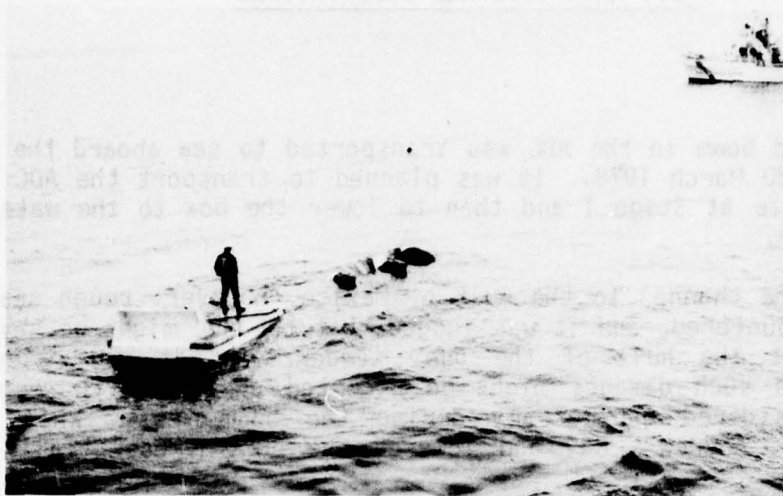
Figure 21. The Coast Guard boom being extracted from the ADC.

Figure 21 shows the boom being extracted from the ADC by the USCGC POINT LOBOS. A man is needed aboard the ADC to release the tailgate and assist in connecting the tow line. During extraction, four flotation bags failed to inflate. The CO₂ bottle on one of these four triggered but failed to inflate the bag due to an improperly tightened valve. The valve was corrected, and the bag inflated properly with a spare CO₂ bottle. The other three did not trigger during extraction, but inflated properly when triggered manually from a Zodiac boat.

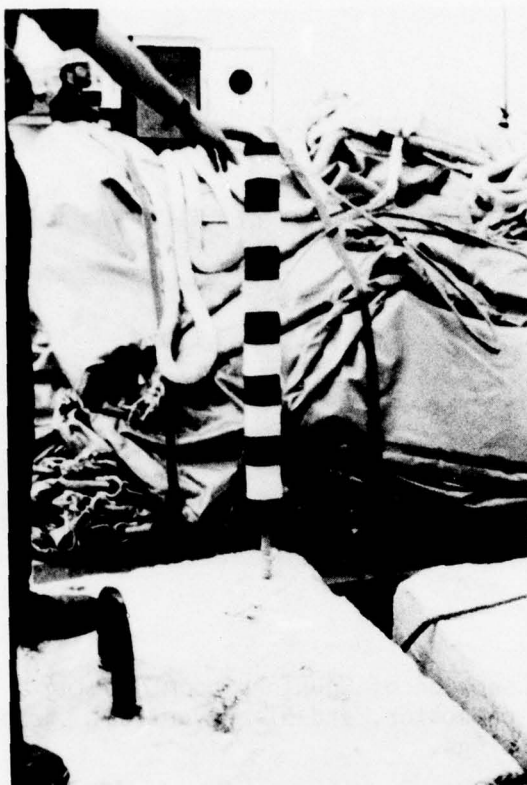
Figure 31. A "barber pole," which was attached to the bottom of the Sjuntorp boom skirt to attempt to observe the skirt motions.

The bottom of the dowel was fastened to the bottom of the skirt, and the styrofoam was slid up or down the dowel so that the pole would float almost vertically but not pull up the skirt excessively. This trick was also tried later with the Whittaker and Bennett booms; however, it failed and provided no useful information.

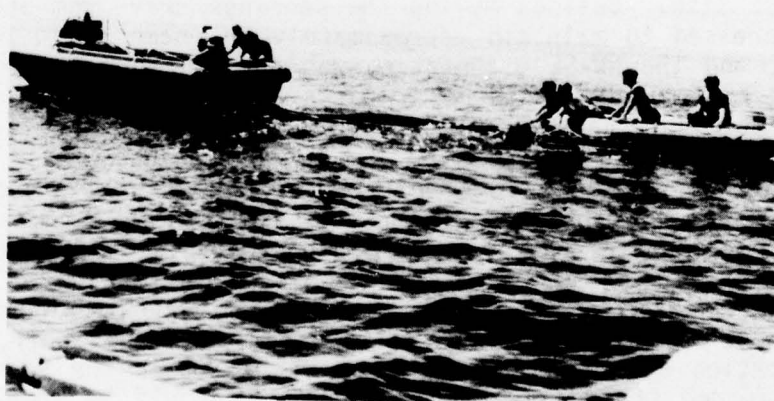
Figure 33. The Vikoma Seapack with the boom being deployed from the stern.

The boom was deployed from the Seapack with the assistance of Canadian Coast Guard personnel. The boom did not deploy automatically as the towing continued after releasing the backboard on the Seapack, however. An installation error resulted in premature inflation of the flotation cuff on the top of the boom, making it very difficult to complete deployment and causing a split seam on the cuff. A further complication was caused by a jammed mechanism in the Seapack which had to be forced physically before deployment could be completed. Rather than merely towing the Seapack to deploy the boom, a Zodiac boat assisted in extracting the boom, as shown in Figure 33.

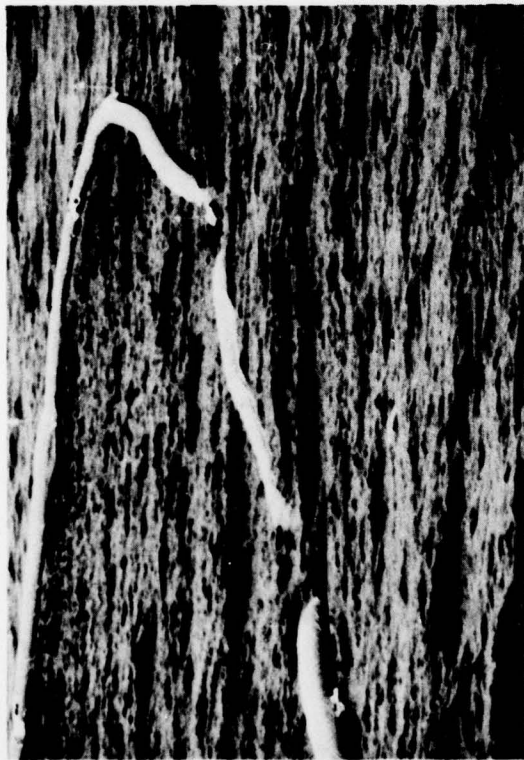
Figure 46. Air leaks in the Bennett boom connectors led to sinking.
