**Phase II Evaluation of a 30-mm  
Thin Wall Steel Cartridge Case**

TECHNICAL REPORT ADTC-TR-79-2

FEBRUARY 1979

3246TH TEST WING  
ARMAMENT DEVELOPMENT AND TEST CENTER  
AIR FORCE SYSTEMS COMMAND • UNITED STATES AIR FORCE  
EGLIN AIR FORCE BASE, FLORIDA

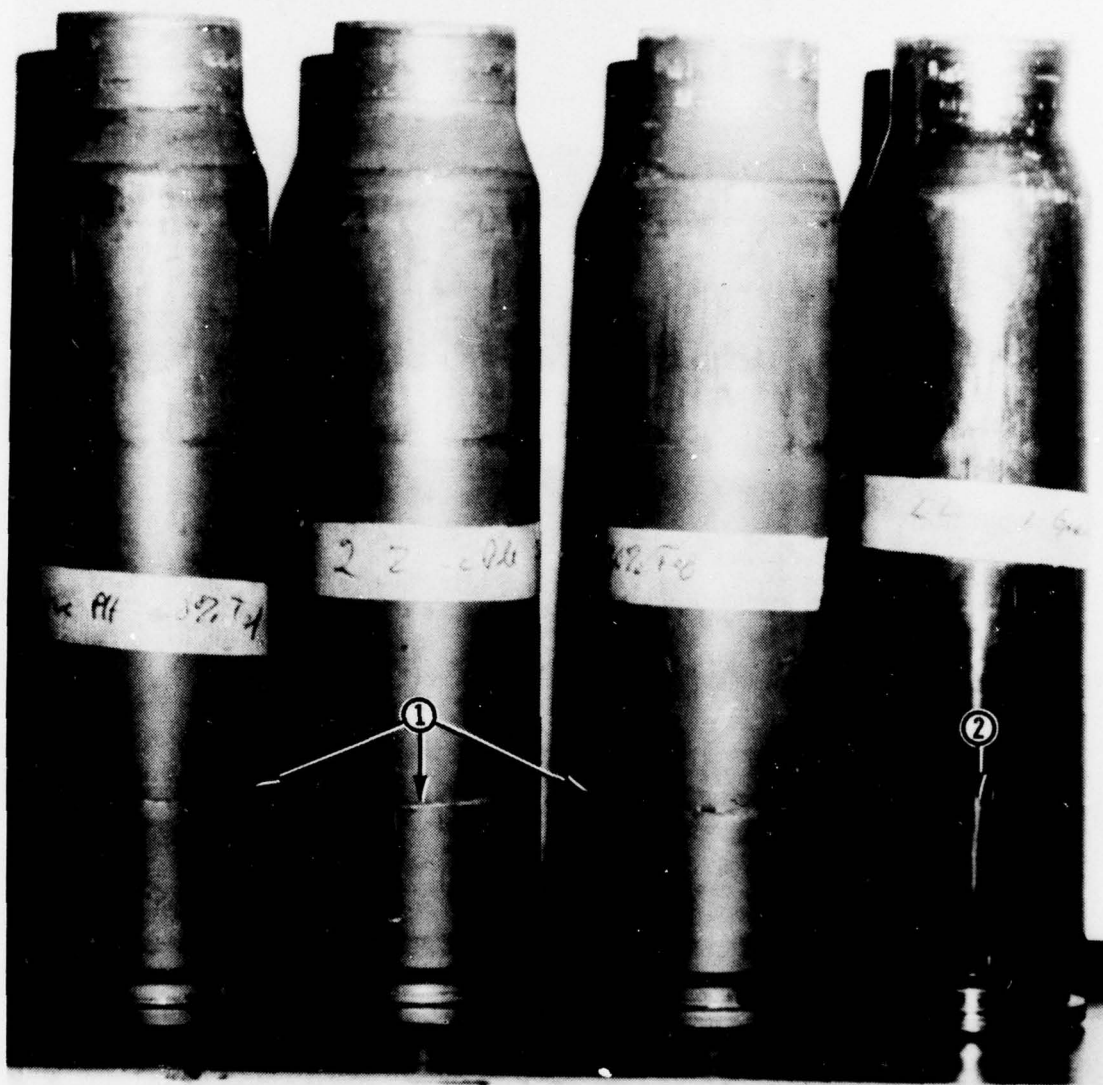
Twenty-eight steel case rounds of various configurations (Table 1) were fired singly. Nineteen rounds cracked or split (Figures 5, 6, and 7) and five rounds stretched. Four rounds had no visible structural degradation. Three of these were regular steel rounds (Figure 6) loaded for high chamber pressure and coated with a thin film of oil. The other was finished with Mader lacquer (Figure 7) over phosphate.

Figure 7. Four cases from Group B showing (1) cracks in cases coated with 30 percent Teflon over zinc plate and (2) stretch in a case coated with Mader lacquer over phosphate

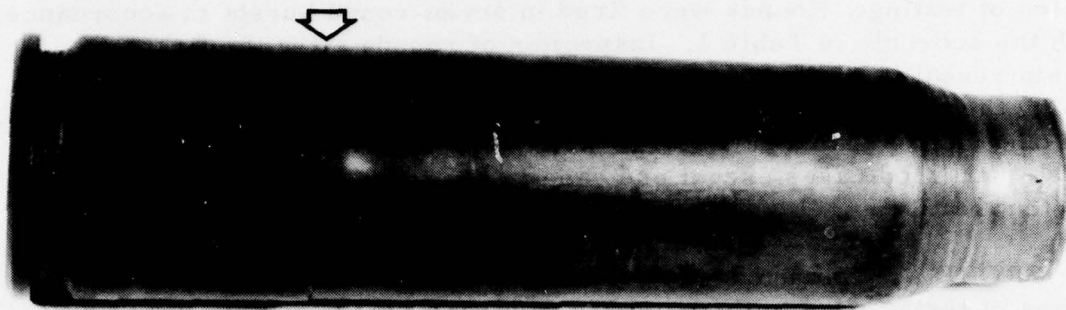
Figure 9. Teflon coated steel case from burst 3 of Group J showing crack (arrow)

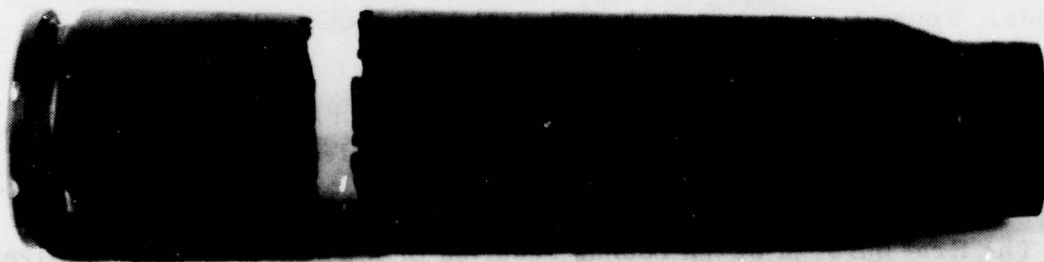
Figure 10. Teflon coated steel case from burst 3 of Group J showing case separation
