# BRITTLE MATERIALS DESIGN, HIGH TEMPERATURE GAS TURBINE

## CERAMIC TURBINE ROTOR TECHNOLOGY

13TH INTERIM REPORT FOR THE  
PERIOD OCTOBER 1977 — MARCH 1978

Arthur F. McLean, Robert R. Baker

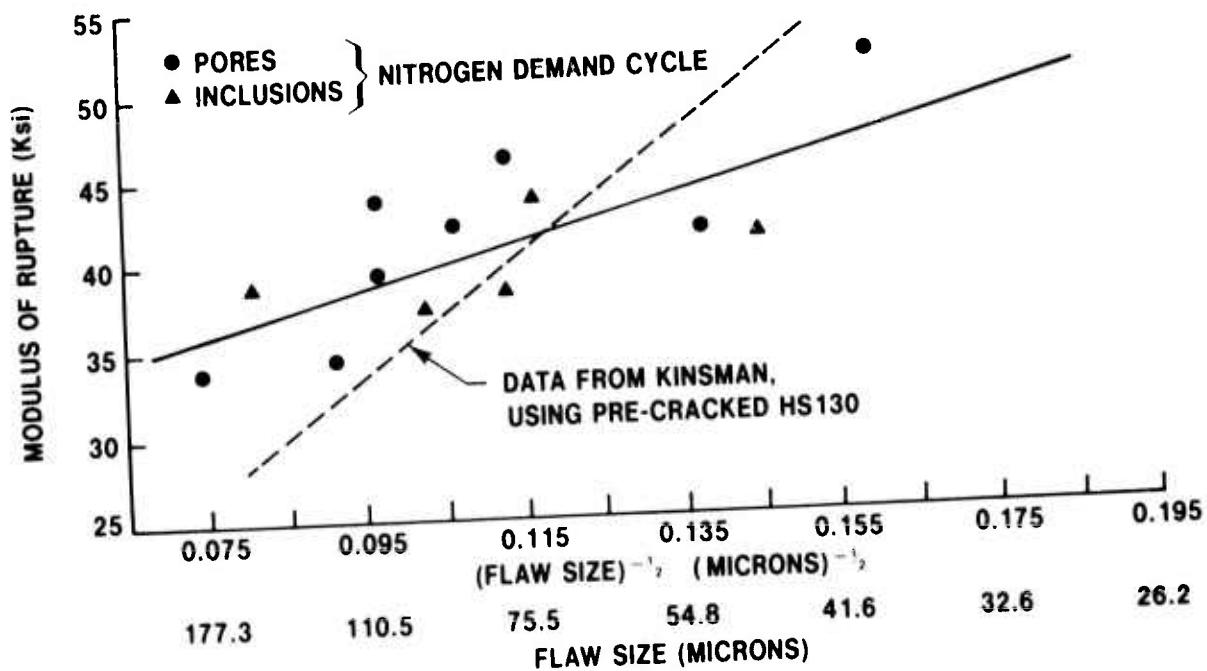
Figure 2.1 Test Bar MOR Versus Flaw Size

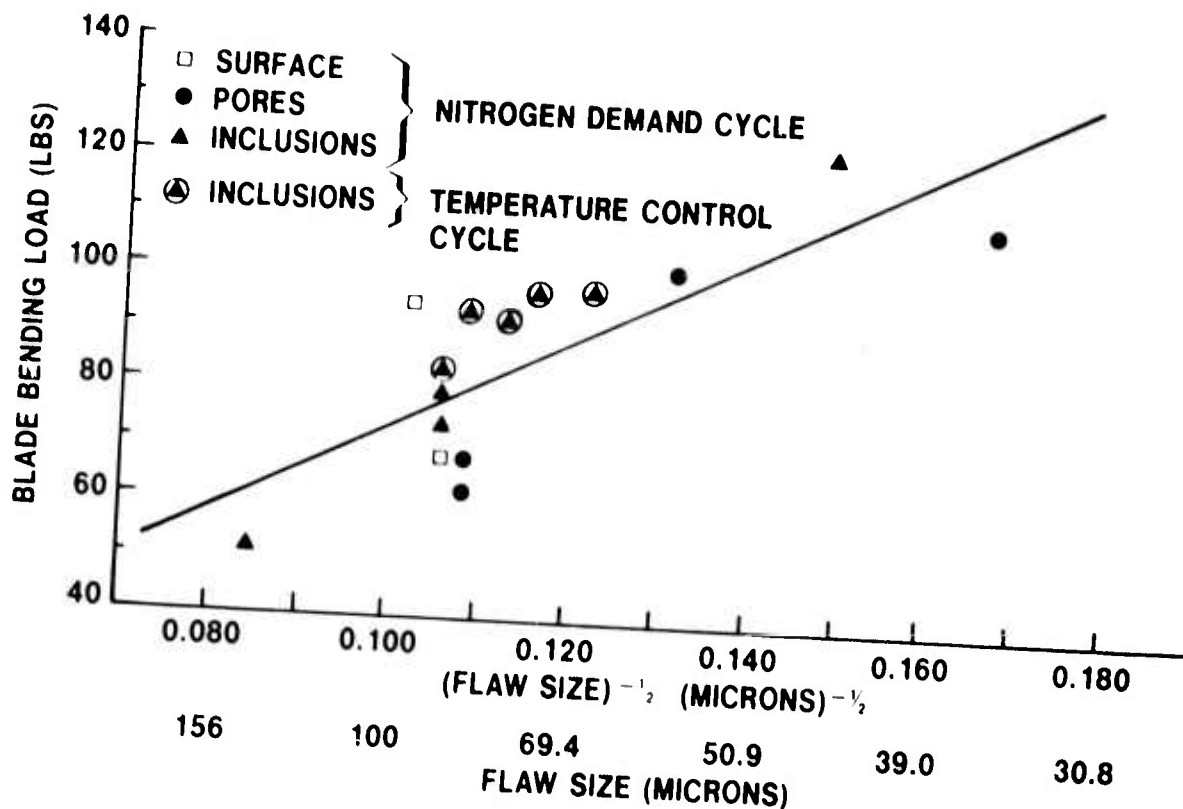
Figure 2.2 Rotor Blade Bend Load Versus Flaw Size

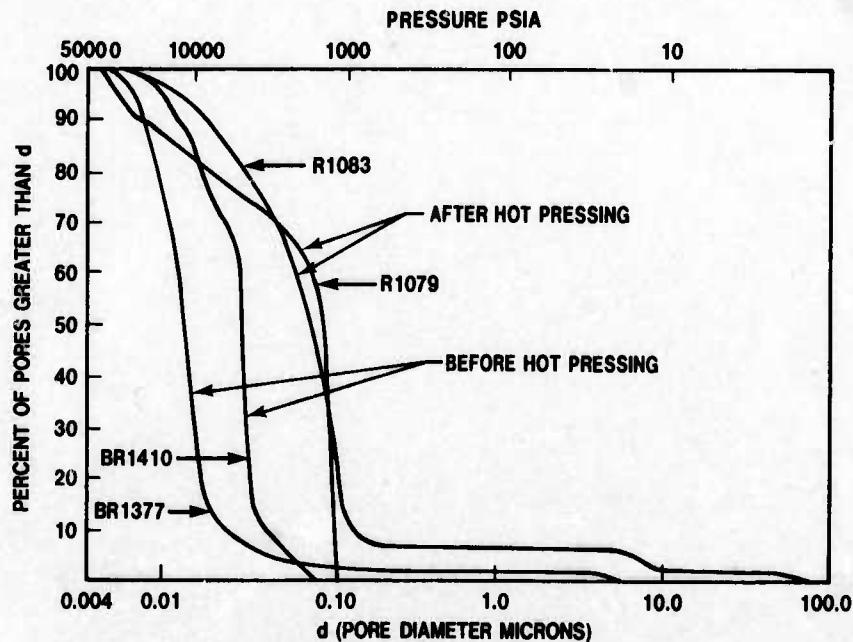
Figure 3.1 Pore Size Distribution Before and After Hot Press Bonding

Analysis of the microstructure of the blades indicated they had changed from a shiny black to a gray color after hot pressing with a corresponding increase in non-uniform porosity as shown in Figure 3.1. X-ray analysis showed the phase composition of the silicon nitride had changed from an average of 70%  $\alpha$ , 29%  $\beta$  before press bonding to an average of 22%  $\alpha$ , 75%  $\beta$  and 3% silicon oxynitride after press bonding (Table 3.2). Also shown in this table is data on two blade rings at an intermediate processing step, (after blade fill nitriding), which indicated that the degradation was occurring during hot press bonding.<sup>(13)</sup>

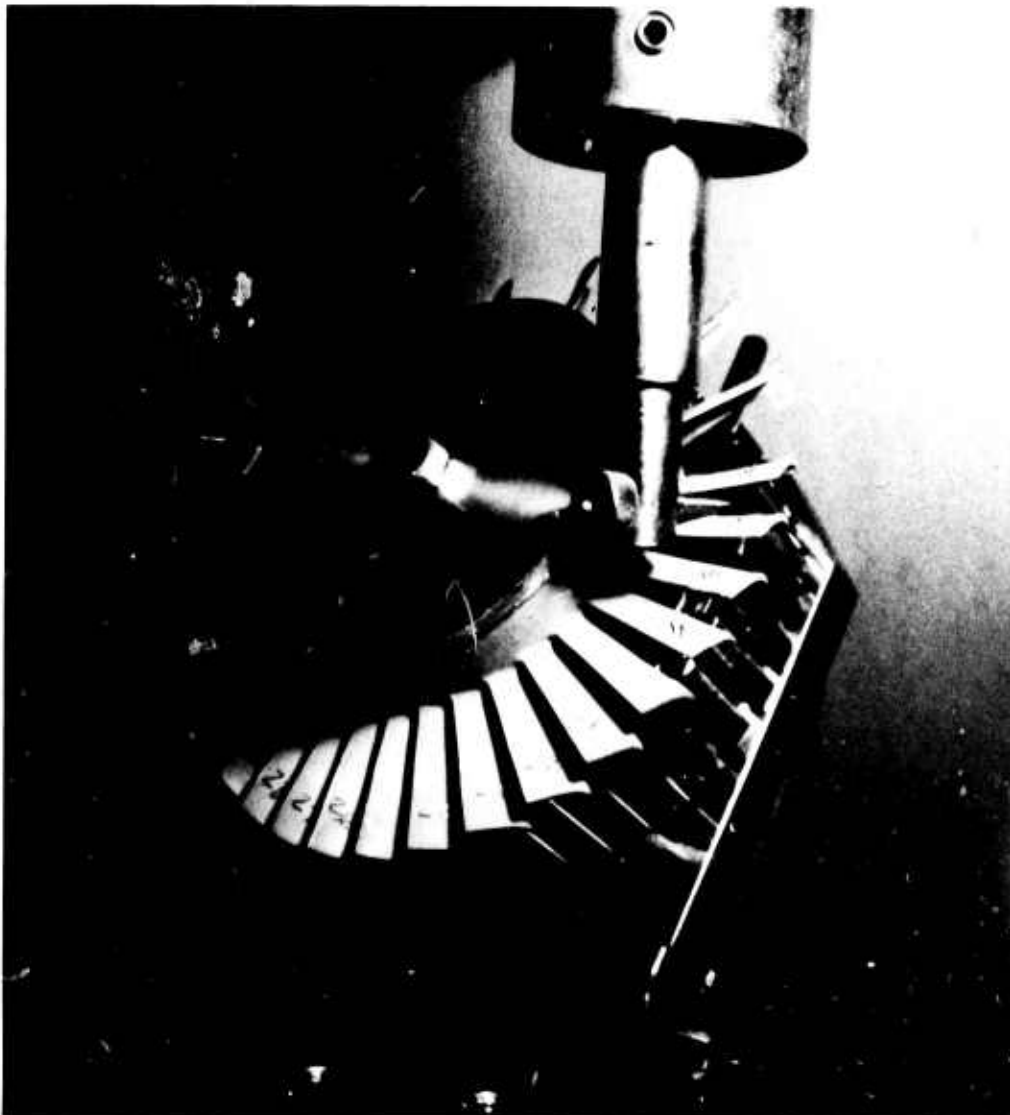
Figure 3.3 Rotor Blade Bend Test Set-Up

- (a) First, the odd numbered blades of a blade ring were loaded to failure in the load test fixture(11) (Figure 3.3) resulting in a blade ring as shown in the top right of Figure 3.4.
- (b) The blade ring with remaining even blades was then processed through the blade filling operation.
- (c) If an "after blade filling comparison" was required, the blade fill was removed and the even blades were loaded to failure.
- (d) If an "after hot pressing comparison" was required, the encapsulated blade ring was processed through the hot pressing operation, then the blade fill was removed and finally the even blades were loaded to failure.

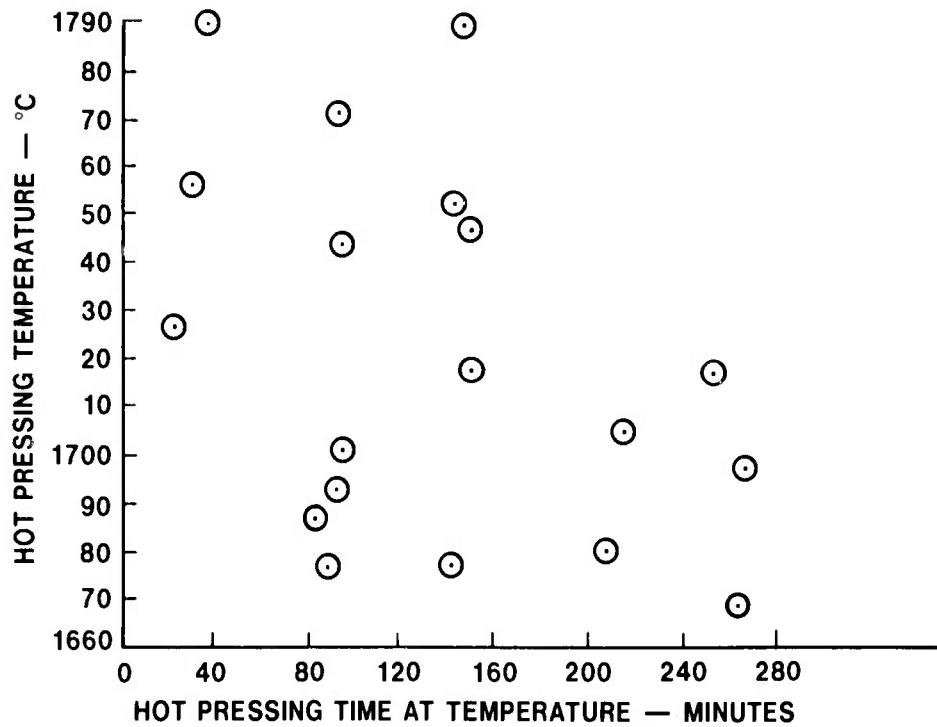
Figure 3.6 Times and Temperatures for Experimental Hot Pressings

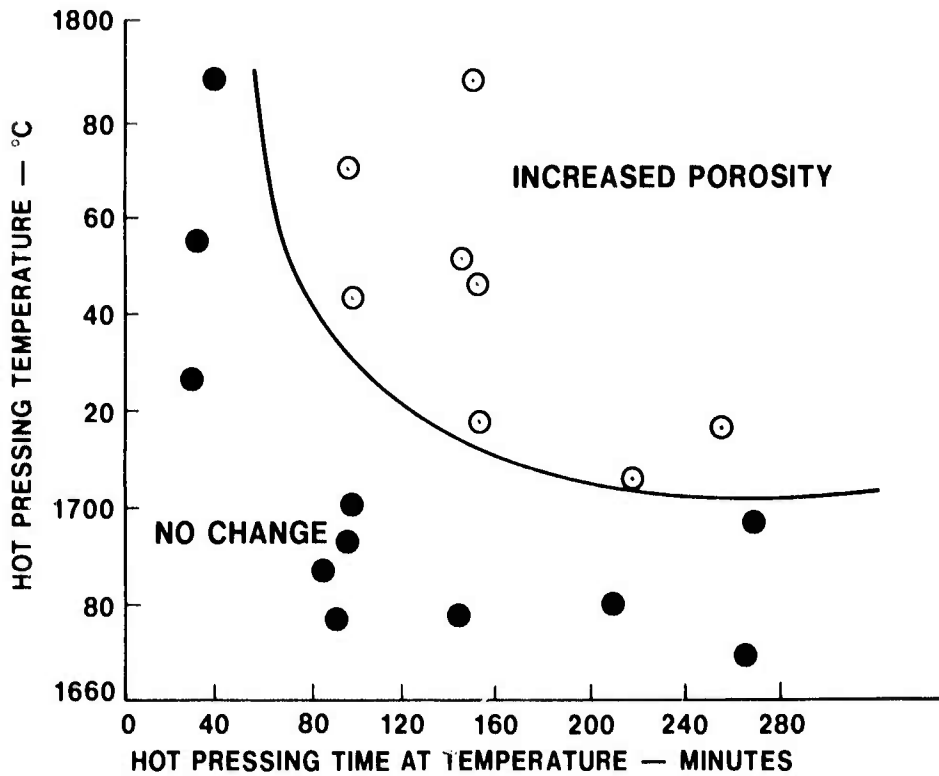
Figure 3.10 Change in Porosity Versus Hot Pressing Parameters

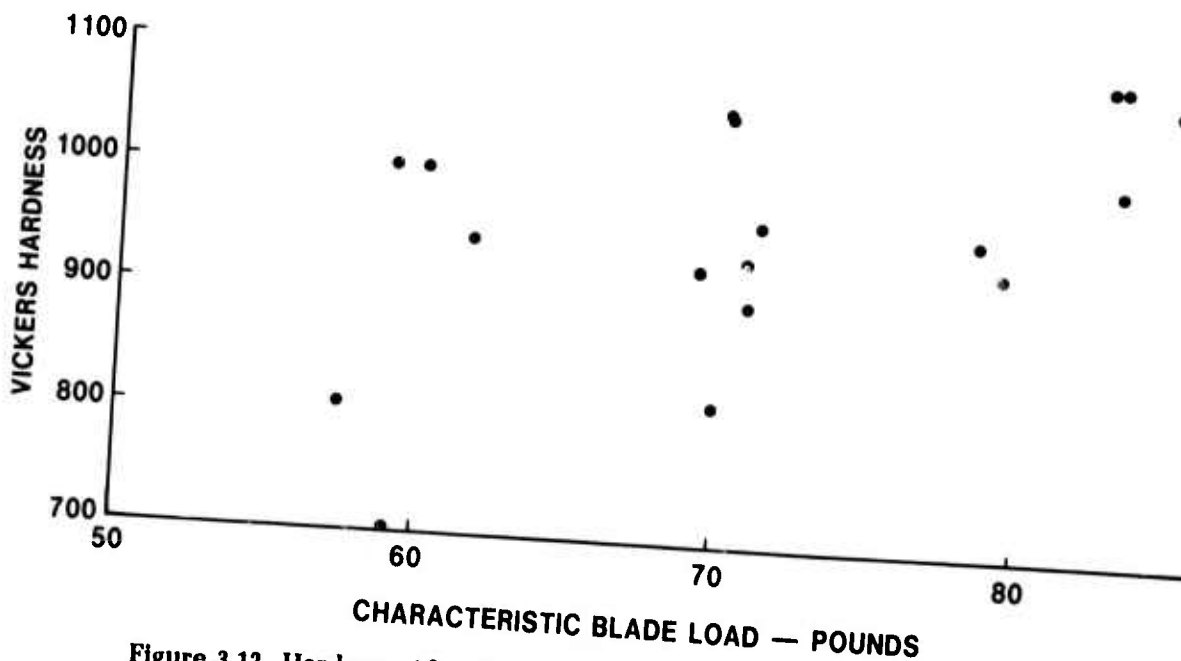
Figure 3.12 Hardness After Hot Pressing Versus Characteristic Blade Load

The hardness of the blade ring material appeared to be a possible method to quantitatively describe the general microstructural appearance. Hot pressed silicon nitride has a hardness of 1700 kg/mm<sup>2</sup> while reaction bonded silicon nitride exhibits hardnesses of 900 to 1300 kg/mm<sup>2</sup>(16). It was assumed that changes in the microstructure (especially the porosity) would effect the hardness value. This was shown to be true for the samples shown in Figure 3.9. However, the hardness data in general only yielded a rough correlation to porosity. It was further assumed that hardness should show a correlation with the strength of reaction bonded silicon nitride. Figure 3.12 shows the relationship between hardness and characteristic blade bend load.

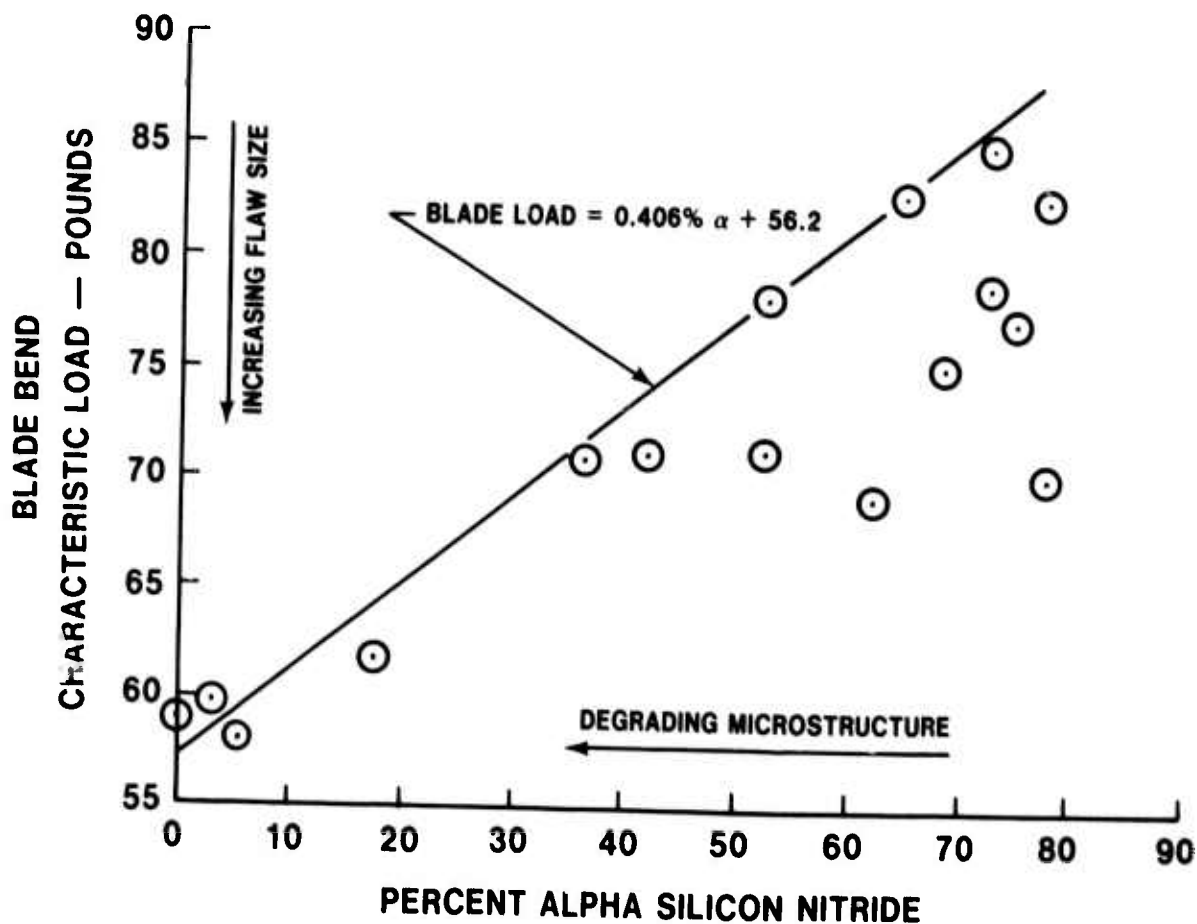
Figure 3.14 Blade Bend Load Versus Percent Alpha Silicon Nitride After Hot Pressing

Converting the data in Figure 3.13 utilizing the relationship established in Figure 3.14 resulted in the strength degradation versus hot pressing parameters (time and temperature) presented in Figure 3.15.

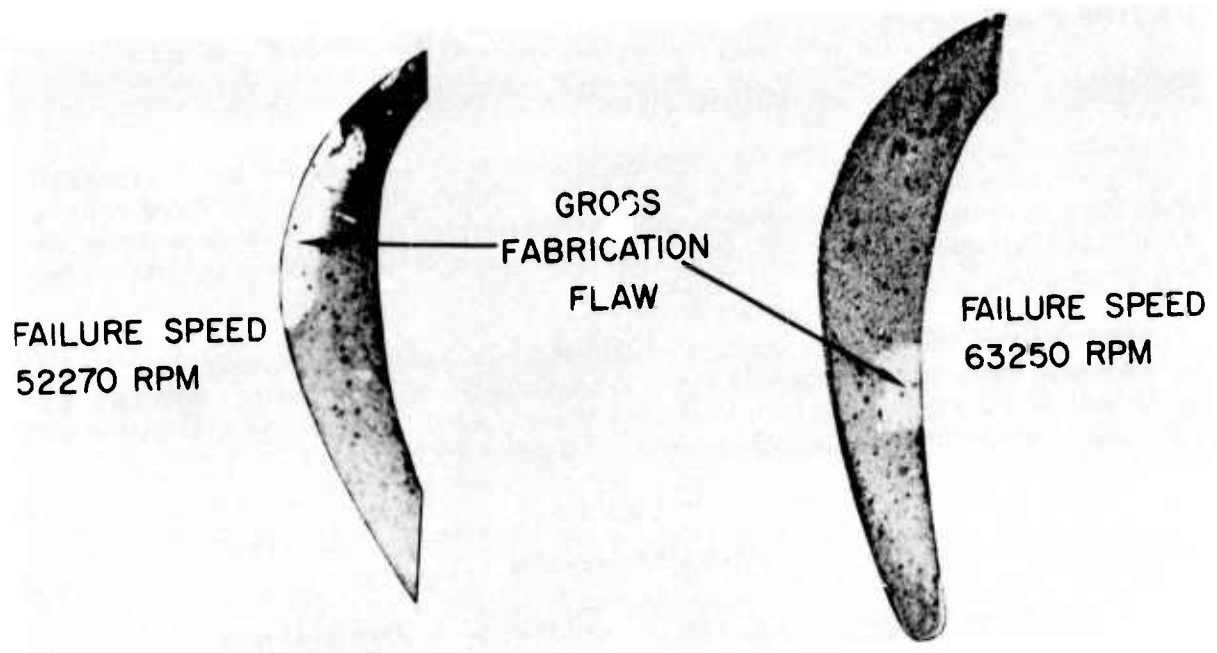
Figure 4.1 Typical Fracture Surfaces with Gross Fabrication Flaws

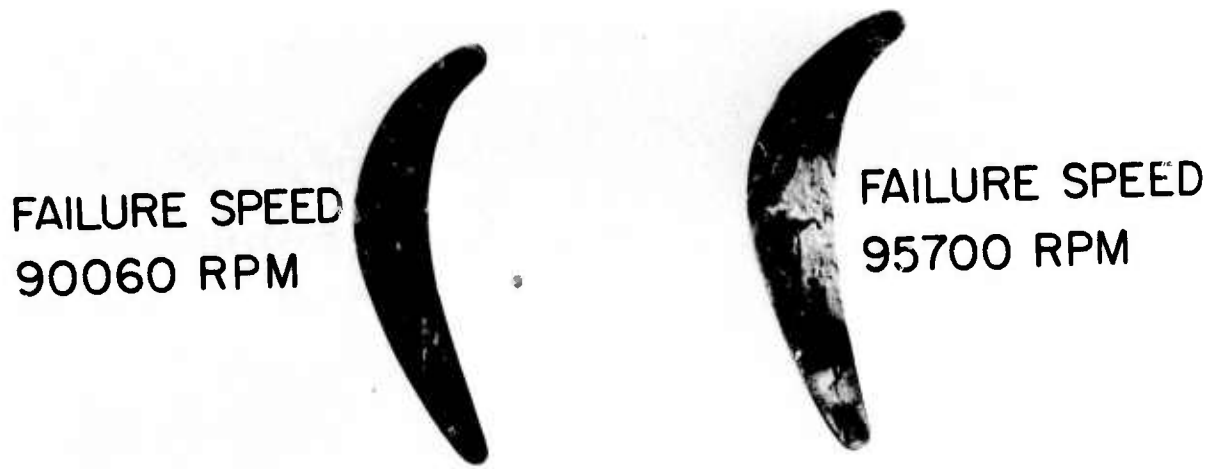
Figure 4.2 Typical Fracture Surfaces without Gross Fabrication Flaws

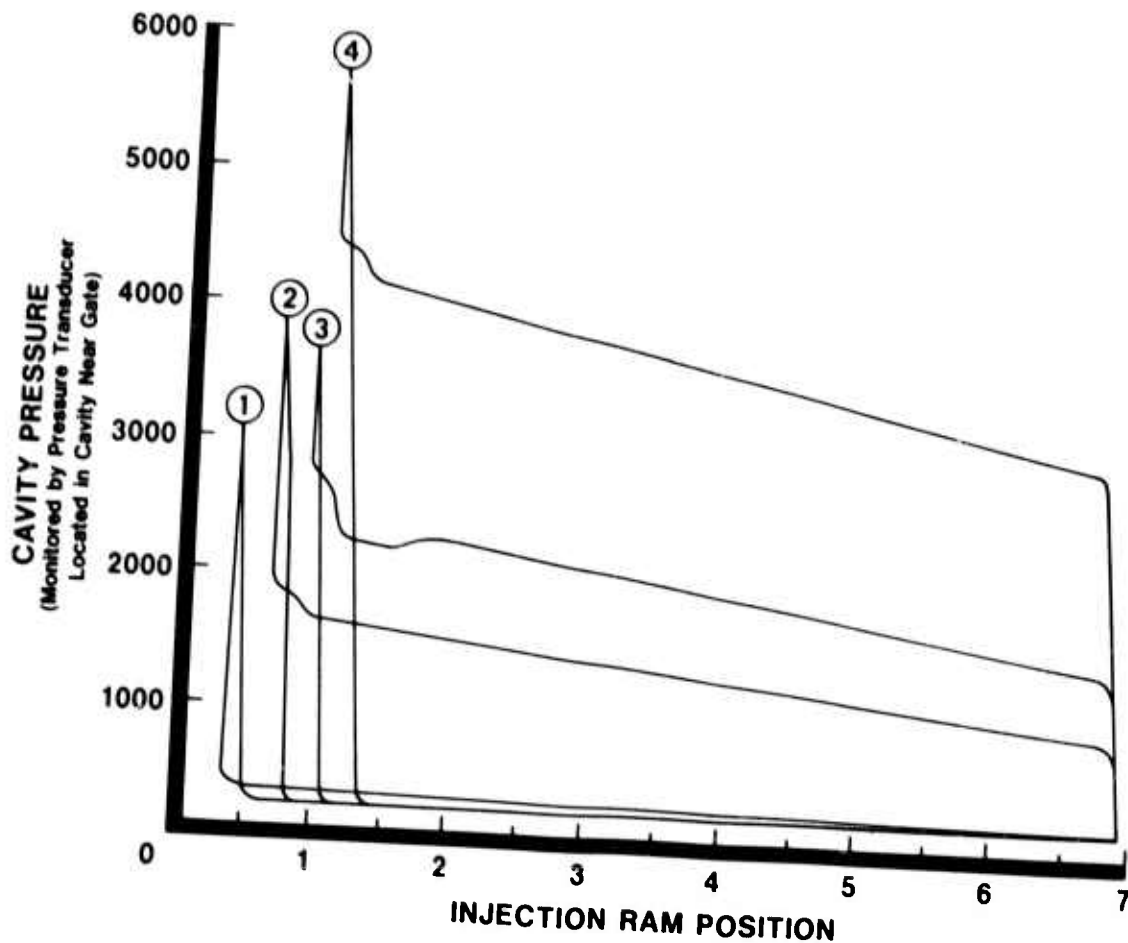
Figure 4.9 Typical Cavity Pressure Profiles During Phase One

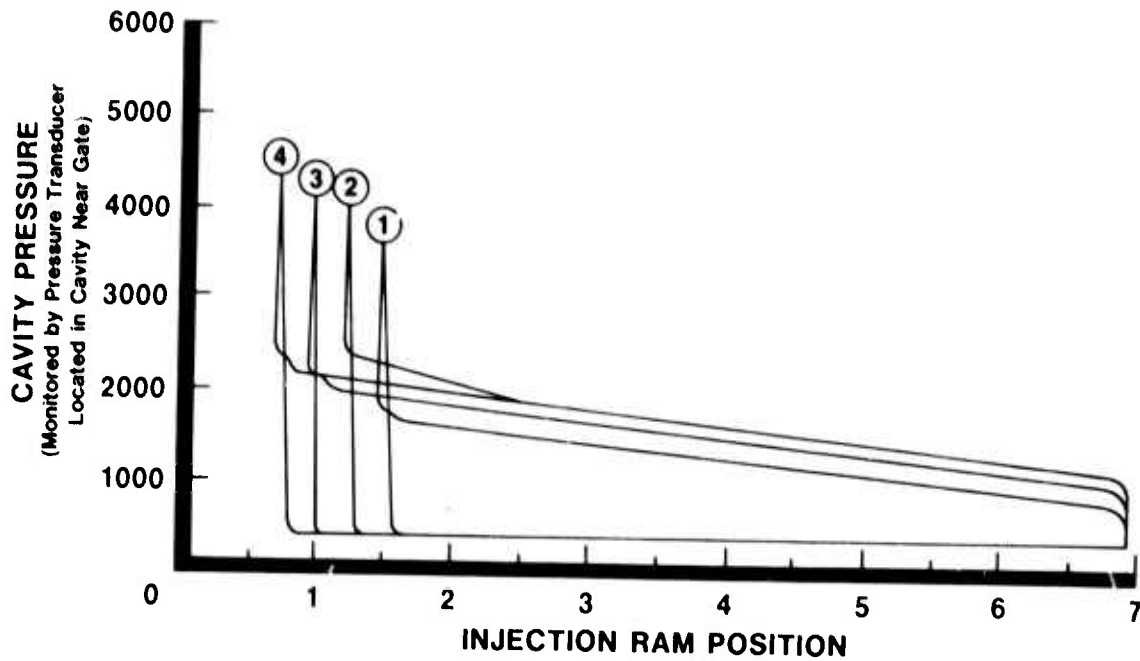
Figure 4.10 Typical Cavity Pressure Profiles During Phase Two

An example of four sequential cavity pressure vs. ram position curves is shown in Figure 4.10. The surface finish and ease of removal for the molded rotors was more consistent during Phase Two controlled molding. Molding parameters used during Phase Two included all those held constant under Phase One and the following adaptive process control unit parameters. Fill stroke was nine inches with a cushion of 0.6 inch. Cavity pressure limit was 1200 psi, this level when achieved shifts the control from the injection mode to the hold mode. Injection profile was a constant 100% of machine capacity for the entire 9" stroke. Hold pressure was ramped from 800 psi to 1300 psi over a 6 second hold time.

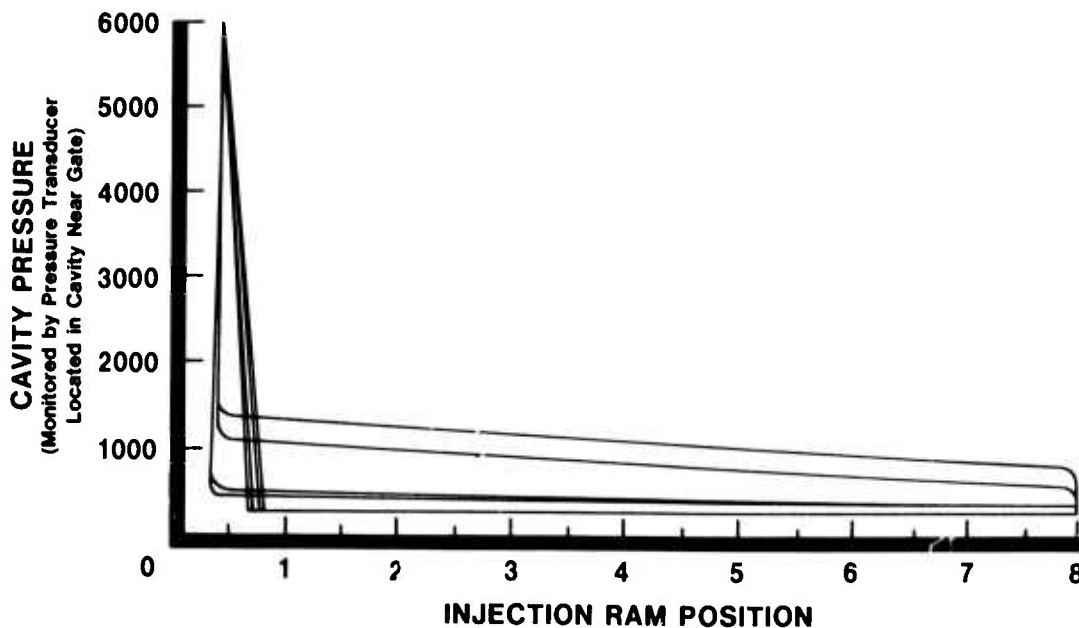
Figure 4.11 Typical Cavity Pressure Profiles with Controlled Cushion

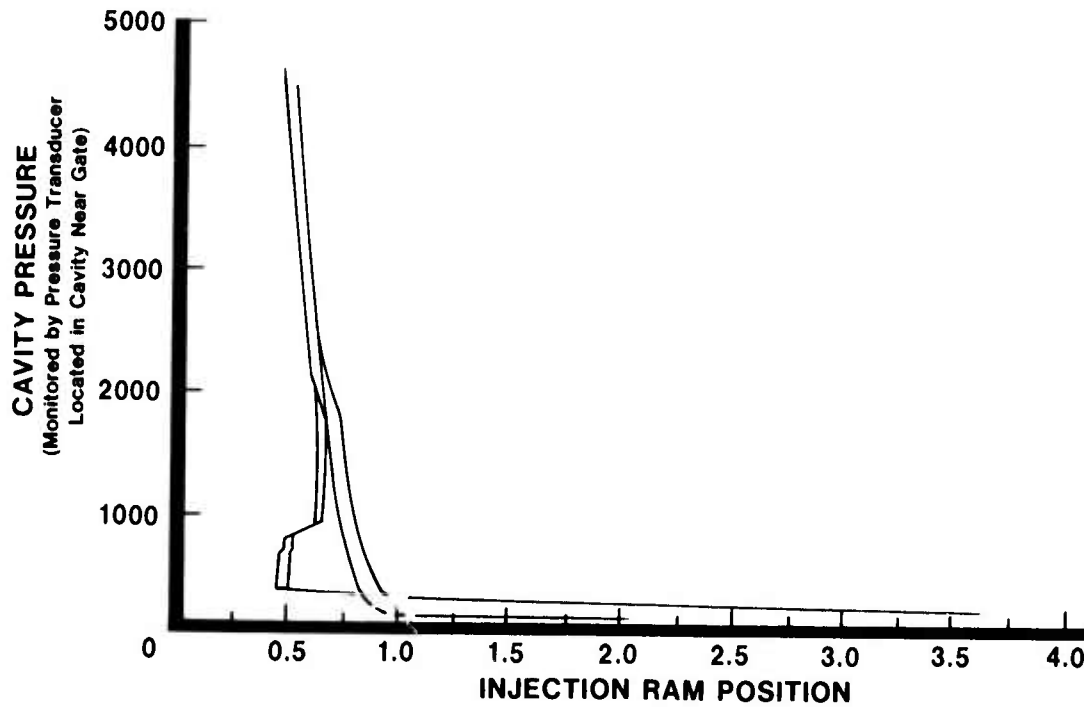
Figure 4.12 Expanded Oscilloscope Scale

In order to more accurately see the results of changing injection and hold profile values the X-(ram position) scale of the oscilloscope was expanded. The resulting curves were more easily interpreted. This change was needed to discern between subtle variations encountered from shot to shot under adaptive process control. As seen in Figure 4.11, prior to scale expansion, the curves for each shot appeared colinear. The expanded scale as seen in Figure 4.12 allowed differentiation between shots.

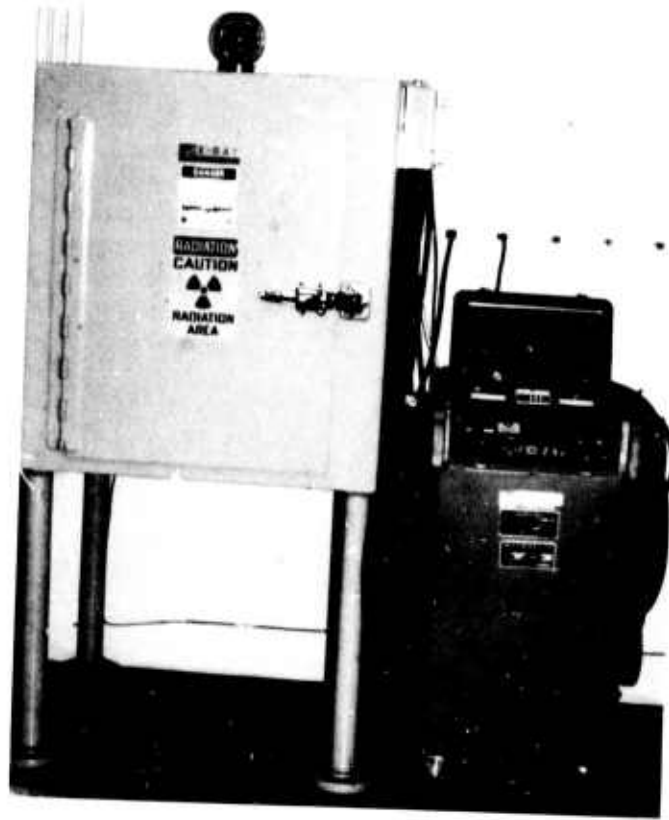
Figure 4.13 Microfocus X-ray Equipment

One of the important features of the MXK-100m Magnaflux x-ray system is the small focal spot (variable from 0.05mm — 0.5mm) which permits film focal distances and direct film enlargements up to 36x with very good geometric sharpness. Another feature of this equipment is the availability of the panoramic accessory tube which can be used for radial x-ray viewing of circular components. This optional tube is shown in Figure 4.15, while the fixture used to obtain panoramic radial views of the rotor blade rim and blades is shown in Figure 4.16.

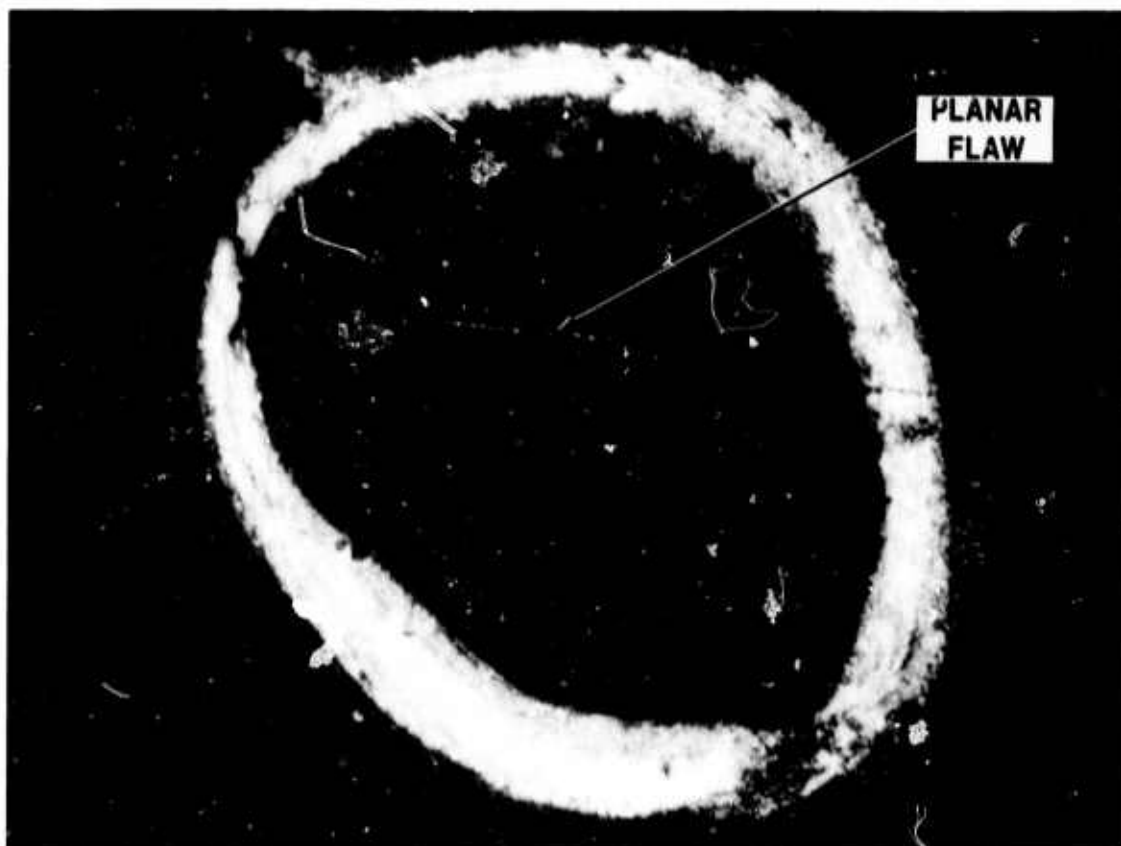
Figure 4.18 Planar Type Defect Detected by Visual Inspection

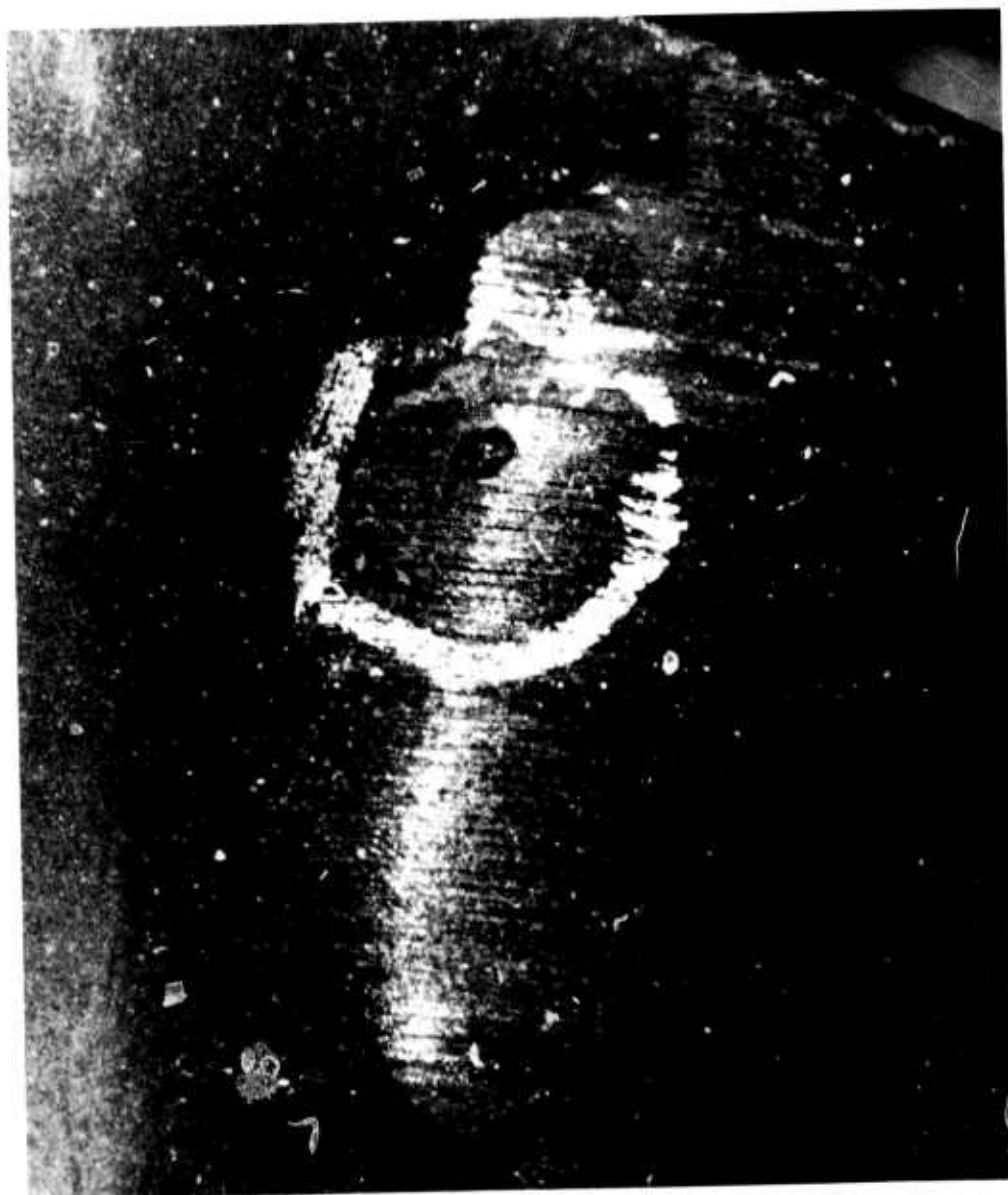
**Figure 4.21 Subsurface Void in Reaction Bonded Silicon Nitride Blade Uncovered by Grinding**

Figure 4.21 illustrates a blade void which was tracked, using x-ray techniques, from molding to nitriding. This void was uncovered by grinding the surface of the part using a small hand grinder. Figure 4.22 is a fractured blade void similarly detected by x-ray. Note the absence of white alpha silicon nitride in Figure 4.21. It was first thought that these flaws were dissimilar in origin, however, repeated grinding and fracturing of other blade voids indicated that grinding of the defective area removed the alpha material and in addition grinding dust tended to mask the presence of alpha silicon nitride.

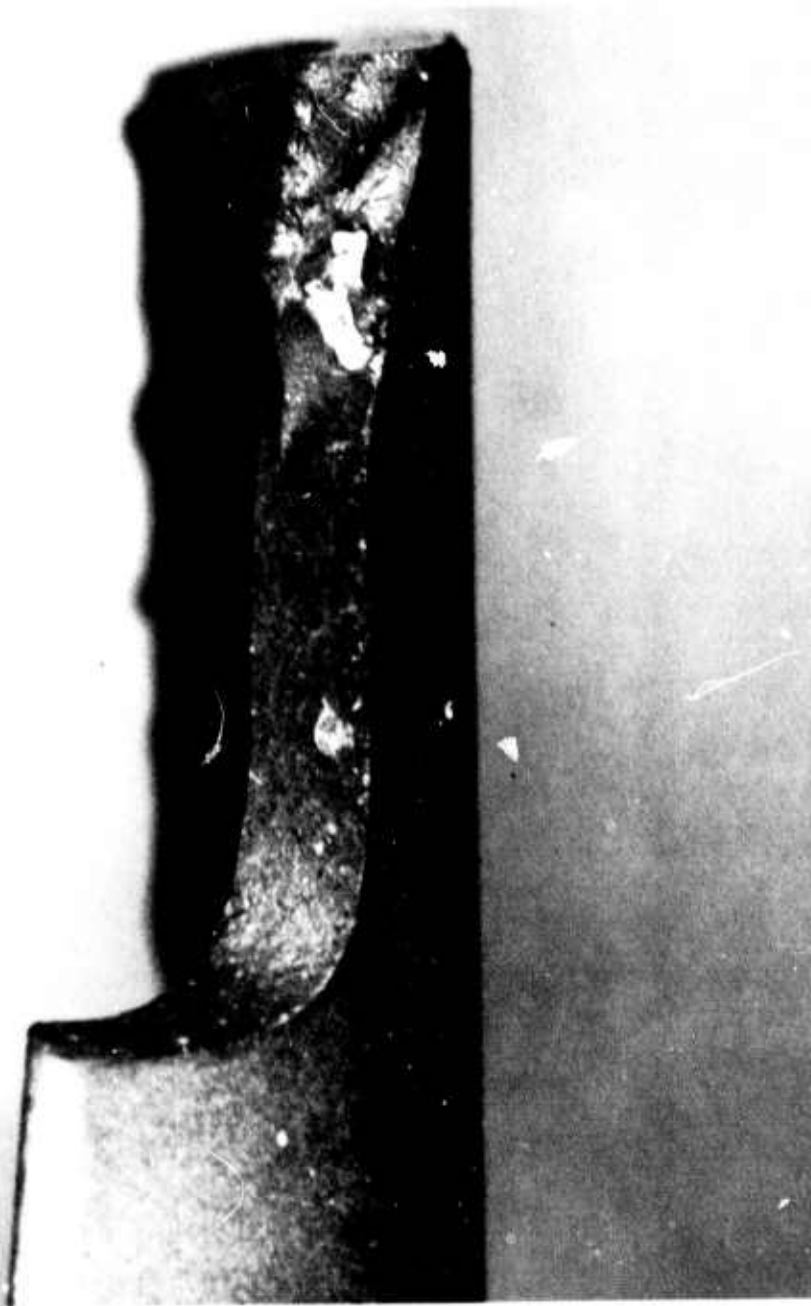
**Figure 4.22 Molding Flaw in Reaction Bonded Silicon Nitride Blade — Fractured Surface**
