AVRADCOM Report No. 79-5

**ESTABLISHMENT OF MANUFACTURING METHOD AND TECHNOLOGY  
FOR THE FABRICATION OF HELICOPTER MAIN ROTOR BLADE SPARS BY  
CONTINUOUS SEAM DIFFUSION BONDING TITANIUM SHEET MATERIAL**

**SIKORSKY AIRCRAFT**

Final Report - Contract Number DAAG-46-76-C-0016

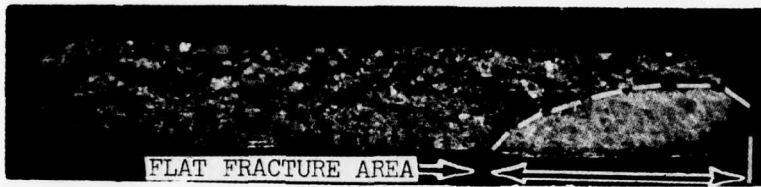
FIGURE 52. FRACTURE INTERFACE OF BEND TEST COUPON S/N 7-3.  
(FINISH END) NOTE FLAT FRACTURE AREA. MAG. 2X.

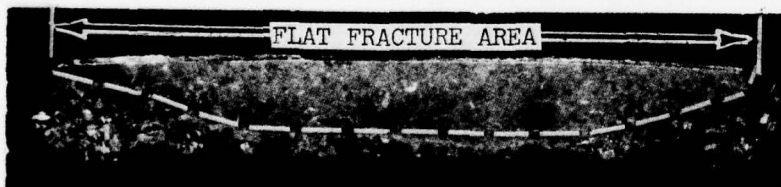
FIGURE 53. FRACTURE INTERFACE OF BEND TEST COUPON S/N 8-2.  
(START END) NOTE FLAT FRACTURE AREA. MAG. 2X.

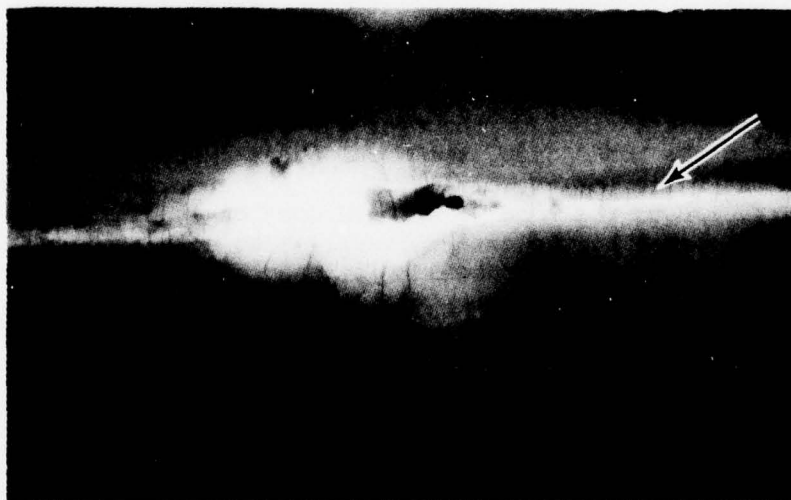
FIGURE 60. PHOTOGRAPH OF X-RAY OF INTERACTION CONDITION ON FLAT AREA ADJACENT TO METAL FLOW CONDITION ON EXTERNAL SURFACE OF PRE-FORM TUBE S/N 6, REFERENCE FIGURE 40. NOTE CRAZING CONDITION IN FLOWED METAL AREA. MAG. 3X.

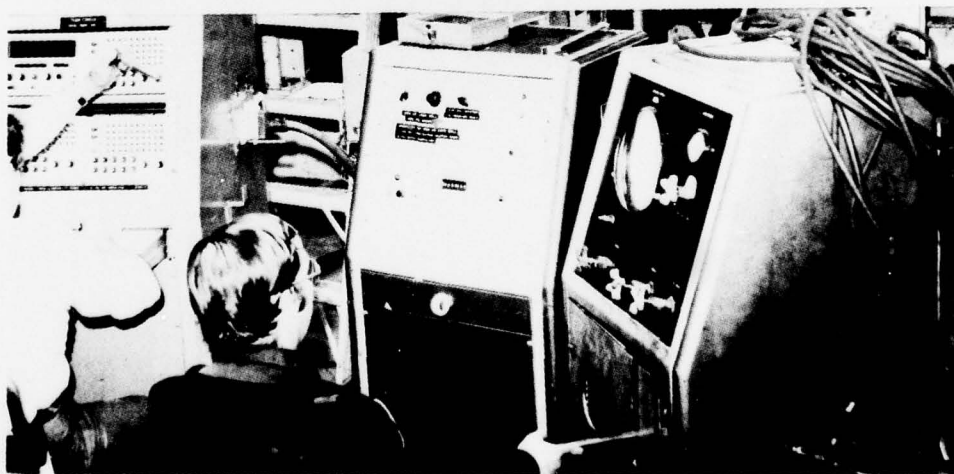
FIGURE 74. CALIBRATION SET-UP OF FULL-SCALE FATIGUE TEST SPECIMEN, S/N 7.

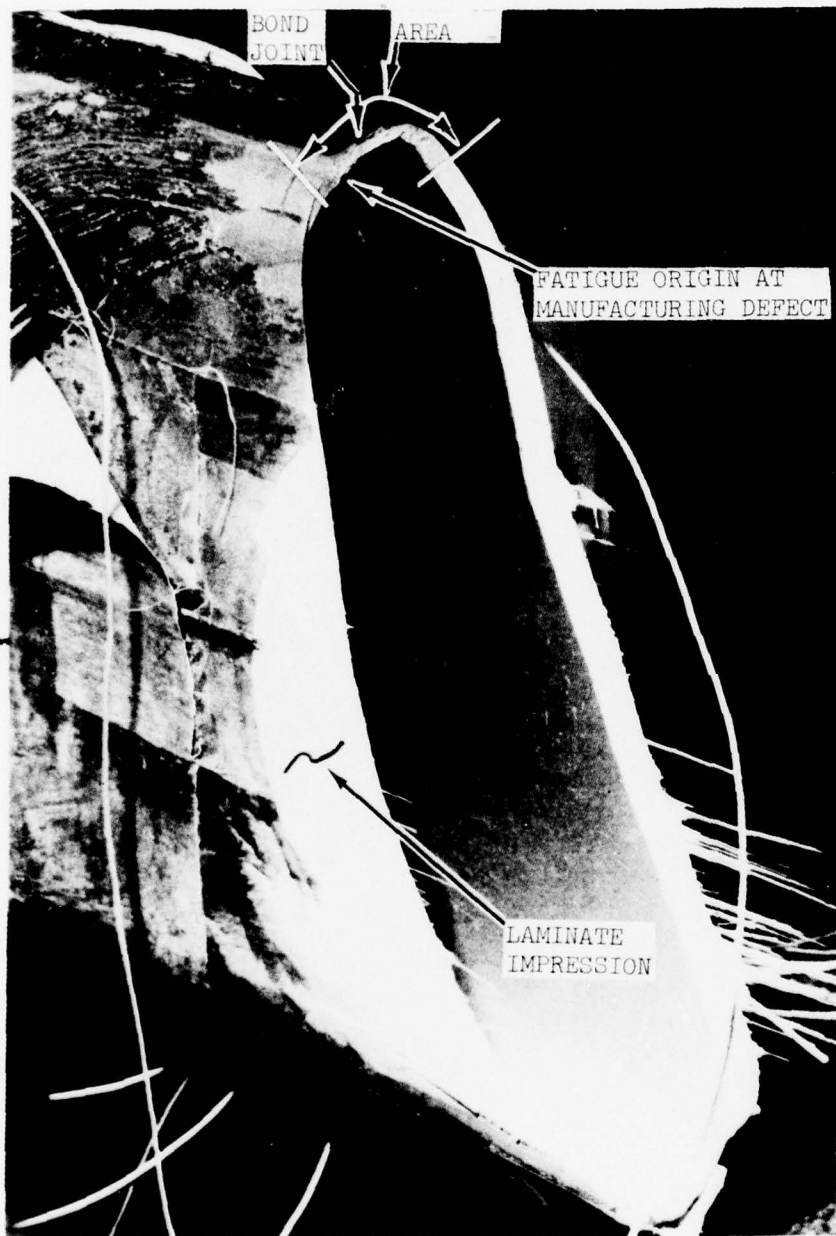
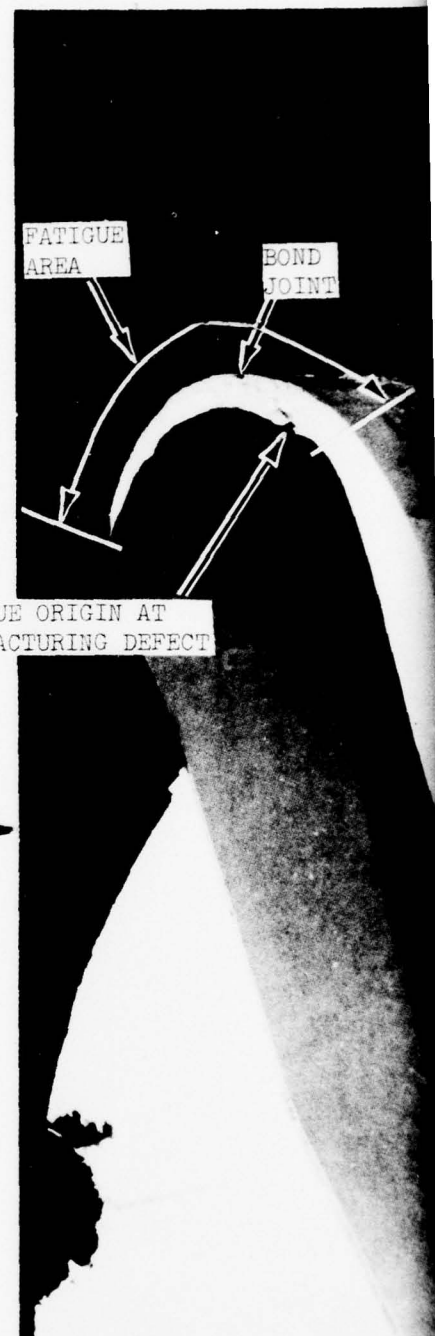
FIGURE 77. FRACTURED TEN-FOOT CSDB BLACK HAWK SPAR FATIGUE SPECIMEN, S/N 7.

FRACTURE INTERFACE - LEFT SIDE

FRACTURE INTERFACE

TAPERED  
LAMINATE  
BUILDUP

In order to ascertain the cause and mode of cracking of the full-scale spar specimen, visual, fractographic, and metallographic examination were performed. Visual inspection disclosed that the specimen separated approximately 30 inches, station 36 from the start end of the spar specimen and that the fatigue origin emanated from a manufacturing defect located on the internal surface of the specimen. Review of the specimen's x-ray film showed that the manufacturing defect was the linear abnormality detected previously during non-destructive inspection, and described in subsection 6.1 and depicted in Figure 59. Examination of the fracture interface confirmed the mode of cracking to be fatigue originating at a linear interaction abnormality on the internal surface of the specimen away from the diffusion bond joint. The cracking was noted to have propagated bidirectionally in a transverse or chordwise mode, perpendicular to the diffusion bond joint with a typical elliptical propagation pattern. The abnormality was observed to be approximately 1/8 inches in diameter extending through 1/3 of the wall thickness at the fracture location. Fatigue propagation of the crack extended through the wall thickness to the external surface of the specimen and was approximately 1-1/2 inches in length before complete separation of the specimen occurred due to static overload. Cyclic loading propagation was approximately 10% of the spar's cross section; the remaining 90% was overload. The origin in the manufacturing defect, at the metal flow region, was located away from the diffusion bond joint on the internal surface of the spar. In conjunction with the applied stresses, the manufacturing defect produced a stress concentration that was sufficient to initiate fatigue cracking. The applied stresses at the crack location were 70 to 75% of maximum stress on the spar specimen reference stress distribution curve, Figure 76. Figure 79 is a view of the separated specimen and cross section of the fracture interface, depicting the origin, fracture texture, and extent of the anomaly. Optical and dye-penetrant spot check examination of the bond at the fracture regions revealed no evidence of longitudinal joint separation. That is, the diffusion bond did not rupture along the longitudinal axis of the spar specimen as the circumferential crack approached and propagated transversely across the bond joint. Previous experience has shown that longitudinal rupturing along the diffusion bond joint occurs when transverse crack propagation reaches a diffusion bond joint of poor bond quality, reference (a). Macro-examination of a transverse section through the bond depicted a well defined 1-1/4 inch heat effected zone with no manifestation of a bondline. Micro-examination of the heat effected zone and base metal disclosed no finite bondline, only a coarse large transformed beta grain structure in the heat effected zone and surrounding alpha-beta structure typically observed in this sheet material, reference Figure 80.
