CORPS OF ENGINEERS ANCHORAGE AK ALASKA DISTRICT
FLOOD PLAIN INFORMATION. MENDENHALL RIVER, JUNEAU, ALASKA. (U)
APR 71

Flood Plain Information, Mendenhall
River, Juneau, Alaska.

<u>Plate</u>		<u>Follows</u>	<u>Page</u>
1	Mendenhall River Watershed		5
2	Index Map		23
3-5	Flooded Areas-Mendenhall Valley		23
6	Discharge Hydrograph-Mendenhall River		23
7	Discharge Hydrograph-Mendenhall River - IRF		23
8	Discharge Hydrograph-Mendenhall River - SPF		23
9	High Water Profiles-Mendenhall River		23
10	High Water Profiles-Montana Creek		23
11-12	Cross Sections-Mendenhall River		23

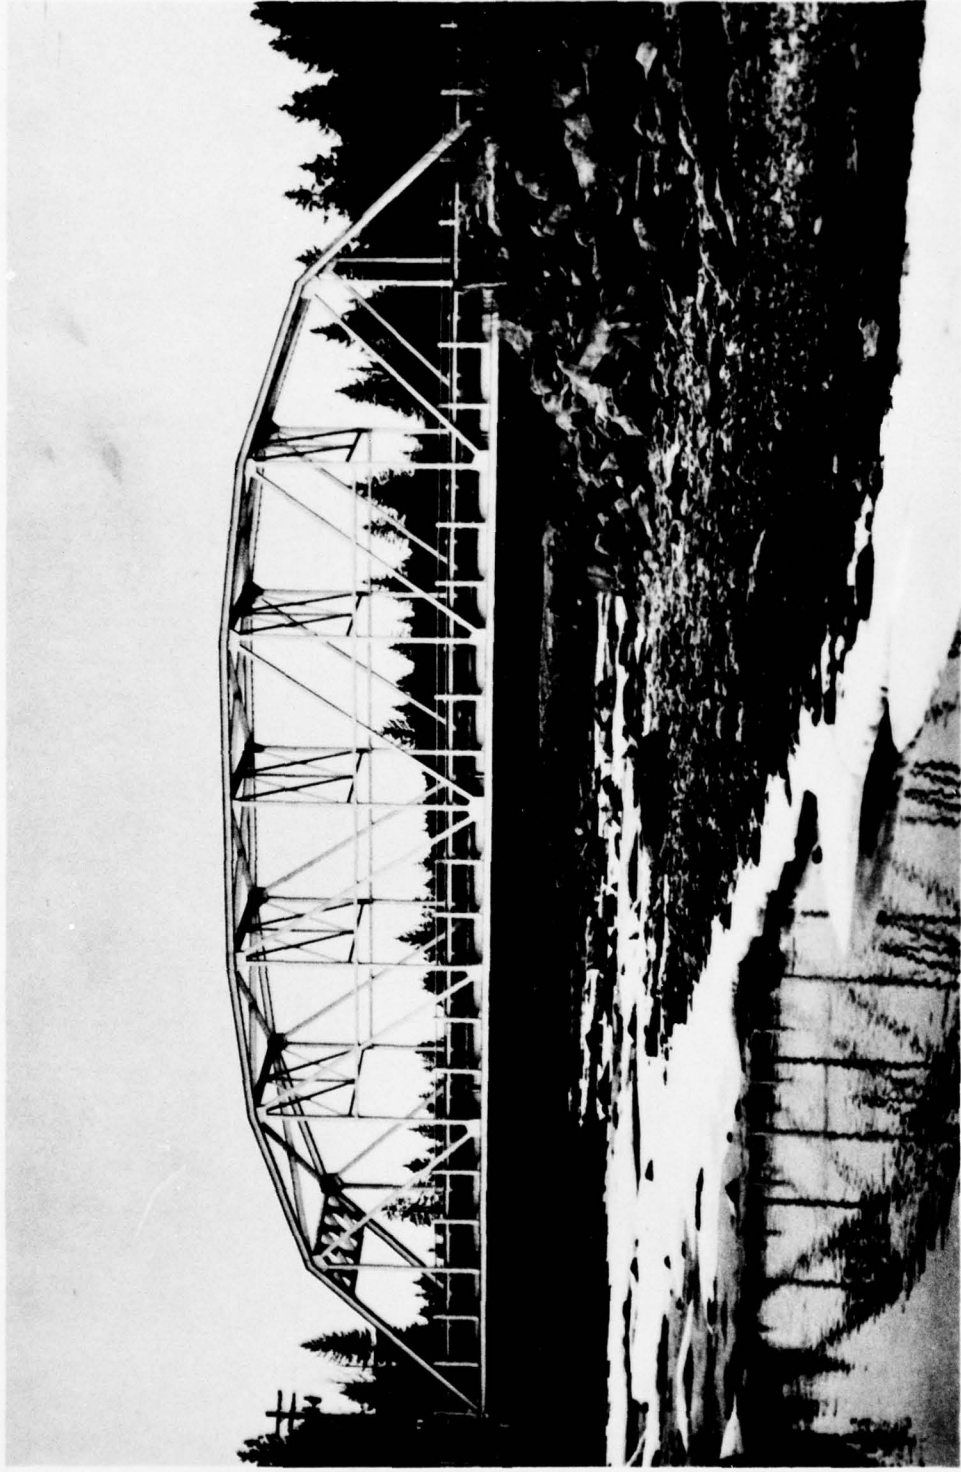
Figure 1

UPPER MENDENHALL RIVER BRIDGE ON THE LOOP ROAD

Mendenhall River is crossed by two bridges in the study reach. Both bridges are classified as highway bridges. Montana Creek is crossed by one highway bridge in the study area. Table 3 lists the pertinent elevations, location for these structures, and their relation to the crest of the Standard Project and Intermediate Regional Floods. Figures 1, 2 and 3 show photographs of the bridges.

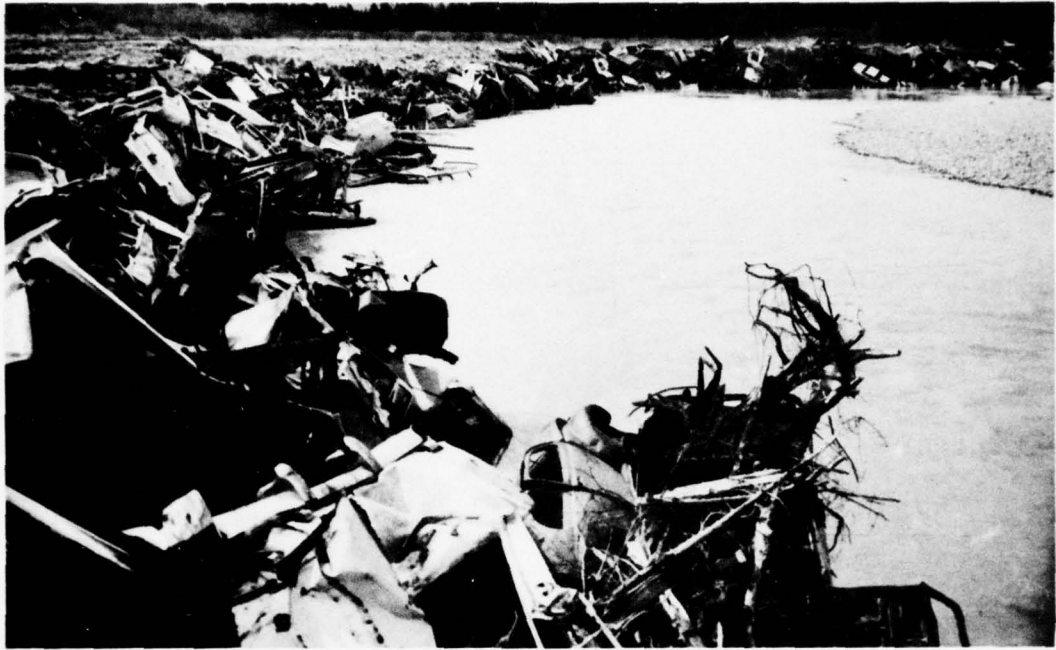
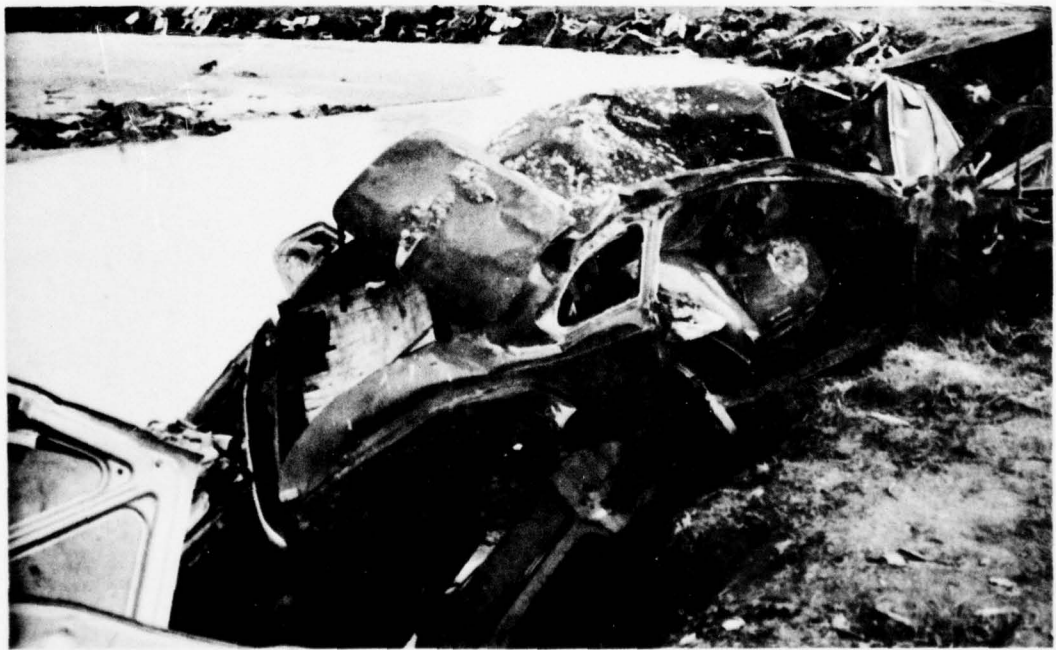
Figure 4

VIEW OF CAR BODIES USED FOR RIPRAP ON
AN ERODING BANK

METHOD OF PLACING CARS WILL NOT STOP EROSION
- IT DOES INCREASE FLOOD HAZARD

The only natural, major obstructions to flood flow in Mendenhall River are the sharp meanders. The effect of the bridges on flood flow was discussed previously. Old car bodies have been strewn on a bank of the river to curb erosion. However, the manner in which the car bodies were placed would serve no useful purpose and could cause considerable damage during high water. Swift currents during high water could dislodge the car bodies and move them downstream. This condition combined with accumulation of debris could create large jams and produce backwater and channel changes. The occurrence of jams at bridges or large jams along the main channel of Mendenhall River would appreciably increase the water surface profiles shown on Plates 9 and 10.

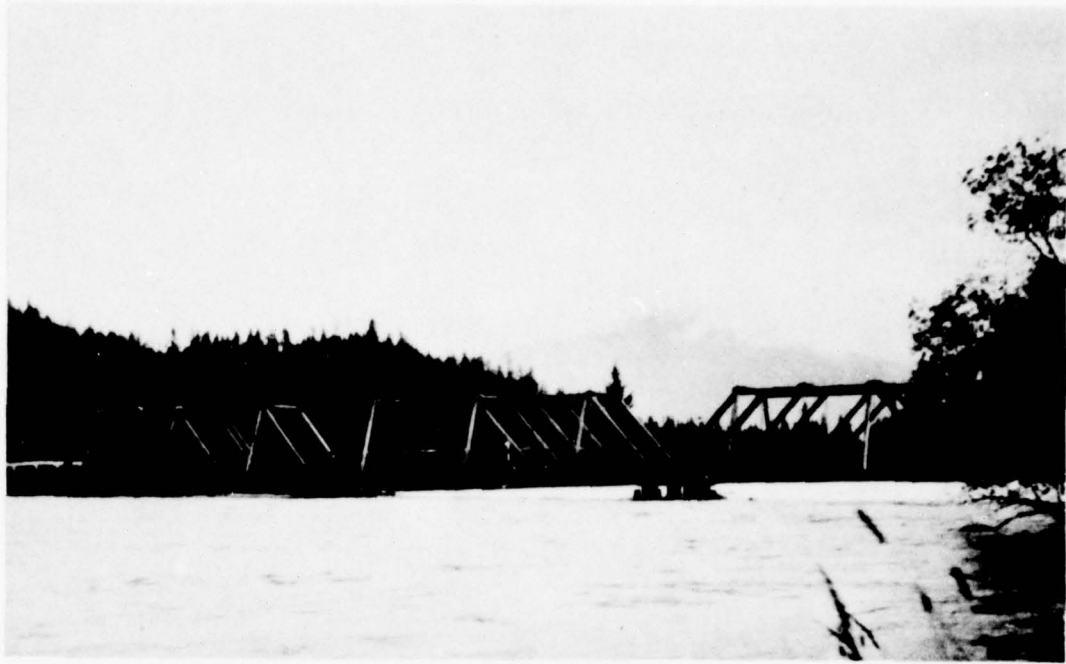
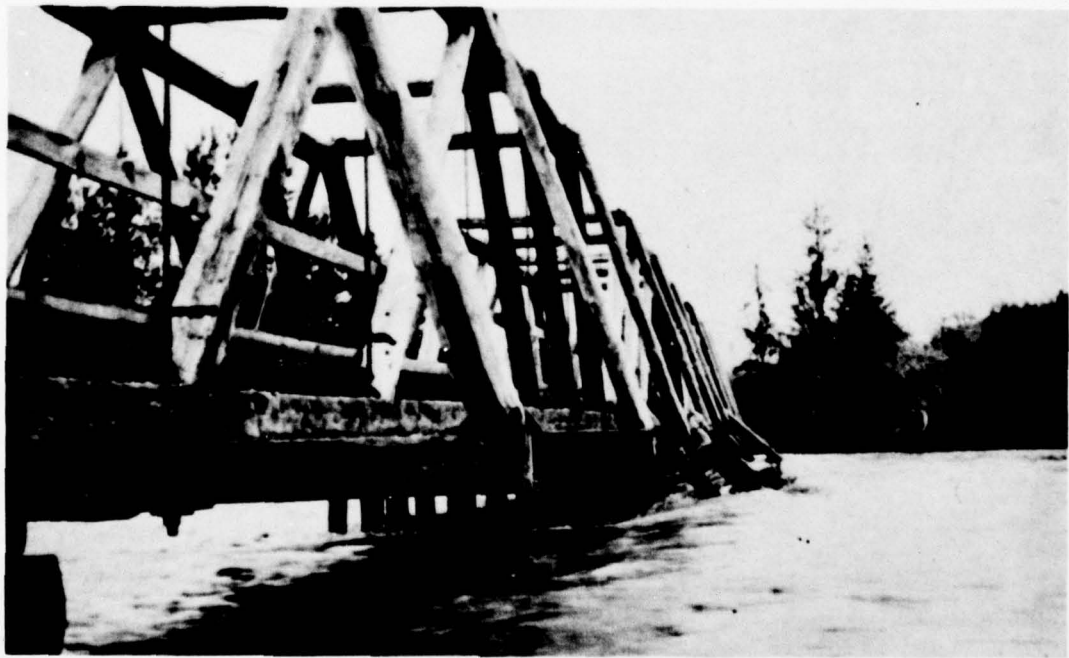
Figure 5

VIEW OF OLD LOWER MENDENHALL BRIDGE
-FLOOD OF SEPTEMBER 1927

DEBRIS STARTING TO COLLECT AGAINST BRIDGE
-FLOOD OF SEPTEMBER 1927

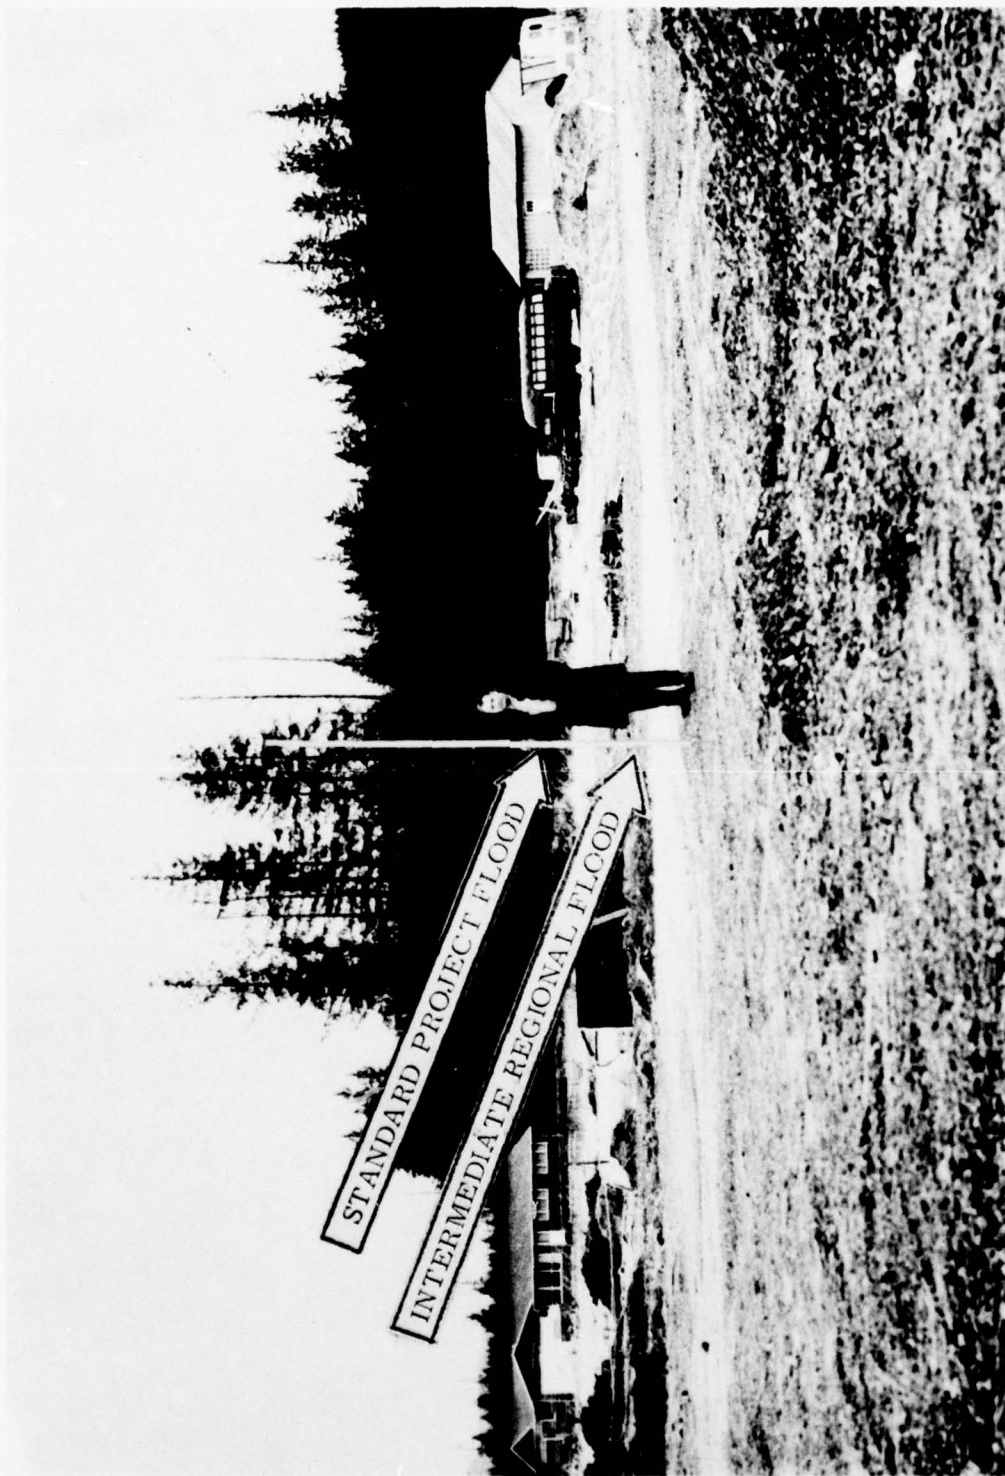
Figure 7

FLOOD HEIGHTS BETWEEN SECTIONS 11 AND 12
NEAR THE RIVER LOOKING SOUTHWEST

(See plate 2 for photo location)

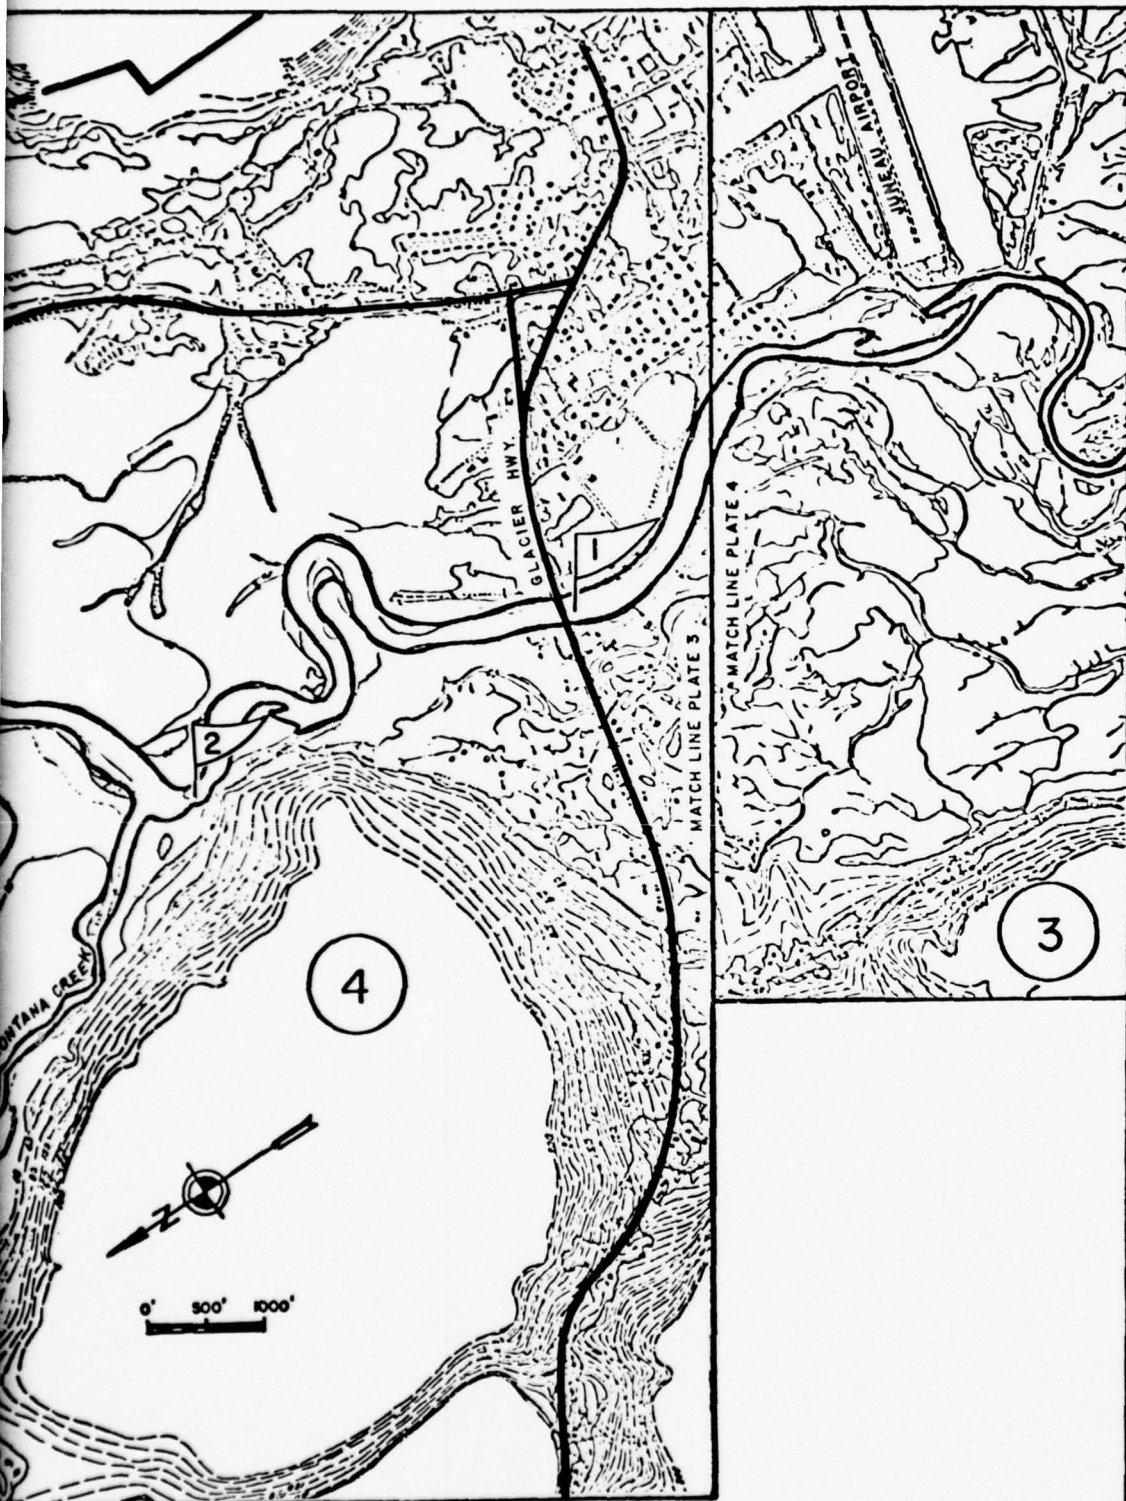
U. S. ARMY ENGINEER DISTRICT, ALASKA
 CORPS OF ENGINEERS
 PLATE 2 APRIL 1971

MENDENHALL RIVER, ALASKA
 INDEX MAP
 FLOOD PLAIN
 INFORMATION STUDY

Plate 2 is an index map of 3 sheets which show the potential flood area of Mendenhall River and Montana Creek. Plates 3 through 5 show the flood plain of Mendenhall River for the reach covered by this report. There is limited development existing in the flood plain. However, with the building of the new pulp mill and a saw mill there will be increasing need for new construction, both commercial and private. The area surrounding Mendenhall River is prime development land necessary to Juneau's expanding economy. The use of this land must be carefully controlled to avoid flood damage in the future.

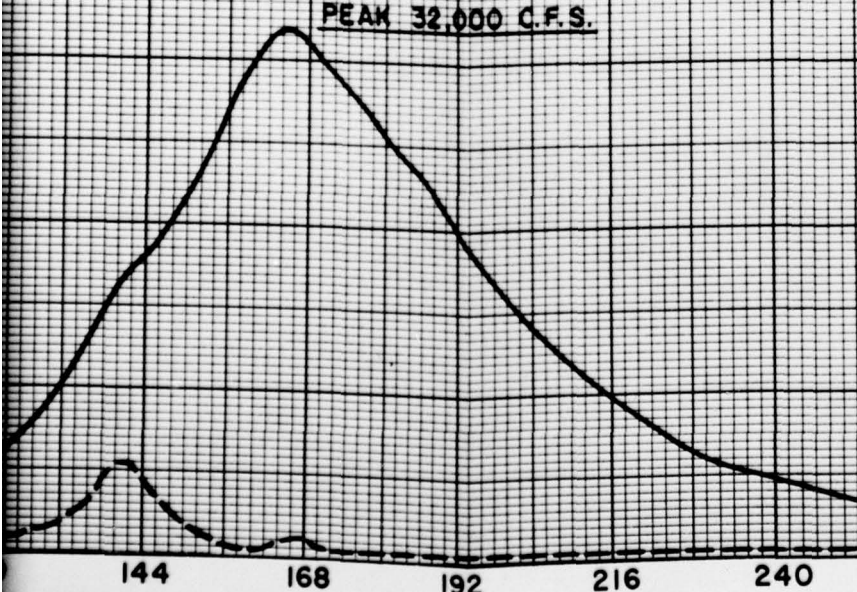
IRF
DISCHARGE HYDROGRAPH
ON
MENDENHALL RIVER
NEAR
JUNEAU, ALASKA

INTERMEDIATE REGIONAL FLOOD
AT MOUTH OF RIVER

PEAK 32,000 C.F.S.

The results of statistical analysis and electronic computer calculation indicates that the Intermediate Regional Flood peak discharge for Mendenhall River is 32,000 cubic feet per second, resulting in a water surface elevation of 60.4 feet at the Upper Mendenhall River Bridge and 25.0 feet at Brotherhood Bridge. A discharge hydrograph of the Intermediate Regional Flood is shown on Plate 7.
