CORPS OF ENGINEERS ANCHORAGE AK ALASKA DISTRICT  
FLOOD PLAIN INFORMATION. GLACIER CREEK, GIRDWOOD, ALASKA. (U)  
AUG 69

GREATER ANCHORAGE BOROUGH  
ANCHORAGE, ALASKA  
SEPTEMBER 1969

Flood Plain Information, Glacier Creek,  
Girdwood, Alaska.

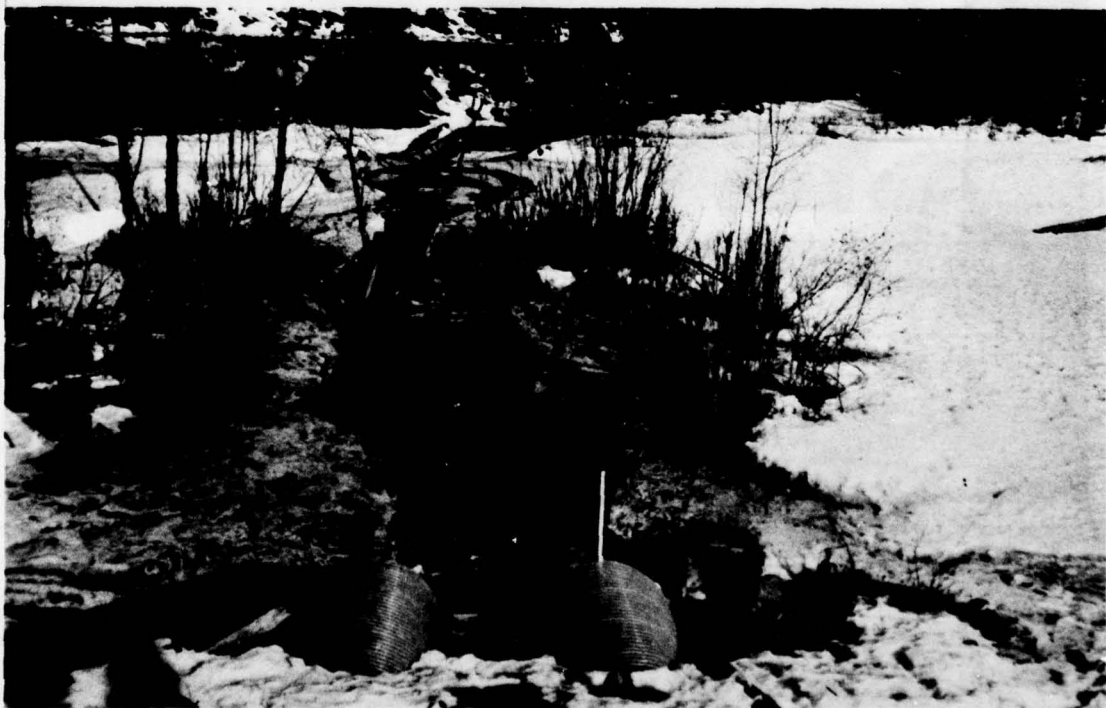
TWO 72 INCH CULVERTS ON CALIFORNIA CREEK  
CROSSING ALYESKA HIGHWAY. NOT OF  
SUFFICIENT SIZE TO CARRY  
INTERMEDIATE REGIONAL FLOOD

California Creek, a tributary to Glacier Creek, is crossed by two culverts. Table 3 lists the pertinent elevations and locations for these structures and their relation to the crest of the Standard Project and Intermediate Regional Floods. Figure 2 shows photographs of some of the bridges and culverts.

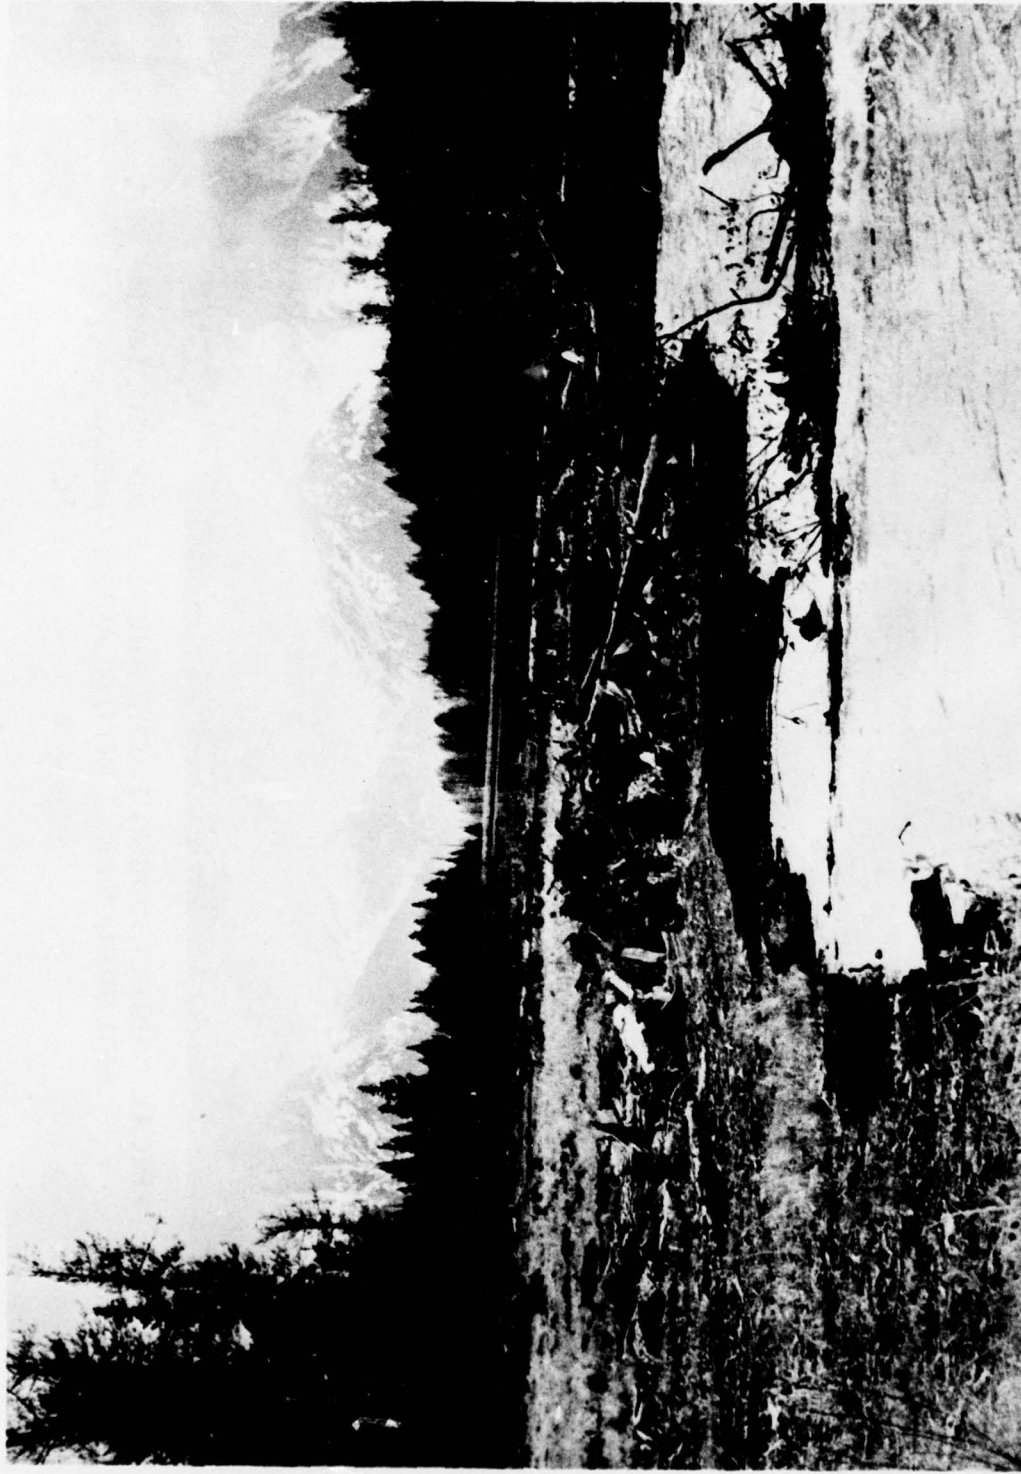
Figure 4

TREES, STUMPS AND BRUSH CLOG THE STREAM  
WHICH STARTS EROSION AND CHANNEL CHANGES

The major obstructions to flood flow on Glacier Creek are the small islands, sharp meanders, silt load and the debris consisting of brush, small spruce and large cottonwood. During heavy runoff periods, considerable change in the configuration of the stream takes place. Erosion of banks and small islands takes place with the resulting silt load building up further downstream where there are obstructions caused by floating debris. It was noted during the course of this study that the land clearing done for the airfield, various roads and sub-divisions was accomplished by bulldozing all overburden on the banks or directly into the stream. As a result high water with the swift currents displaces this material farther downstream and causes large jams, backing up the water and causing changes in course.

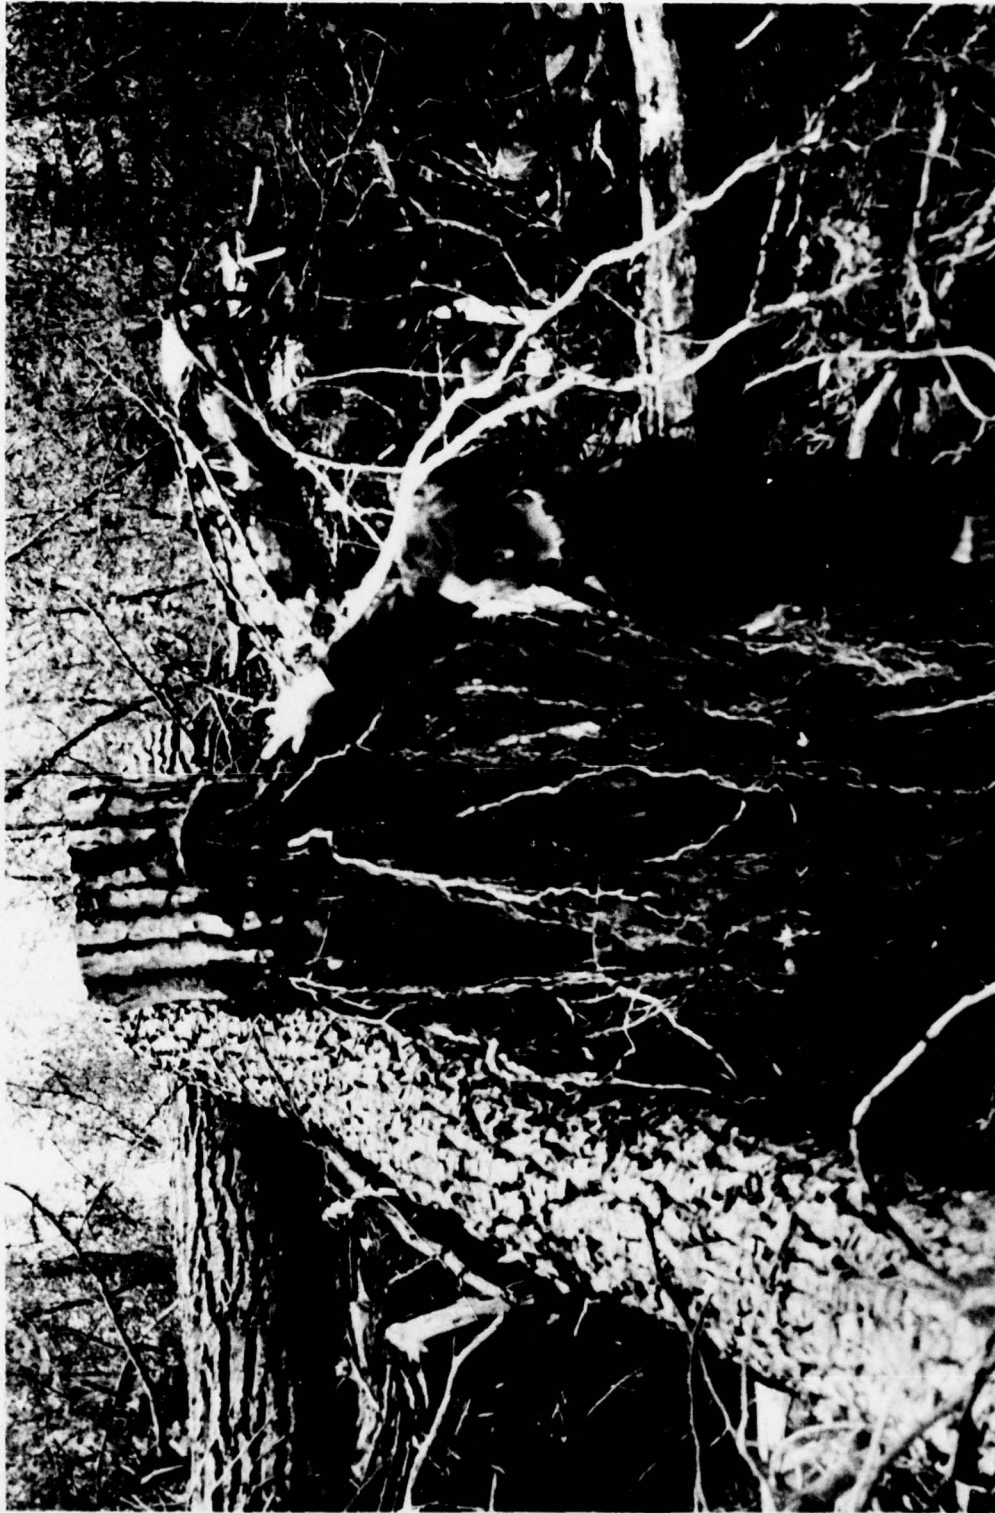
Figure 6

COTTONWOOD TREE WITH ROOTS GROWING OUT OF TRUNK TEN FEET ABOVE BASE OF TREE. PAST YEARS SILT HAD BUILT UP SO THE TREE PRODUCED NEW ROOTS THE 1967 FLOOD ERODED THE BUILD UP BACK TO THE ORIGINAL BASE.

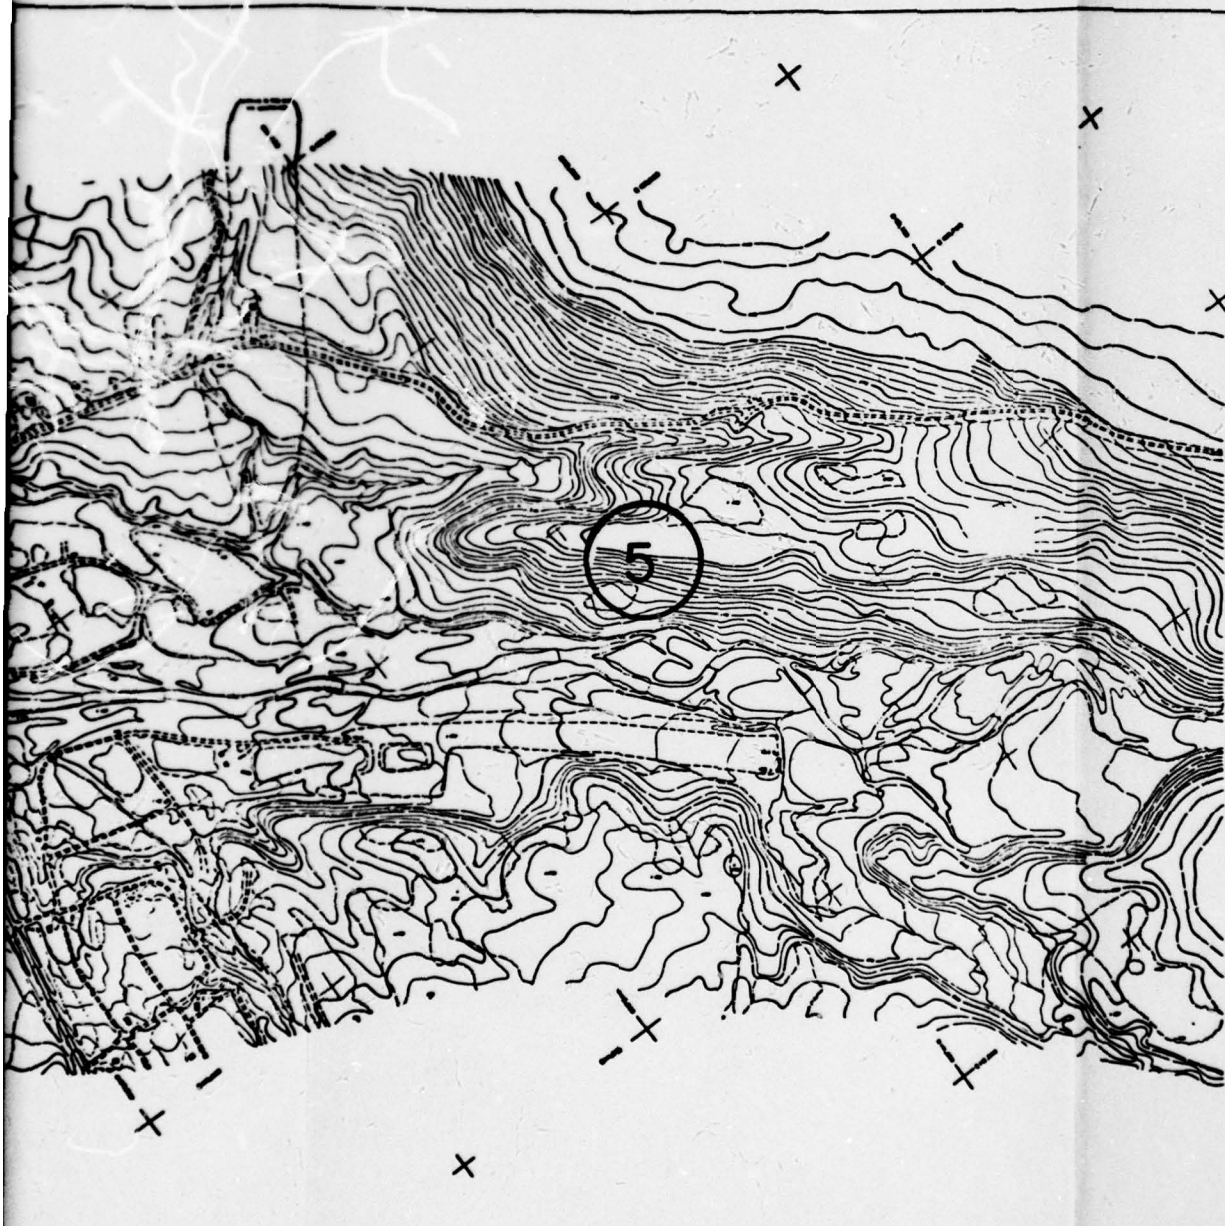
PLATE 2 JULY 69

Plate 2 is an index map of 3 sheets that show the potential flood area of the Girdwood area. Plates 3 through 5 show the flood plain of Glacier Creek for the reach covered by this report. There is limited development existing at present in the flood plain, but it is apparent that development is proposed. The area immediately upstream from the report area is sparsely developed at this time, but with the continued winter sports activities the area could later become a fully developed valley of ski slopes with related winter activities, as well as summer homes.

from observed flood profiles, topographic maps, and valley cross sections which were surveyed in April 1969. The elevations shown on Plate 2 and the overflow areas shown on Plates 3 through 5 have been determined with an accuracy consistent with the purposes of this study and the accuracy of the basic data. The profiles of the Standard Project and the Intermediate Regional Floods depend in part upon the degree of destruction or clogging of various bridges during the flood. Bridges that are particularly affected by these flows are discussed on Page 11.
