| REPORT DOCUMENTATION PAGE | | READ INSTRUCTIONS<br>BEFORE COMPLETING FORM |
|---|---|---|
| 4. TITLE (and Subtitle)<br><b>CERAMIC MAINSHAFT ROLLER BEARING<br/>PERFORMANCE IN A GAS TURBINE ENGINE</b> | | 5. TYPE OF REPORT AND PERIOD COVERED<br><b>Final Report.<br/>Aug 1976 - Nov 1978</b> |
| 7. AUTHOR(s)<br>G. W. Hamburg<br>W. F. Prusaitis | | 6. PERFORMING ORG. REPORT NUMBER<br>1623 |
| 9. PERFORMING ORGANIZATION NAME AND ADDRESS<br>Teledyne CAE<br>1330 Laskey Road<br>Toledo, Ohio 43612 | | 8. CONTRACT OR GRANT NUMBER(s)<br><b>NO 00149-76-C-1104</b><br><b>MIPR-</b><br><b>AMRDL-75-5</b> |

## CERAMIC BEARING FINAL REPORT

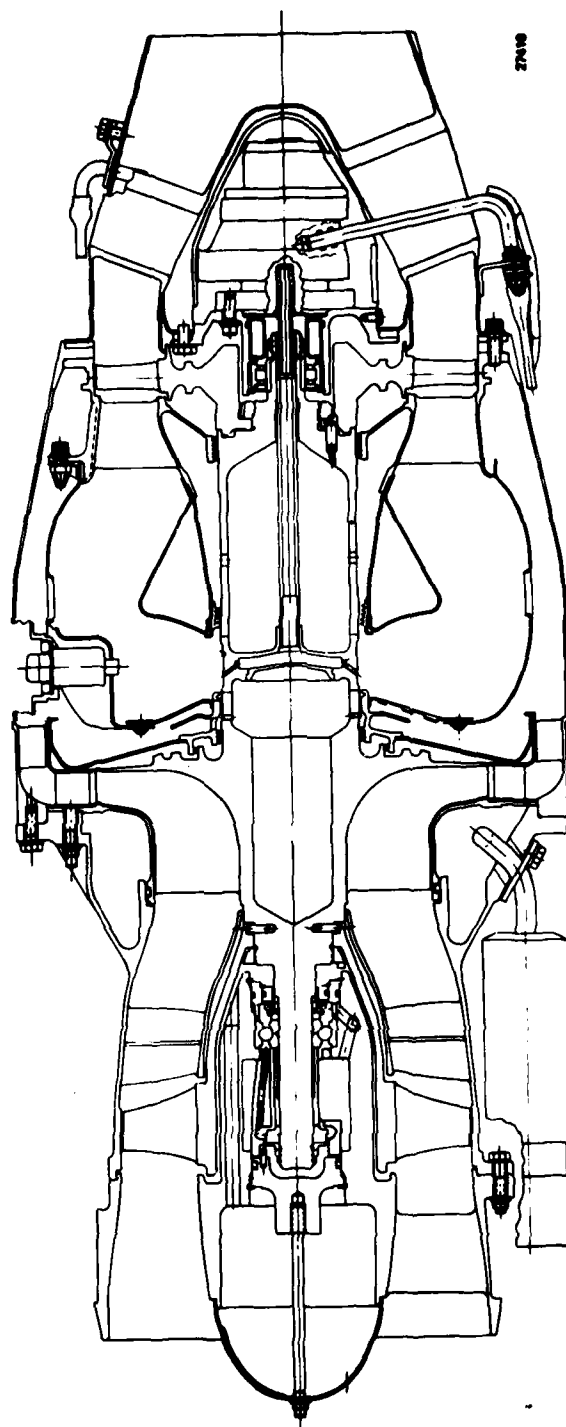
FIGURE 1.

# J402-CA-400 HARPOON MISSILE ENGINE

LIMITED LIFE (< 1 HR)

STORAGE LIFE GOAL: 5 YR'S IN CORROSIVE (SALT WATER) ENVIRONMENT

| THRUST: | 660 LBS |
| SHAFT SPEED: | 41,200 RPM |
| TURBINE INLET TEMP.: | 1900°F |
| EXHAUST GAS TEMP.: | 1550°F |

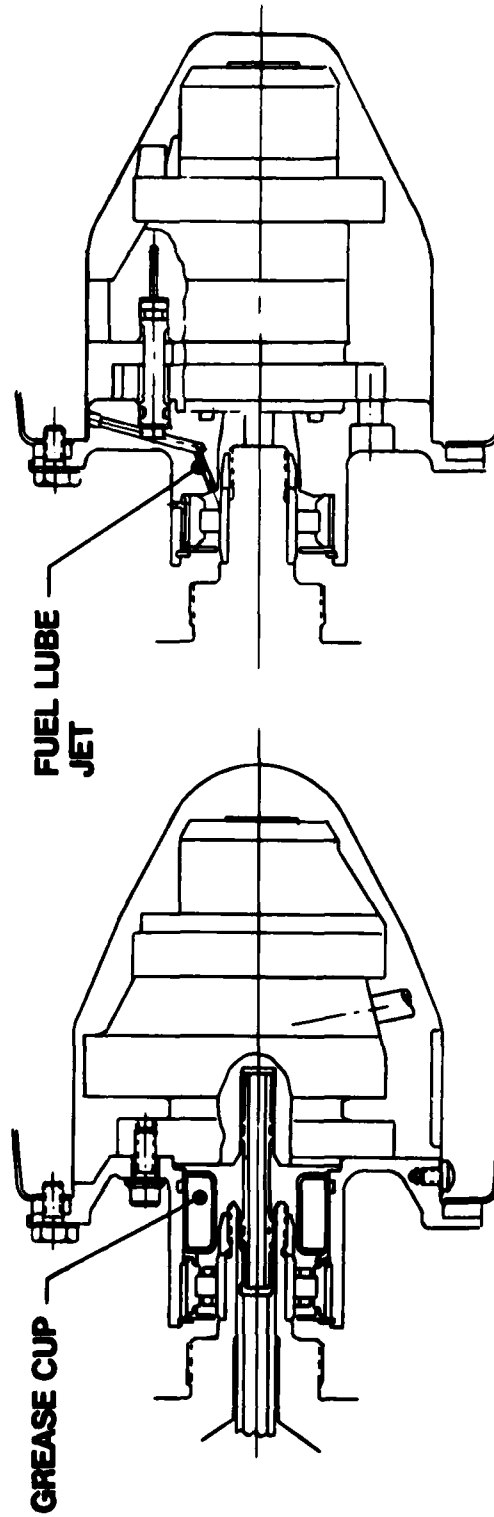
FIGURE 2.

# J402 PRODUCTION ENGINES REAR BEARING LUBE SYSTEMS

**HARPOON**  
REAR BEARING LUBRICATION:  
GREASE CUP  
15cc KRYTOX 240AC

**VSTI**  
REAR BEARING LUBRICATION:  
FUEL LUBED  
60cc/MIN

These engines have innovative lubrication systems, (Figure 2) designed to save weight, volume, and cost. The J402-CA-400 rear bearing has a 30-minute life requirement and is grease lubricated. However, the J402-CA-700 rear bearing has a 30-hour life requirement, and therefore is lubricated by a fuel mist system. The latter system was used to provide baseline data relative to engine operation of ceramic rolling element bearings and to provide a convenient means of controlling lubricant flow to the bearing. Following successful demonstration of ceramic bearing operation in a fuel lubricated mode, the bearing fuel lube system was modified to permit fuel lube flow modulation.

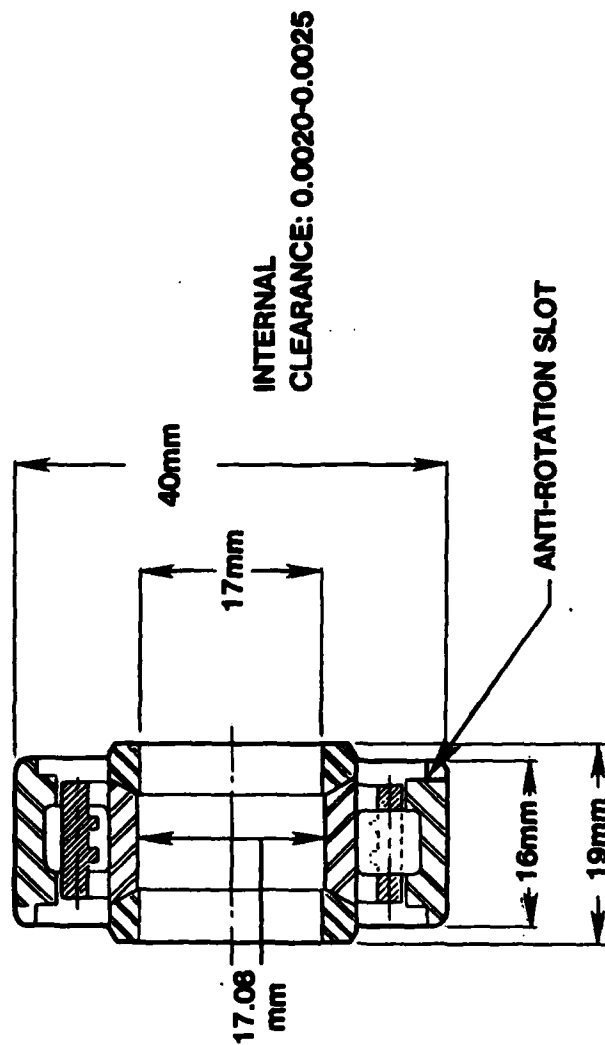
FIGURE 3.

# CERAMIC BEARING CONFIGURATION

| | MATERIAL | REMARKS |
|---|---|---|
| RACES & ROLLERS<br>CONED SPACERS | SILICON NITRIDE NC-132<br>440C STST<br>DIMENSIONALLY STABLE TO 900°F<br>HARDNESS R <sub>C</sub> 33-40 | 10 ROLLERS: 6 x 6 mm<br>0.0000-0.0004 TIGHT<br>FIT ON SHAFT |
| ROLLERS SEPARATOR | AMS 6415(4340 ST)<br>HARDNESS R <sub>C</sub> 28-35 | SILVER PLATED<br>PER AMS 2412 |

The bearings were manufactured by the Federal Mogul Corporation from Hot Press Silicon Nitride billets supplied by the Norton Company. Figure 3 describes the bearing's salient features. The inner race mounting rings are conical at the ceramic inner race interface to accommodate the thermal differential growth between the steel shaft and the ceramic inner race, both axially and radially. This conical innerface maintains the inner race centering requirements throughout the operating temperature range of the ceramic bearing. The bearing outer race is supported in a damping ring which absorbs the shaft vibrations within the bearing housing. This damping ring is identical to the production ring with the exception of the ceramic bearing outer race anti-rotation pin slot. A number of design modifications were implemented after the first test resulted in a bearing failure due to axial movement of the outer race caused by the disengagement of the outer race retaining ring from its groove. These modifications are summarized below:

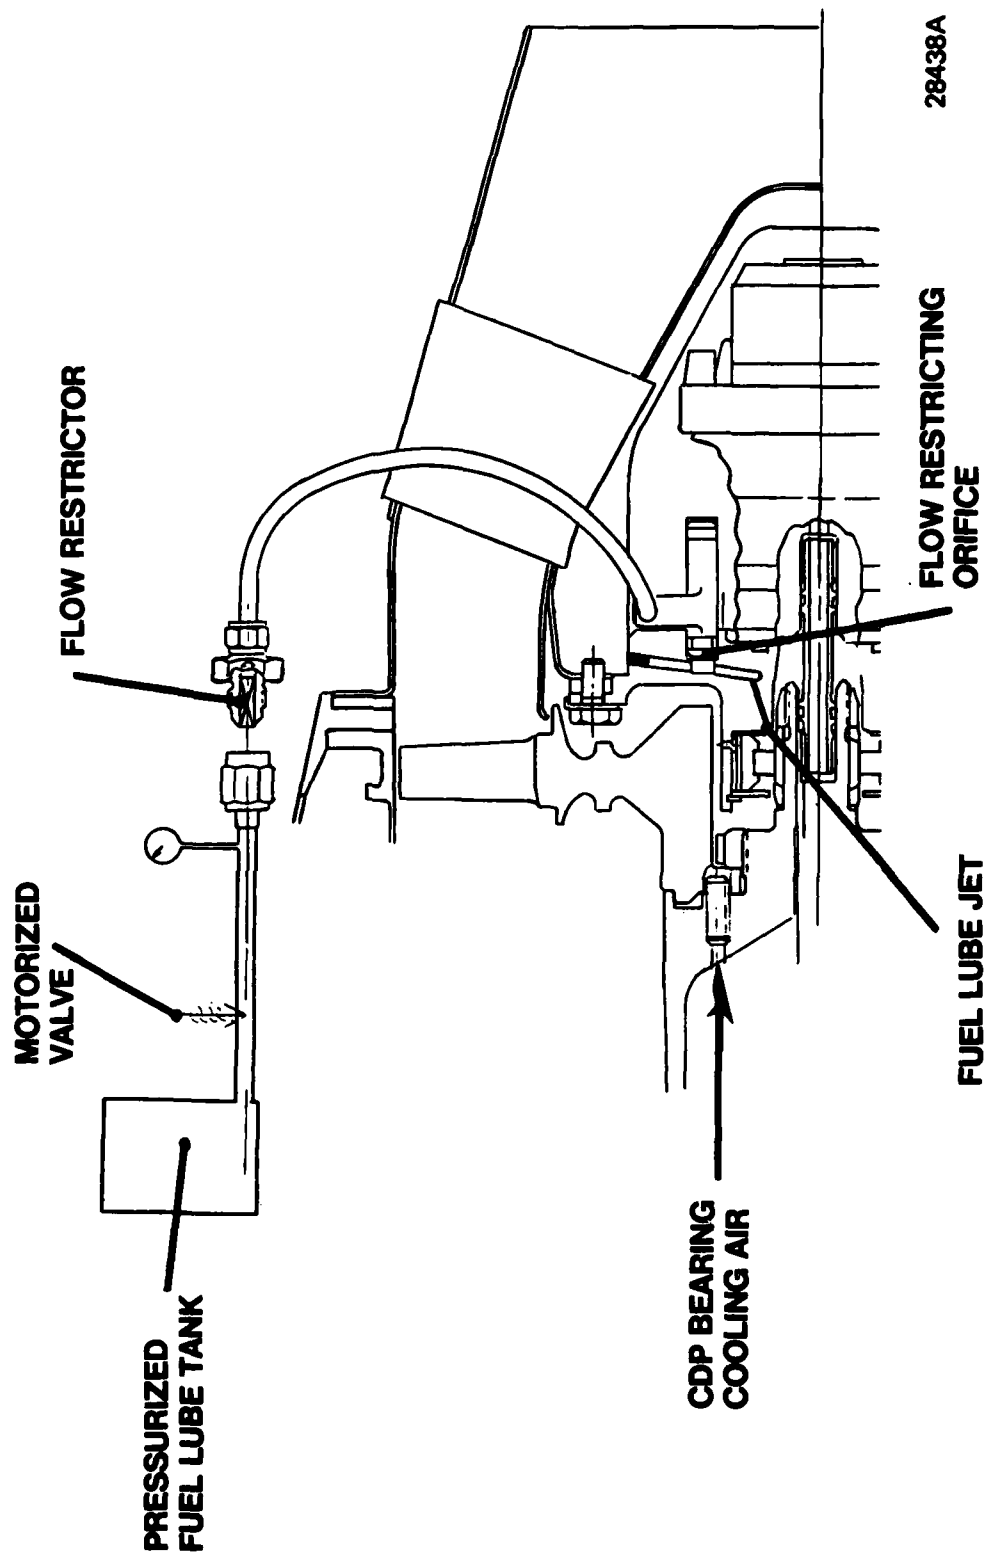
FIGURE 5.

# CERAMIC BEARING TEST LUBE FLOW CONTROL

Following demonstration of successful ceramic bearing operation in a lubed configuration, the engine was modified to provide fuel lube flow modulation. The production engine fuel pump discharge passage was blocked and replaced with an external source of fuel lube (Figure 5). Fuel lube flows of from 60cc to zero were established as a function of pressure (P) on a hydraulic flow bench (Figure 6). An air pressurized fuel lube tank provided the lube pressure, and an electrically actuated motorized valve varied the flow control orifice. In engine operation the desired fuel lube flow was established by actuating the motorized valve to obtain the required P between the valve discharge pressure and the pressure in the bearing cavity.

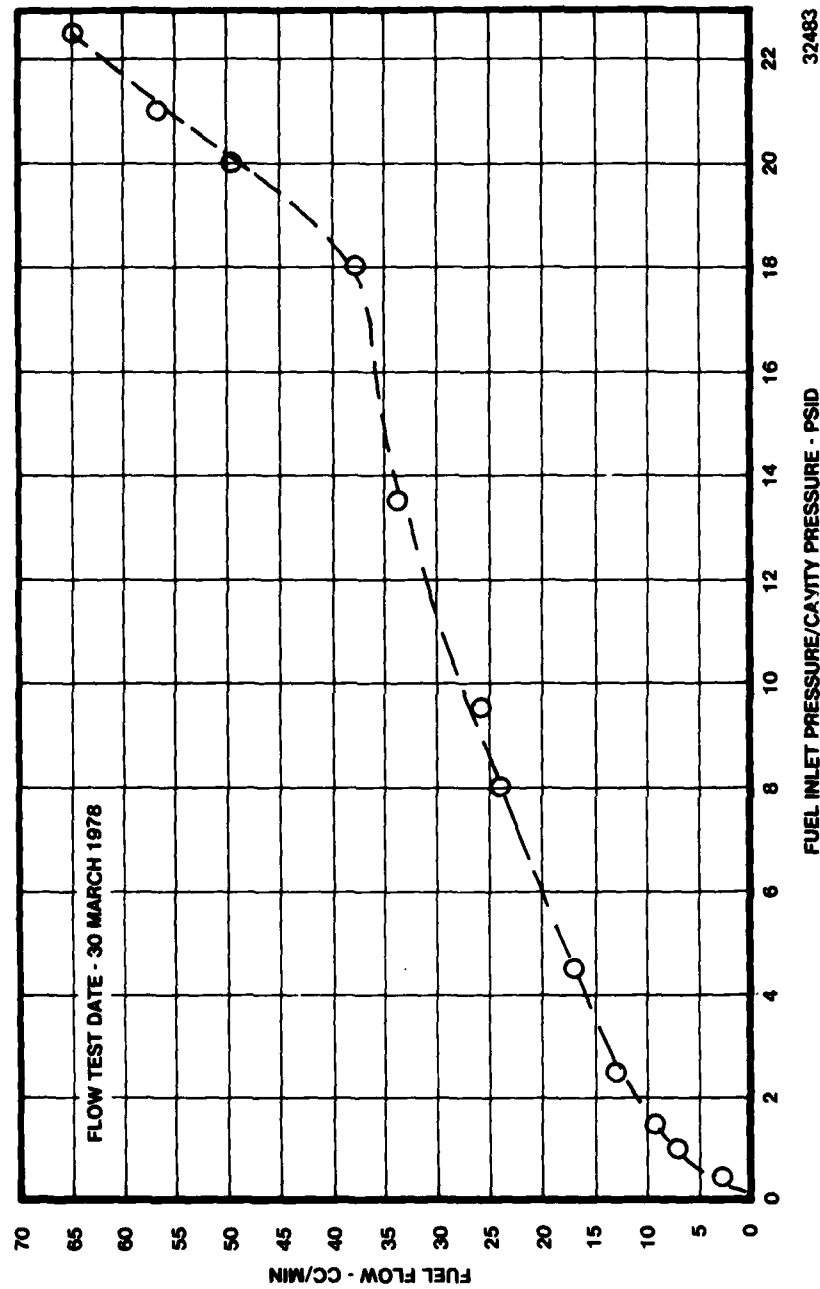
FIGURE 6.

# REAR BEARING LUBRICATION FLOW CHARACTERISTICS AS ASSEMBLED PER FIGURE 5

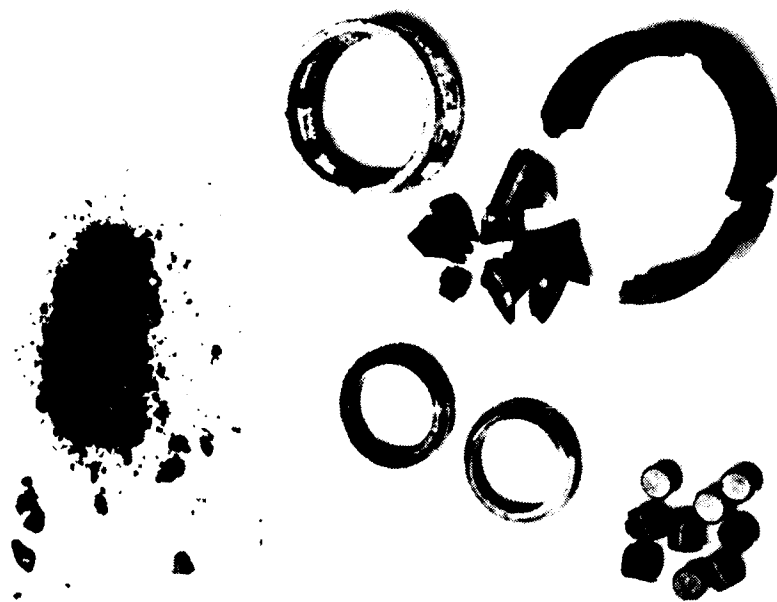
FIGURE 9.

**AFTER TEST 1**  
**CERAMIC BEARING FAILURE DUE TO LOSS OF OUTER RACE AXIAL**  
**RESTRAINT AND SUBSEQUENT MOVEMENT OF ROLLER ASSEMBLY**  
**BEYOND EDGE OF INNER RACE (TOTAL TIME, 17 MIN.)**

The test objective was to establish the capability of a ceramic roller bearing to operate in a gas turbine. After 17 minutes of a scheduled 50 minute test the bearing failed. The bearing failure was caused by disengagement of the bearing retaining (Spiralox) ring from its groove, which allowed the outer race and roller assembly to move axially forward over the edge of the inner race. The resultant high edge load and stress concentration caused chipping and subsequent cracking which eventually resulted in complete bearing failure (Figure 9). Loosening of the snap ring in its groove was initiated by spinning of the bearing outer race and end shield. The spinning occurred as a result of increased O.D. clearance at operating temperature due to the large difference in coefficients of thermal expansion between the silicon nitride bearing race and the steel housing, and was further accentuated by the extremely smooth bearing O.D.

For subsequent tests, an anti-rotation slot was ground in the outer race, and a longer, more stable inner race mounting ring was incorporated in the bearing assembly. Modifications to the bearing housing consisted of introducing a bearing outer race anti-rotating pin and deepening the retaining ring groove. The Spiralox wound ring was replaced by a "True-Arc" type with substantially greater retention capability.
