VOUGHT CORP ADVANCED TECHNOLOGY CENTER INC DALLAS TEX F/G 1/3
N-RAY INSPECTION OF AIRCRAFT STRUCTURES USING MOBILE SOURCES: A--ETC(U)
APR 79 W D DANCE N68335-77-C-0555

4. TITLE (and Subtitle) 6 N-Ray Inspection of Aircraft Structures Using Mobile Sources: A Compendium of Radiographic Results		5. TYPE OF REPORT & PERIOD COVERED Final Rept. 18 May 77 - 22 Dec 78

7. AUTHOR(s) 10 Dr. W. E. Dance		8. CONTRACT OR GRANT NUMBER(s) 15 N68335-77-C-0555 New	
9. PERFORMING ORGANIZATION NAME AND ADDRESS Vought Corporation Advanced Technology Center, Inc. P. O. Box 226144, Dallas, TX 75266		10. PROGRAM ELEMENT, PROJECT, TASK AREA & WORK UNIT NUMBERS W A3400000/051B/8F41461406

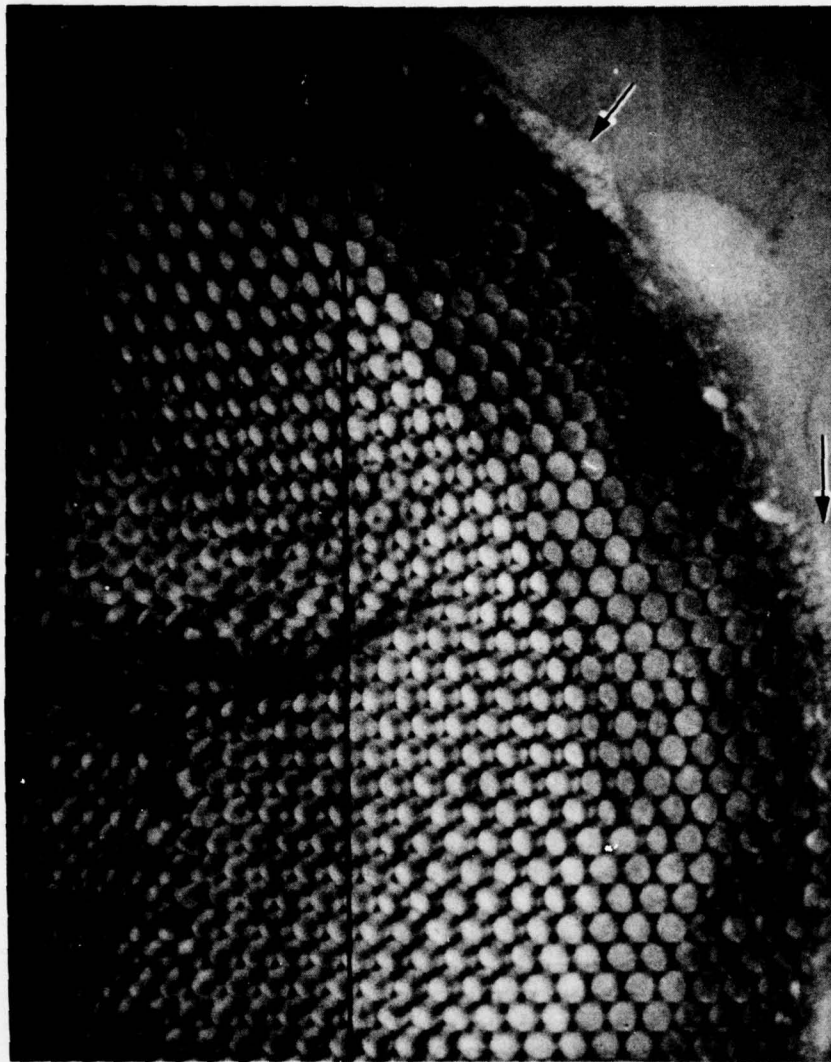
Figure 1 - Neutron Radiograph of Aluminum Honeycomb Aircraft Panel - Side 1

SPECIMEN THICKNESS	TYPE AND STRENGTH OF SOURCE	L/D RATIO	CONVERTER FILM COMBINATION	EXPOSURE TIME OR FLUENCE	RADIOGRAPH ORIGIN
1.1"	^{252}Cf , 1.5 mg	18	Gd/M	16 Hr	ATC

The area of chief interest in this radiograph is that showing the condition of the bond line in the honeycomb closeout region. Many adhesive voids are present in this area (indicated by the arrows). The aluminum core was resin-coated in this case.
