USARTL-TR-78-37C

**AQUILA REMOTELY PILOTED VEHICLE SYSTEM TECHNOLOGY  
DEMONSTRATOR (RPV-STD) PROGRAM  
Volume III - Field Test Program**

John A. Nicoletti  
LOCKHEED MISSILES & SPACE COMPANY, INC.  
Sunnyvale, Calif. 94086

Final Report for Period December 1974 - December 1977

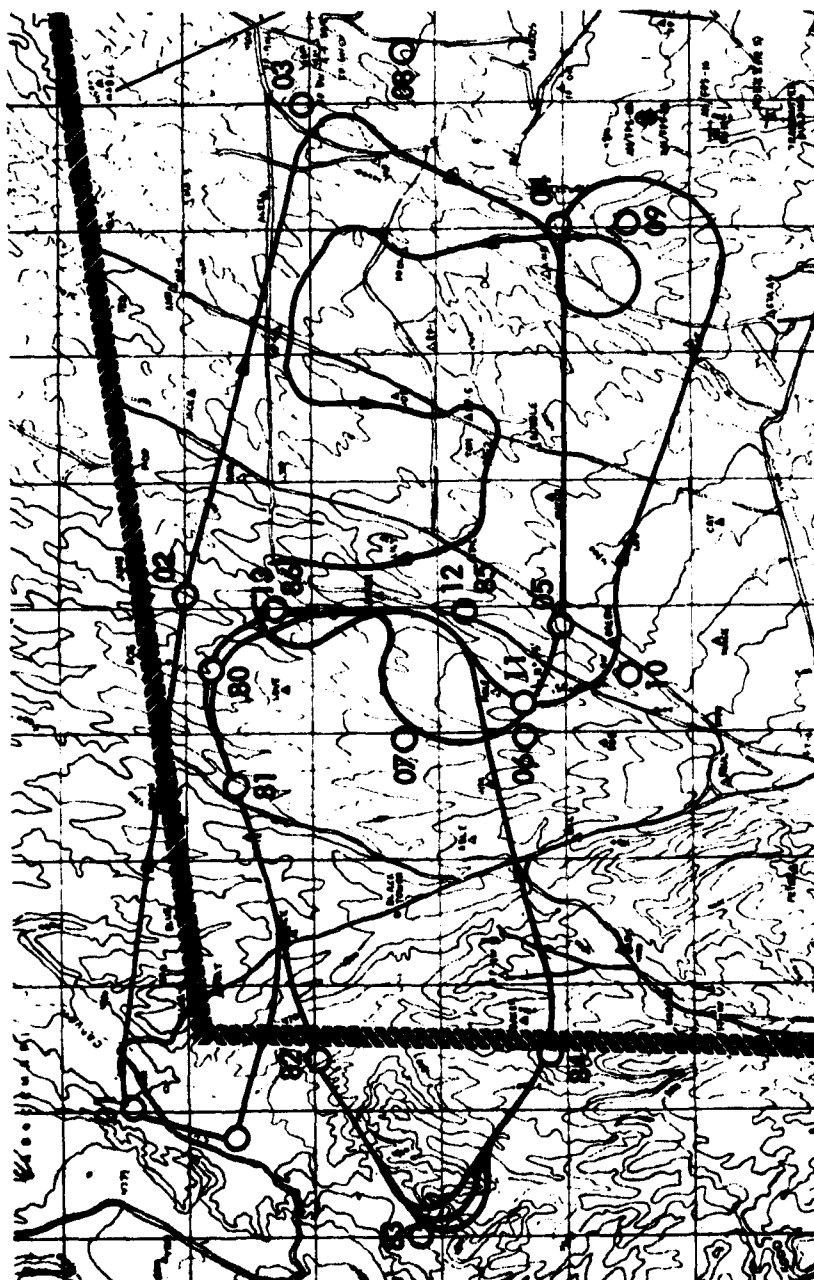
Figure 12. Flight Path, Flight 26
