NAVAL RESEARCH LAB WASHINGTON DC
ENGINEERING PHYSICS OF DIELECTRICS. (U)
OCT 53 A T MCCLINTON, H RABIN, E L BRANCATO
NRL-MR-218

ENGINEERING PHYSICS OF DIELECTRICS.

9 Progress Report No. 2

Shipboard Systems Branch
Electricity Division
Naval Research Laboratory
Washington, DC 20375

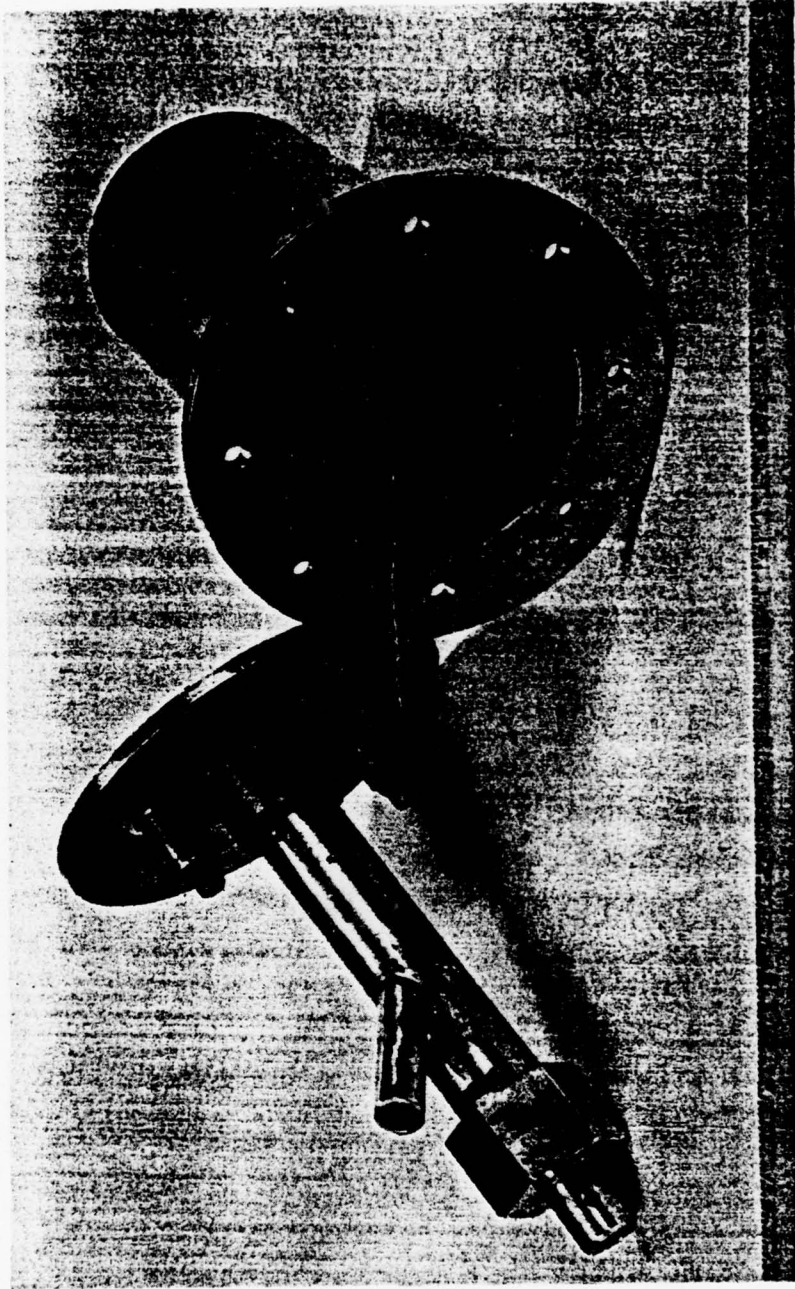
Figure 7. Open Inner Test Cell.

The inner test cell is designed to permit continuous electrical measurements of dielectric specimens. Electrical leads may be brought through the angled extension at the top of the unit to a sample holder which supports the dielectric within the cell. The cell is constructed of stainless steel and it has a wall thickness of $1/32$ of an inch. It is provided with a pin arrangement, of the same design as that located at the base of the source cans, to position the cell with respect to angle in the central hole of the source plate. A view of the opened inner test cell is shown in Figure 7.

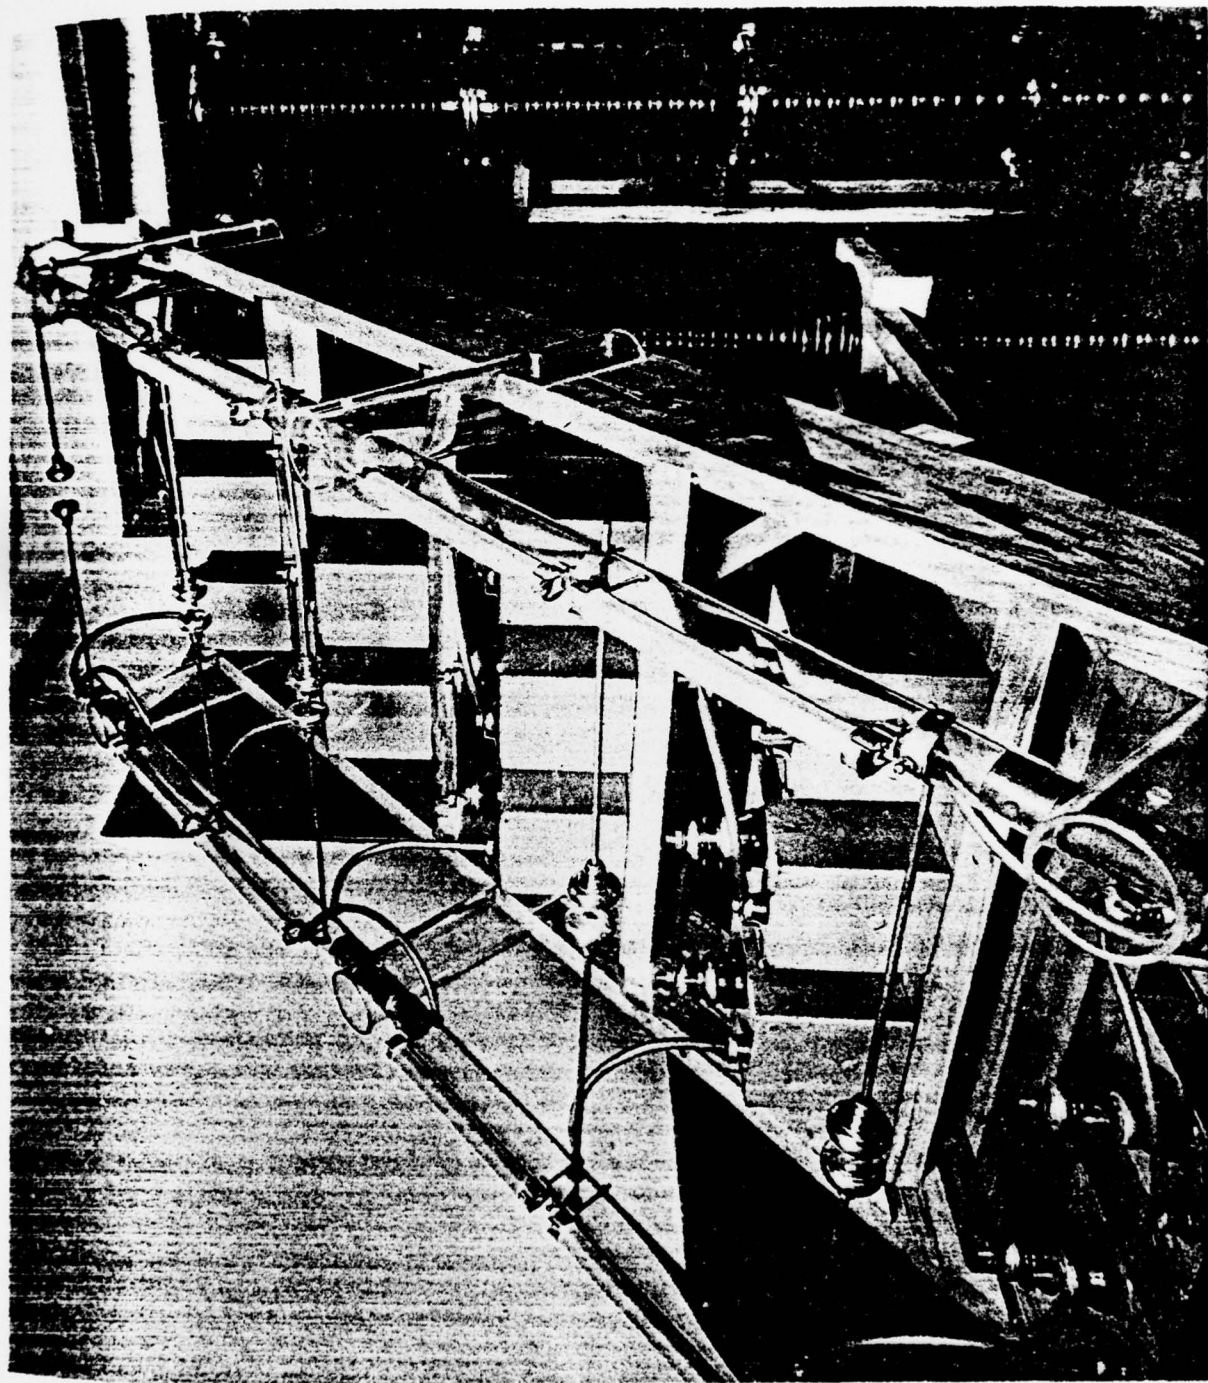
Figure 27. The capacitor bank of the NRL impulse generator.
