CAPE COD EASTERLY SHORE BEACH EROSION STUDY

VOLUME III
APRIL 1979

4. TITLE (and Subtitle) (6) Cape Cod Easterly Shore Beach Erosion Study, Volume III, Reconnaissance Reports.		5. TYPE OF REPORT & PERIOD COVERED Beach Erosion, Early History to 2029

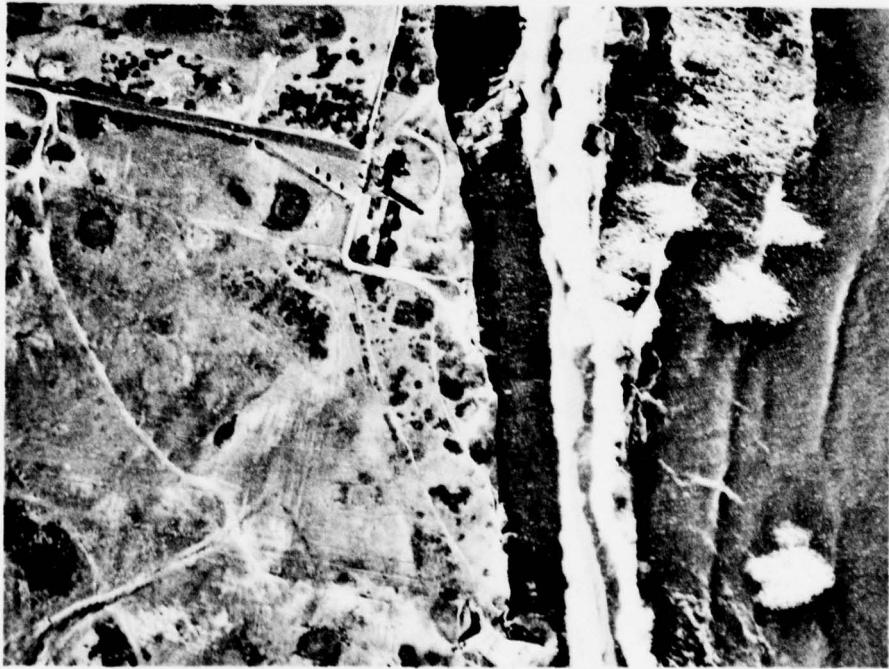
Figure 11. Aerial photographs of Highland Beach (top) and Highland Light Beach (bottom), Truro, Massachusetts, April 1978

Erosion problems in the area are aggravated by several factors. Access to the beach is not controlled and as a result, beach users walk up and down the bank to the beach wherever it is convenient. In addition, surface drainage is routed by pipe to outfall over the face of the bank.

Overland flow of runoff from the parking area, the access road, and the surrounding area also causes severe erosion.

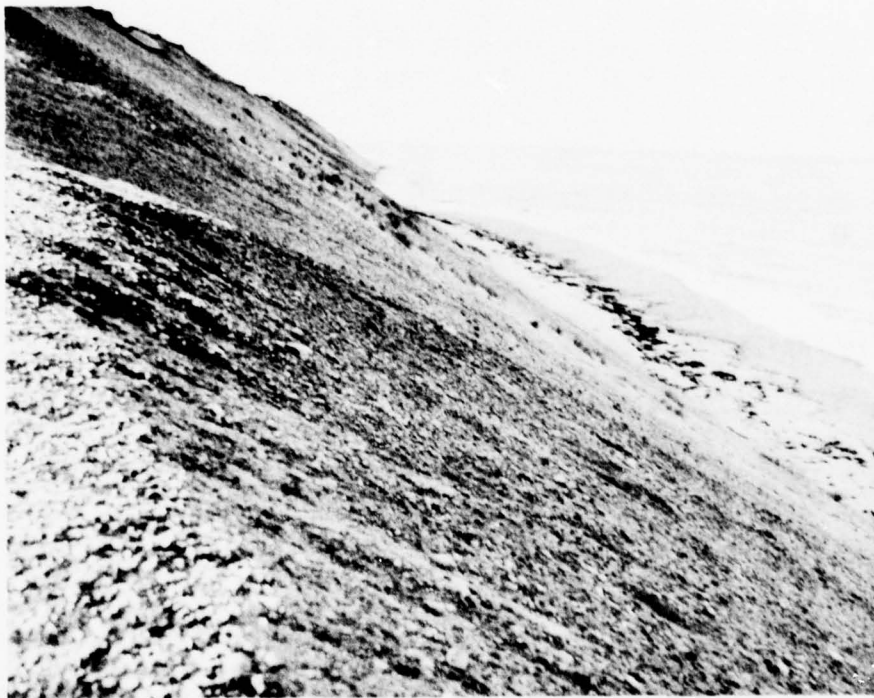
Location - Between the northern boundary of the North Truro Air Force Station and the Green Hill radio towers (Air Force Station) (Figure 12).

Figure 12. Longnook Beach, Truro, Massachusetts,
November 1977

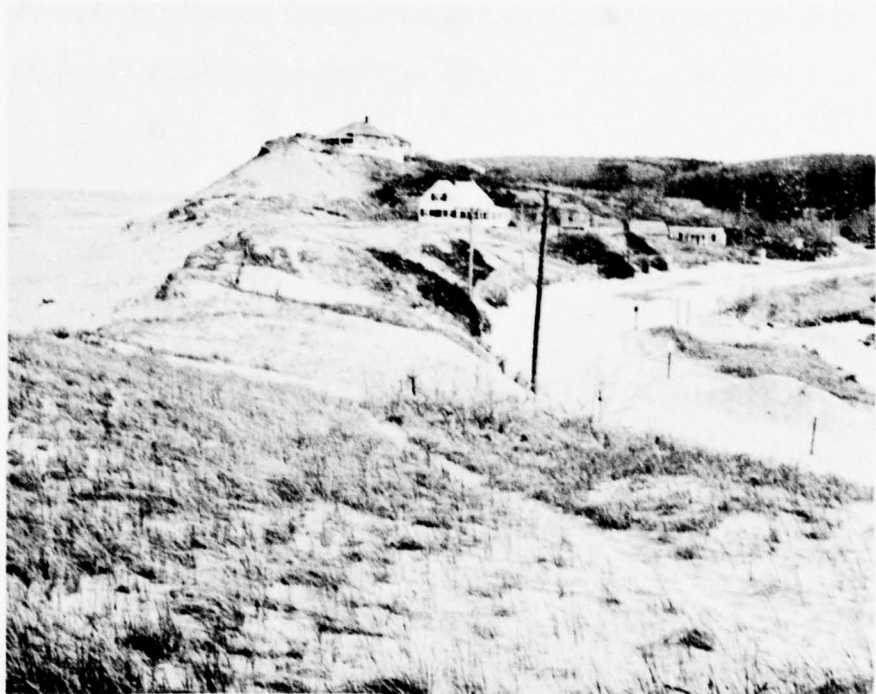
Figure 13. Ballston Beach, Truro, Massachusetts, April 1977

A different problem is seen at Ballston Beach where the low, narrow dune and beach are all that separate the Atlantic Ocean from the freshwater Pamet River valley. Should this dune be permanently breached, salt water would flow into the Pamet River valley making the land to the north an island, but, of more importance, invading a freshwater valley and recharge area. The water supply in the area would be affected, necessitating remedial action. Local interests feel very strongly that this critical barrier beach should be maintained and protected.

Erosion at Ballston Beach is a potentially more serious situation because it could allow salt water to enter the Pamet River valley, threatening the ground water of the area.

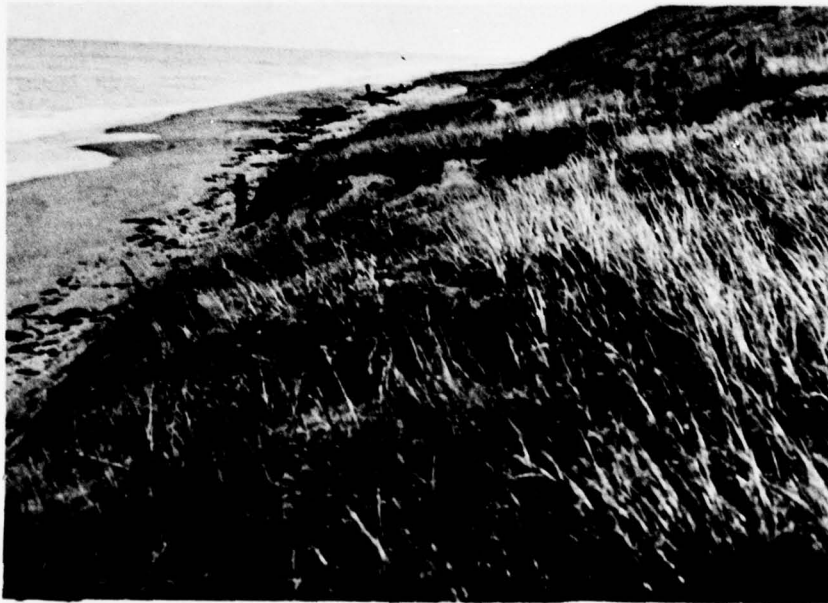
Photo 4. November 1977. A view to the south through the dunes on LeCount Hollow Beach, Wellfleet. Merriam grass in picture is a key dune builder in beach processes.

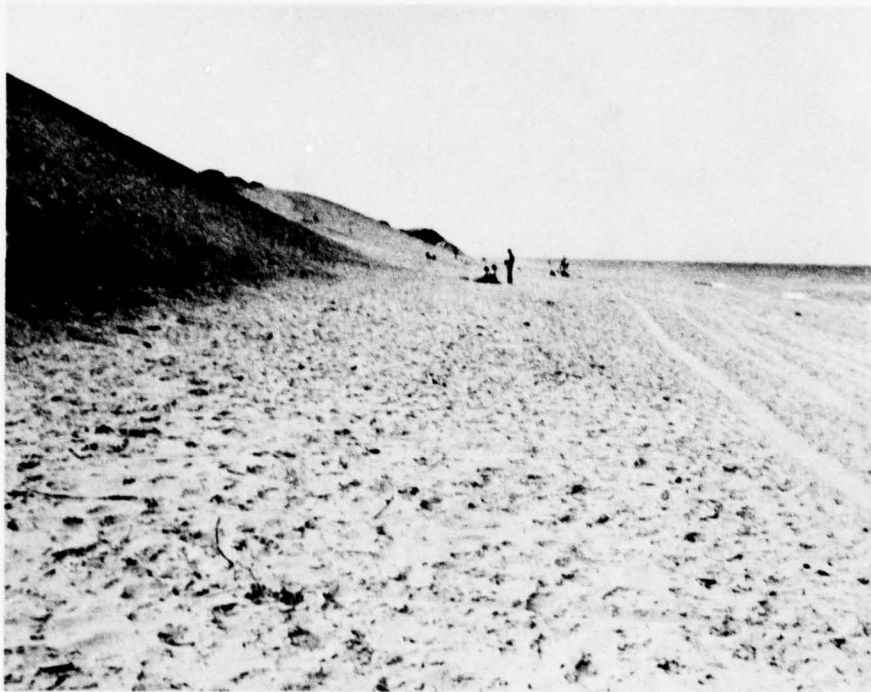
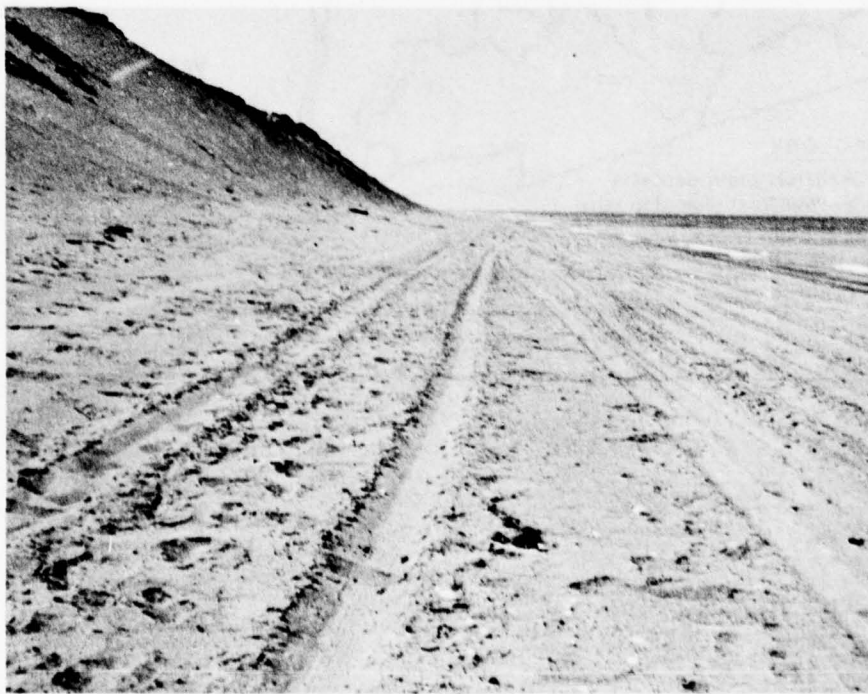
Location - Between the Truro-Wellfleet town line and the parking area north of Wellfleet by the Sea (Figure 18).

Figure 18. Newcomb Hollow Beach (top) and Cahoon Hollow Beach (bottom), Wellfleet, Massachusetts, April 1977

Character of Development - The beach itself is not developed, but there are nearly 50 houses west of Newcomb Hollow Beach and around Gull Pond. Ocean View Drive more or less parallels the shoreline, being closest to the shoreline at the parking area at the south end of Cahoon Hollow Beach.

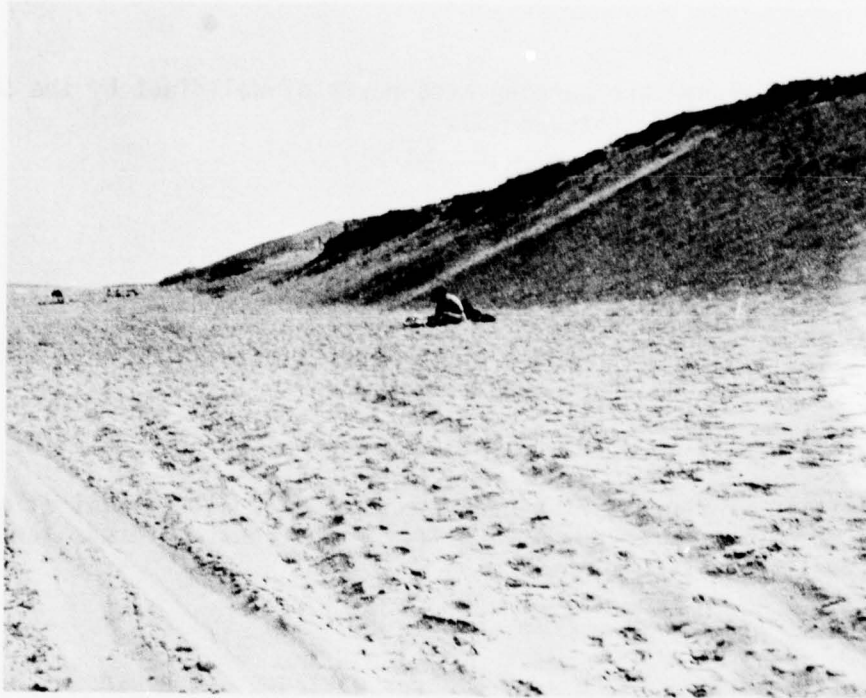
Location - Between the parking area north of Wellfleet by the Sea and the Marconi Station site (Figure 19).

Figure 19. LeCount Hollow Beach, Wellfleet, Massachusetts,
April 1977

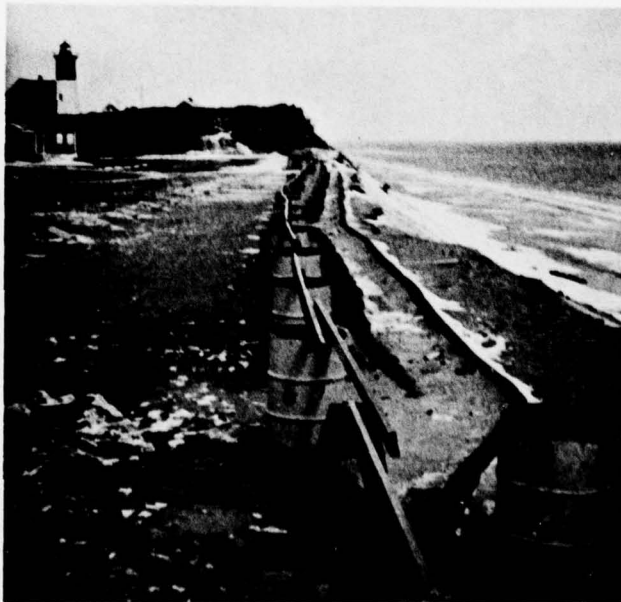
Photo 2. February 1971. Looking north from Nauset Light parking area across eroded pavement onto the beach.

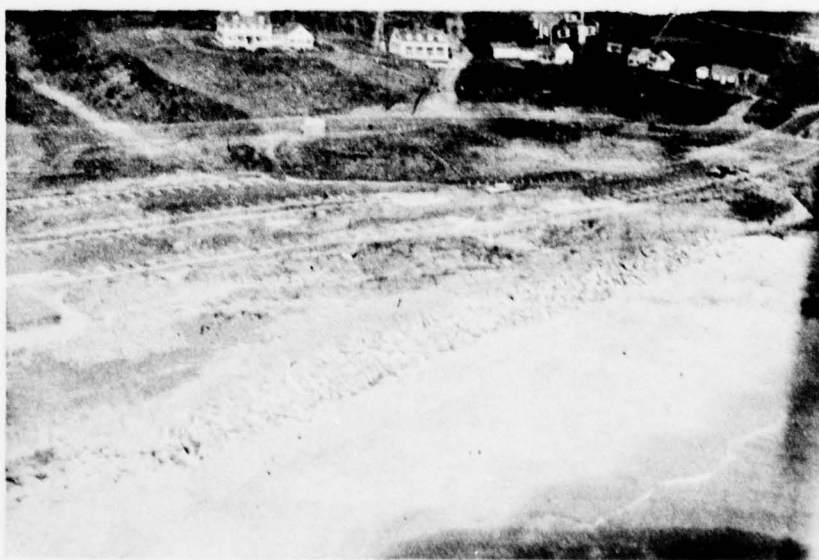
Photo 4 . June 1967. An aerial view of Coast Guard Beach, Eastham and parking area. Note distance between beach and parking area.

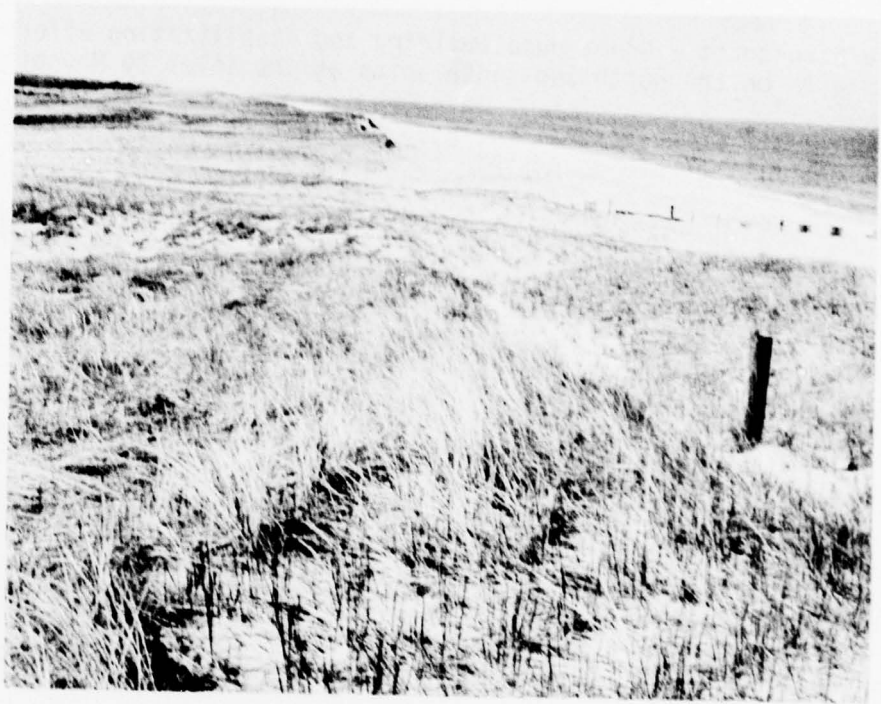
Location - From the Eastham-Orleans town line (near Nauset Harbor inlet) to the Orleans-Chatham town line, including Orleans Town Beach (Figure 29).

Figure 29. Nauset Beach, Orleans, Massachusetts

50 to 200 feet. On Nauset Spit near the Orleans-Chatham town line, the beach extends on both the east and west sides of the spit which ranges from 500 to more than 1000 feet in width. Actual beach width varies from 10 to 30 feet in winter to greater than 100 feet in summer.

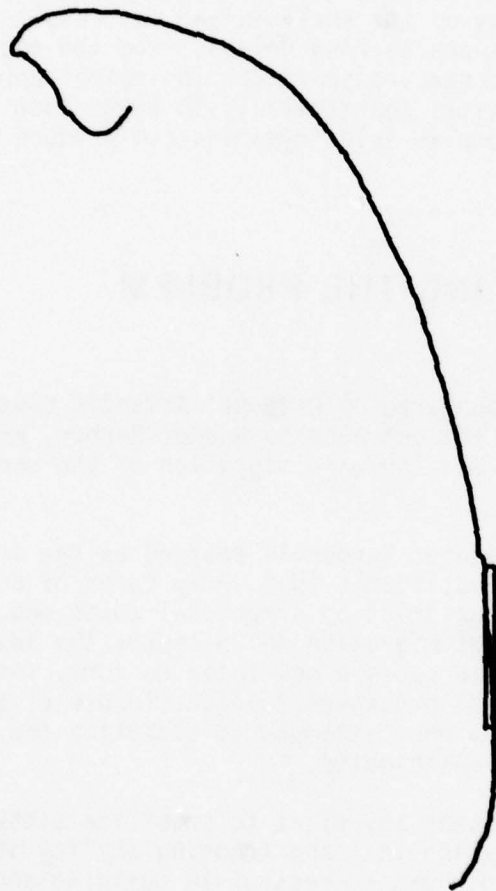
Wave refraction analysis (Cornillon et al, 1976) predicts that southerly longshore transport will predominate throughout the year along the Orleans coast (Figure 30). The southerly movement is induced primarily by waves from the north through east-northeast. Waves from the east, east-southeast and southeast will produce northerly currents. Northerly longshore currents should also result when waves approach Orleans from the southeast and south, but these cases were not run because of depth constraints in the area of Georges Bank and Nantucket Shoals. Waves approaching from these areas should contribute little to the longshore current because traveling through shallow water removes much of their energy.

Figure 30. Atlantic coast of Orleans, Massachusetts -
location of area shown in Figure 31

No nodal points (location at which the longshore transport changes direction) or fulcrum points (location at which the longshore transport attains a maximum or minimum and no net erosion or accretion occurs) are predicted for Orleans by the wave refraction analysis. The predicted sediment transport rate along this section of the coast is 675,000 cubic yards per year to the south.

Wave refraction analysis predicts little erosion south of the 10-mile mark. In fact, slight amounts of accretion are indicated in this area (Figure 31). However, accretion is not anticipated on this section of Nauset Beach. Landward migration of the barrier beach should result in shoreline retreat rather than advance for the foreseeable future. (The amount of accretion predicted is within the limits of accuracy of the analysis and may result at least in part from the omission of waves approaching Orleans from the south and southeast.) At this time, accurate erosion/accretion rates cannot be predicted for the barrier beach system, particularly in areas such as the spits at Nauset Harbor inlet where complex inlet dynamics can produce changes in the inlet with every tide.

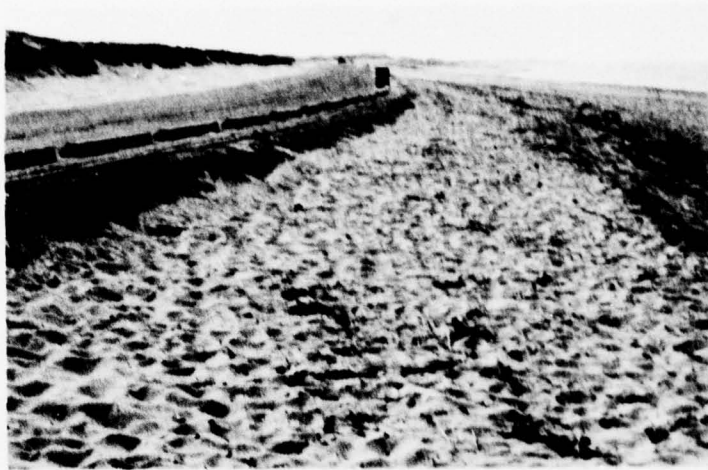
Photo 1. January 1967. The effect of sand fences in dune building is easily seen in this aesthetic view of southern Nauset Beach, Chatham. The now removed Old Harbor Coast Guard Station looms in background.

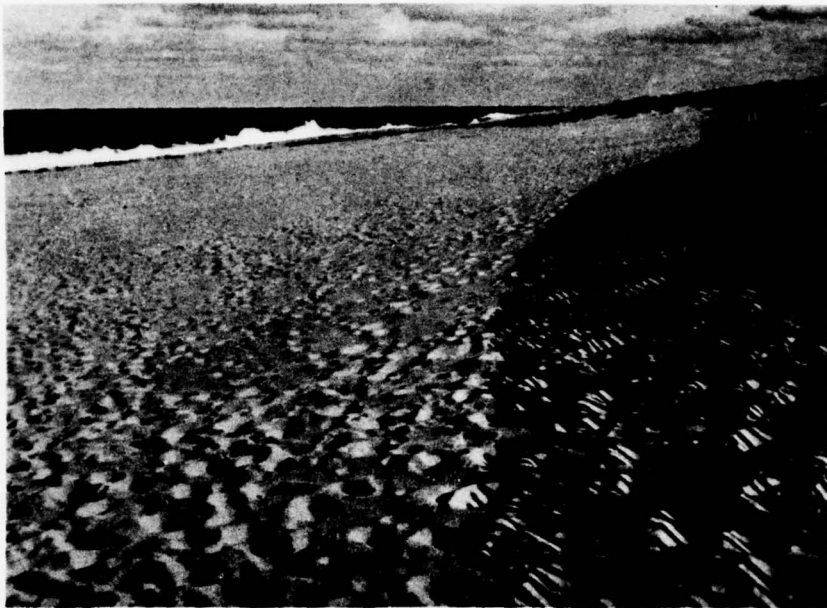
Photo 4 . November 1977. A shot taken near the Coast Guard Station at Race Point Beach, Provincetown looking to the northeast. Note dune formation behind sand fence.

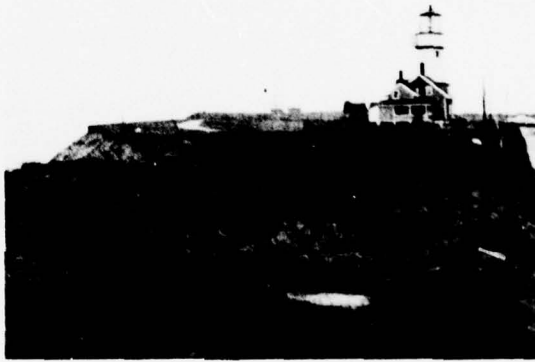
Figure 39. Highland Light, Truro, Massachusetts

Location and Description - Highland Light, also known as Cape Cod Light, is located in the Highlands of Truro about 1.5 miles northeast of the settlement of North Truro (Figure 39). The light station, manned and operated by the U.S. Coast Guard, is situated on the high marine scarp overlooking the Atlantic.

The coast at Highland Light trends northwest-southeast. Fetch from the east (at an angle of 45 degrees to the coast) is unlimited; the fetch distance decreases to 150 nautical miles at 90 degrees to the coast and to 100 nautical miles from the north (at an angle of 45 degrees to the coast). High glacial cliffs behind the beach supply sand both to the beach and to the littoral currents that carry the material to the north. Offshore bars are located about 2,000 feet from the beach, and numerous complex bars are located in the nearshore zone (Zeigler et al, 1959).

History - The light station was constructed in 1797 to reduce the large number of shipwrecks in the area. So that it would not need to be moved repeatedly, the lighthouse was situated back from the edge of the bluff. When Highland Light was constructed, the lighthouse was located about 450 feet back from the edge of the bluff; this distance has been reduced to about 200 feet by erosion. Less than 3 acres remain of the original 10 acres on which the lighthouse was constructed. Erosion has removed the rest (Chamberlain, 1964). Many of the outbuildings, including the keeper's house, have been moved several times. Remains of several buildings and foundations are visible on the beach below. Highland Life Saving Station, built in 1872, was located about 0.8 miles west of Highland Light (Dalton, 1902).

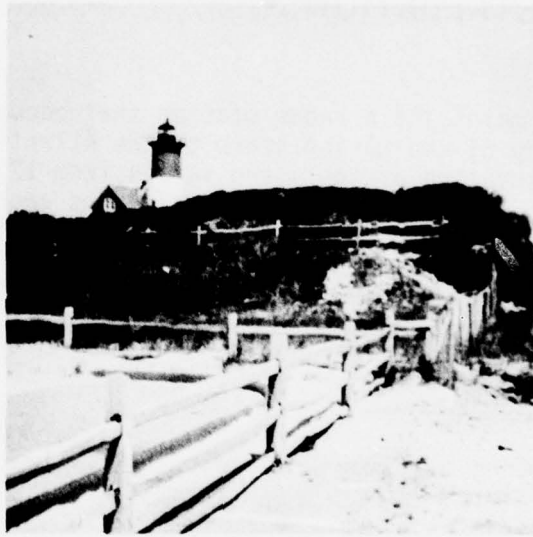
Figure 40. Nauset, Eastham, Massachusetts

Location and Description - Nauset Lighthouse is located at the end of Cable Road in Eastham, approximately 1 mile north of Nauset Bay on the Atlantic Ocean. The lighthouse is situated about 50 feet above the ocean on a high scarp that is part of the Eastham outwash plain (Figure 40).

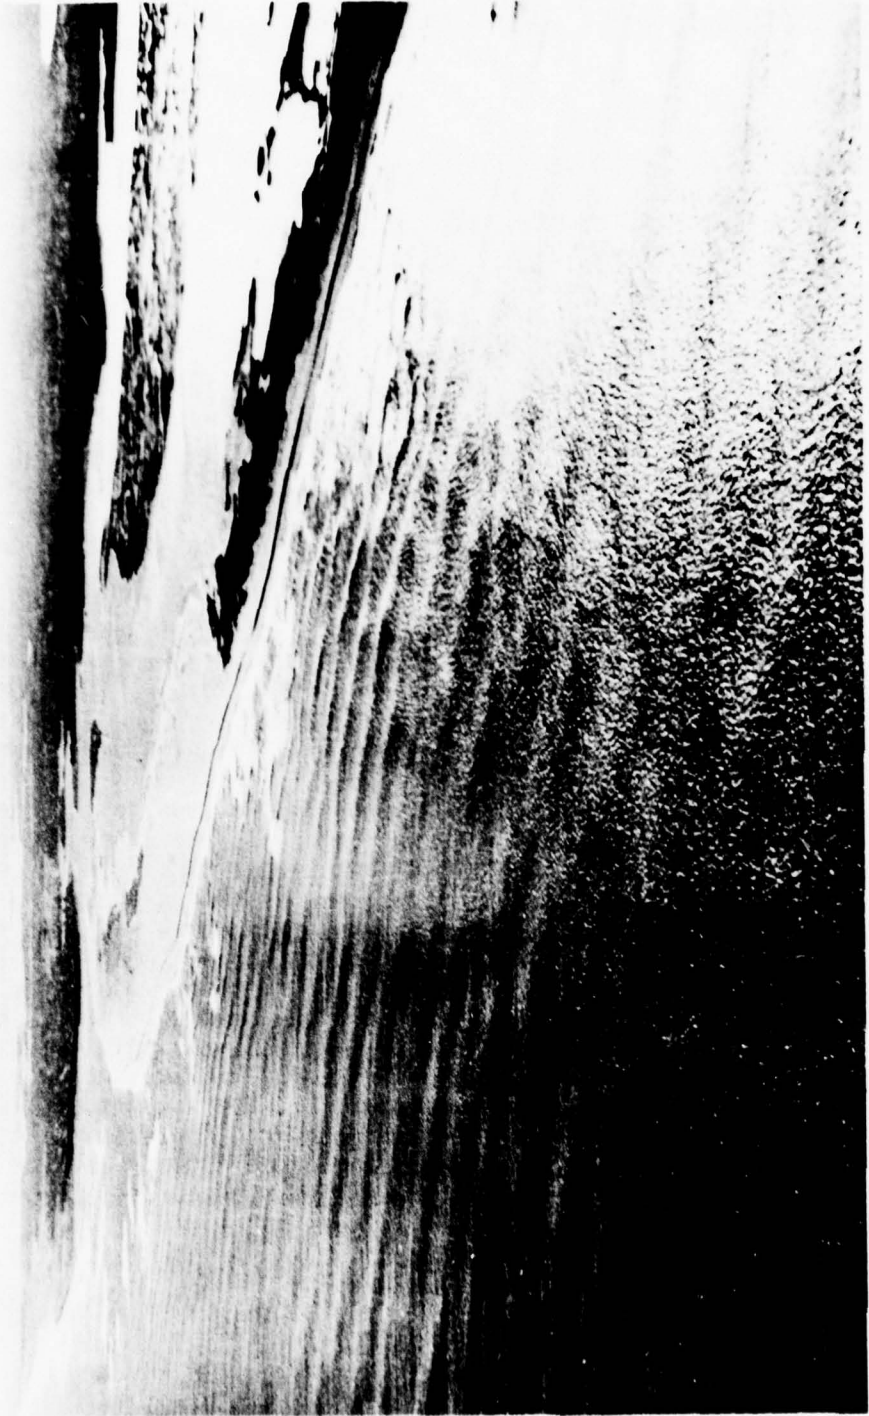
Figure 41. Nauset Harbor Inlet, Cape Cod, Massachusetts

Navigation through the inlet to Nauset Harbor is hampered by the shoaling and shifting of natural channels which reduce its usefulness for commercial

and recreational craft and as a harbor of refuge. Washovers and eolian transport introduce large amounts of sand into Nauset Bay and Harbor, filling navigation channels and covering shellfish beds.

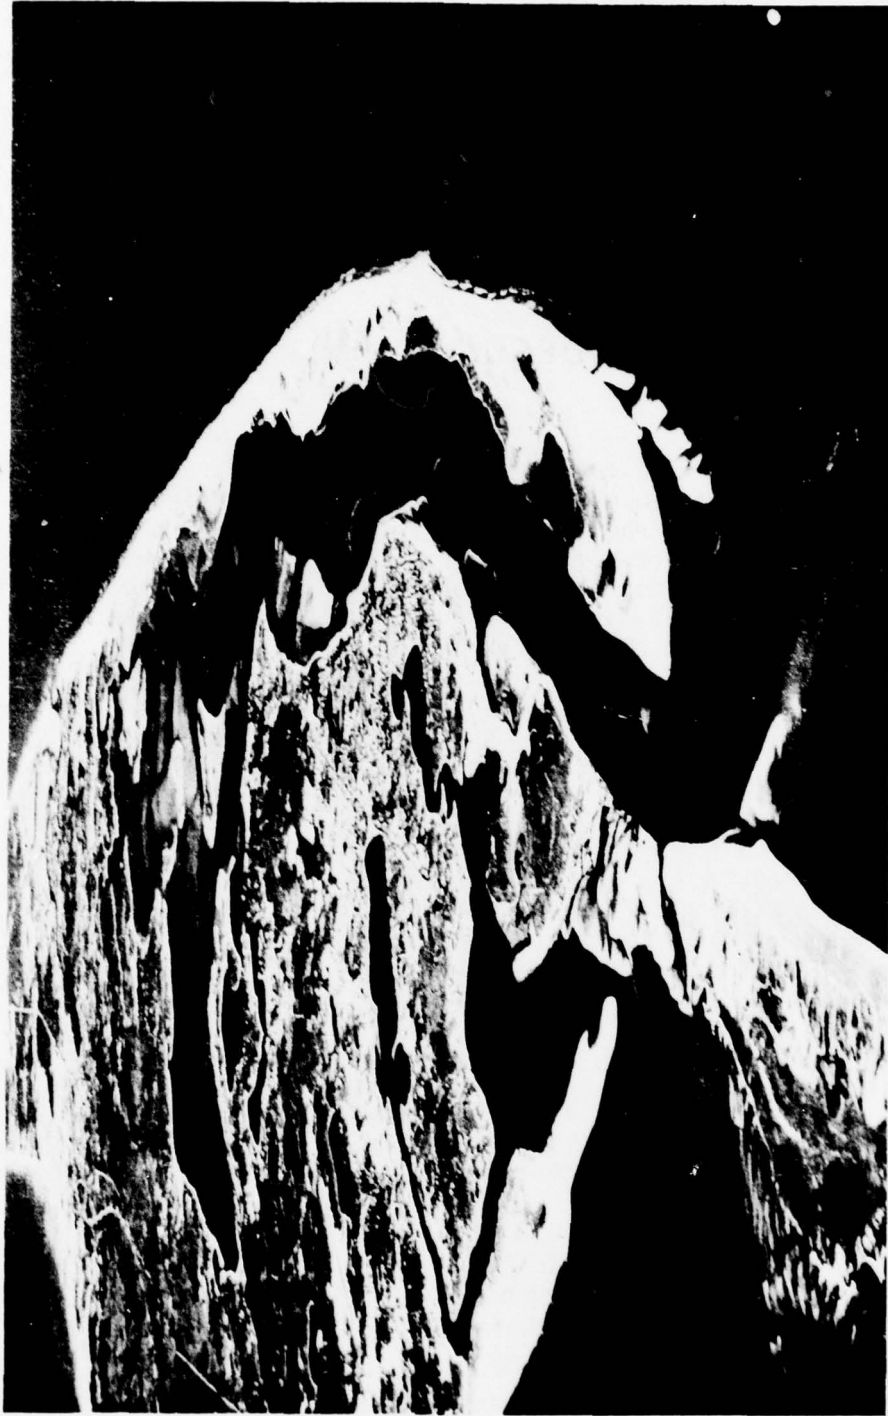
Figure 43. Pleasant Bay and Chatham Harbor, Cape Cod, Massachusetts

Pleasant Bay, a shallow salt water lagoon, is located in the towns of Orleans, Harwich and Chatham at the "elbow" of Cape Cod (Figure 43). Little Pleasant Bay and Chatham Harbor are adjacent to it. The harbor and bay complex is bounded on the north by the town of Orleans, on the west by the towns of Orleans, Harwich and Chatham, on the south by Nantucket Sound and Monomoy Island, and on the east by the Atlantic Ocean and Nauset Beach (U.S. Army Corps of Engineers, 1968).

Nauset Beach is a low, sandy spit about 8 miles long extending south from Nauset Heights. Dunes are found on the northern end of the spit, but because of the relatively recent origin of the southern end of the spit, large dunes are not generally found in this area. Overtopping during storms and the formation of washovers are common (U.S. Army Corps of Engineers, 1968).

Monomoy, now an island, extends about 8 miles south from the mainland of Cape Cod into Nantucket Sound. Prior to the winter of 1957-58, Monomoy was attached to the southern coast of Chatham but winter storms separated Monomoy from Morris Island, leaving tidal flats (U.S. Army Corps of Engineers, 1968). The separation was completed by the Great Atlantic Storm of March 1962 (Gatto, 1975).
